**Building recording
at Home Farm, Moor Place,
Much Hadham, Hertfordshire
October 2013**

**report prepared by
Chris Lister**

**commissioned by
Foxley Builders**

CAT Report 735
January 2015

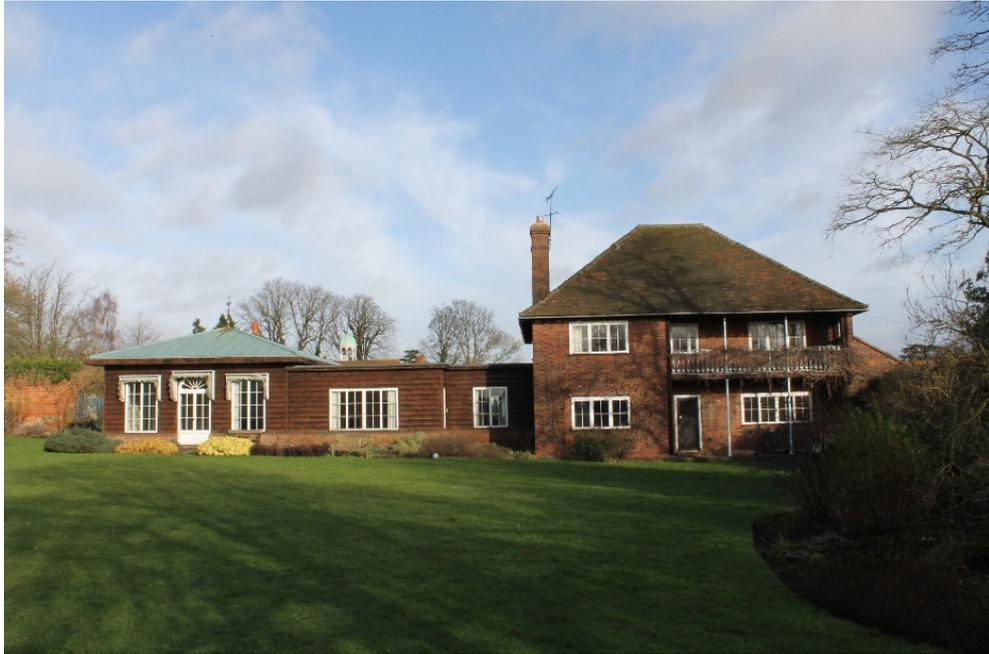
Plate 120 Structure 17 Garden House west elevation showing the single-storey extension with attenuated door hood and the recessed veranda on the first floor – view north-west

Garden House is a two-storey dwelling with single-storey extensions located at the south-east corner of the walled kitchen garden (Plates 120, 121). The two-storey house is brick-built with a hipped tile roof and has a single-storey extension to the east with an entrance under an attenuated hood. To the west there are two timber single-storey extensions, one flat-roofed, the other pyramidal. The first floor to the south elevation of the main house has a recessed veranda.

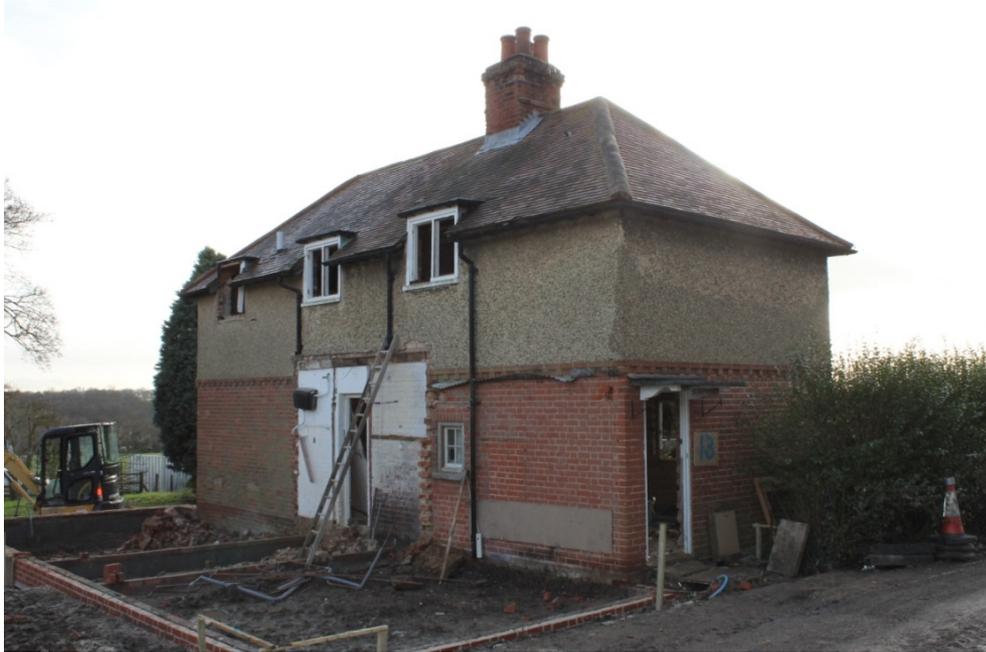
Plate 124 Structure 21 Dairy Cottage south elevation showing the half-dormer windows to the first floor and the eastern extension (source: AHP 2012) – view north-east

Dairy Cottage is a two-storey brick dwelling with a hipped tile roof (Plates 124,125). The first floor has been pebble-dashed and has casement windows forming half-dormers. The cottage originally had a centrally-located stack until the addition of an extension to the east created a third bay in matching style. The cottage first appears on the 1918 estate plan (Map 9) and may have been constructed at the same time as Garden House was rebuilt. There is no obvious reason for the name but it may indicate the home of the head dairyman to the farm.

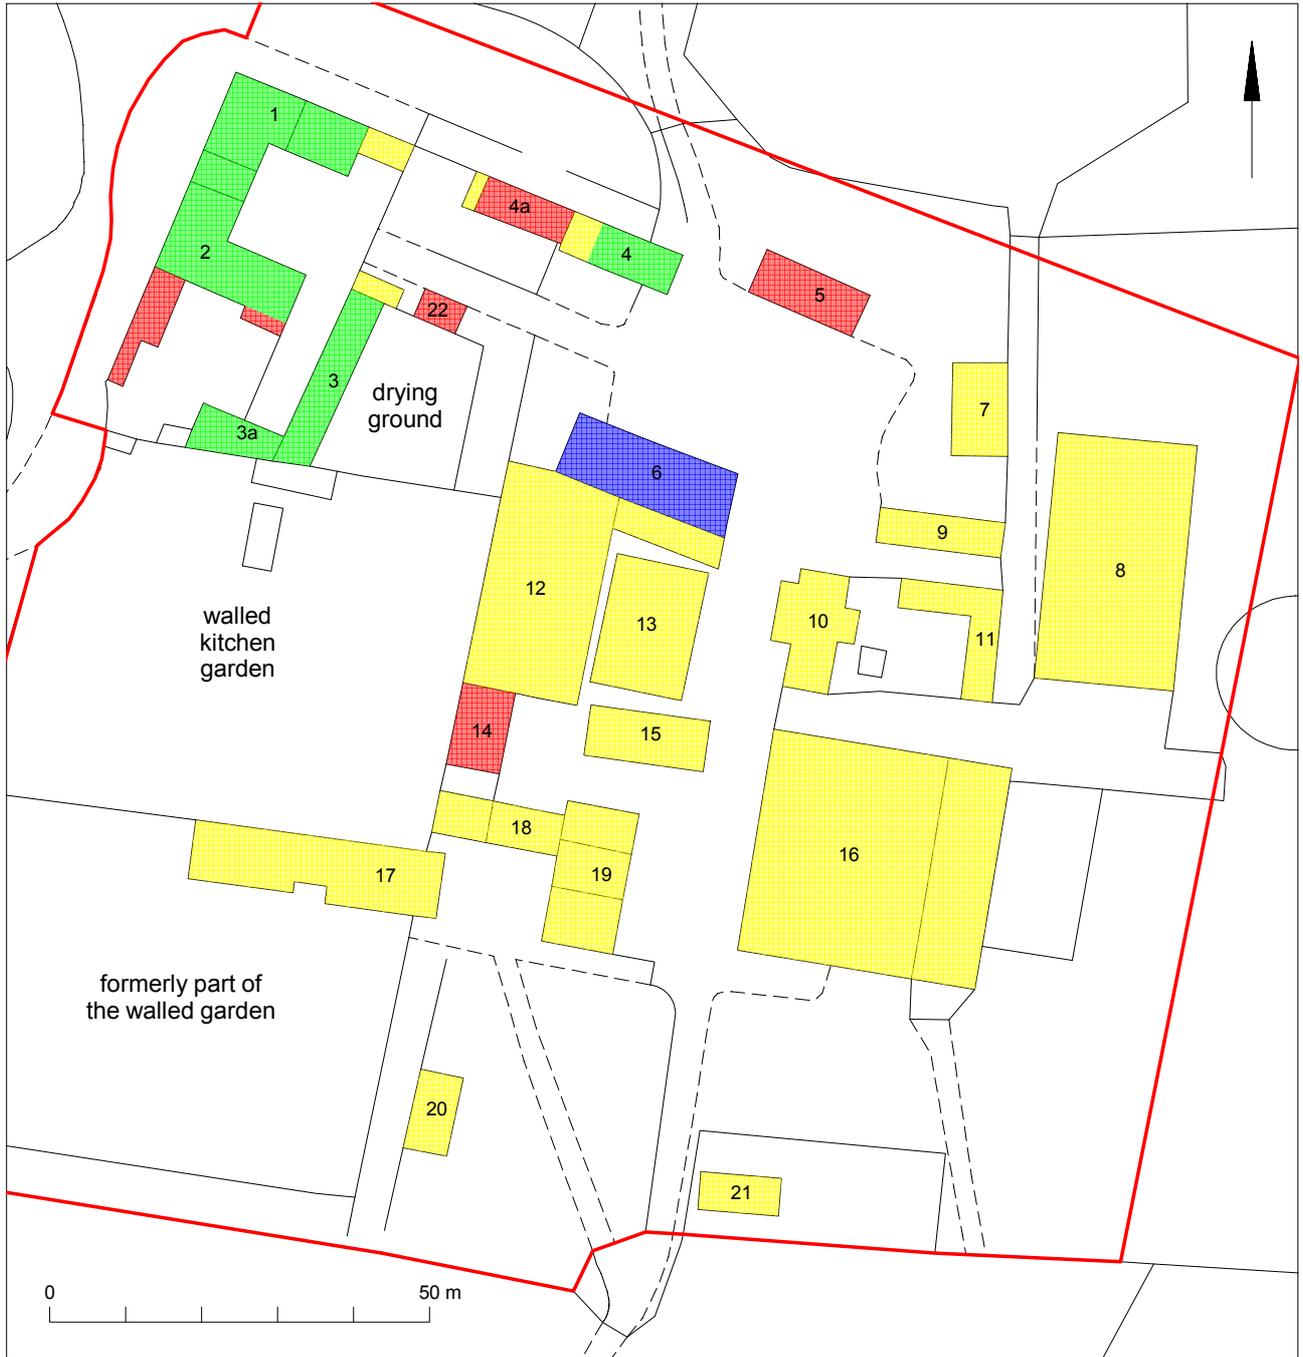
Fig 2 Block plan.

| <ul style="list-style-type: none"> 17th century 18th century 19th century 20th century | <ul style="list-style-type: none"> 1/2 The Stables, early-mid C18th 3 Estate office, C18th 3a Gardener's stores, C18th 4 Granary/cow house, C18th 4a Farm Cottage, 1870? 5 Dutch barn, 1898-1918 6 Barn, C17th 7 Brick outbuilding, 1928-46 8 Modern farm building, post 1946 9 Concrete blockwork building, post 1946 10 Milking shed, 1898-1918 11 L-shaped range east of milking shed, 1928-46 12 Large shed south of barn, 1898-1918 13 Second large shed south of barn, post 1946 14 Squash court, 1886-98 15 Engine house, 1911 16 Modern stables and manege, post 1946 17 Garden House, 1898-1918 18 Garages to Garden House, post 1946 19 Wall and modern shed adjoining garages, 1838 and post 1946 20 Apple store, 1918 21 Dairy Cottage, 1898-1918 22 Tool shed opposite Farm Cottage, 19th-century |

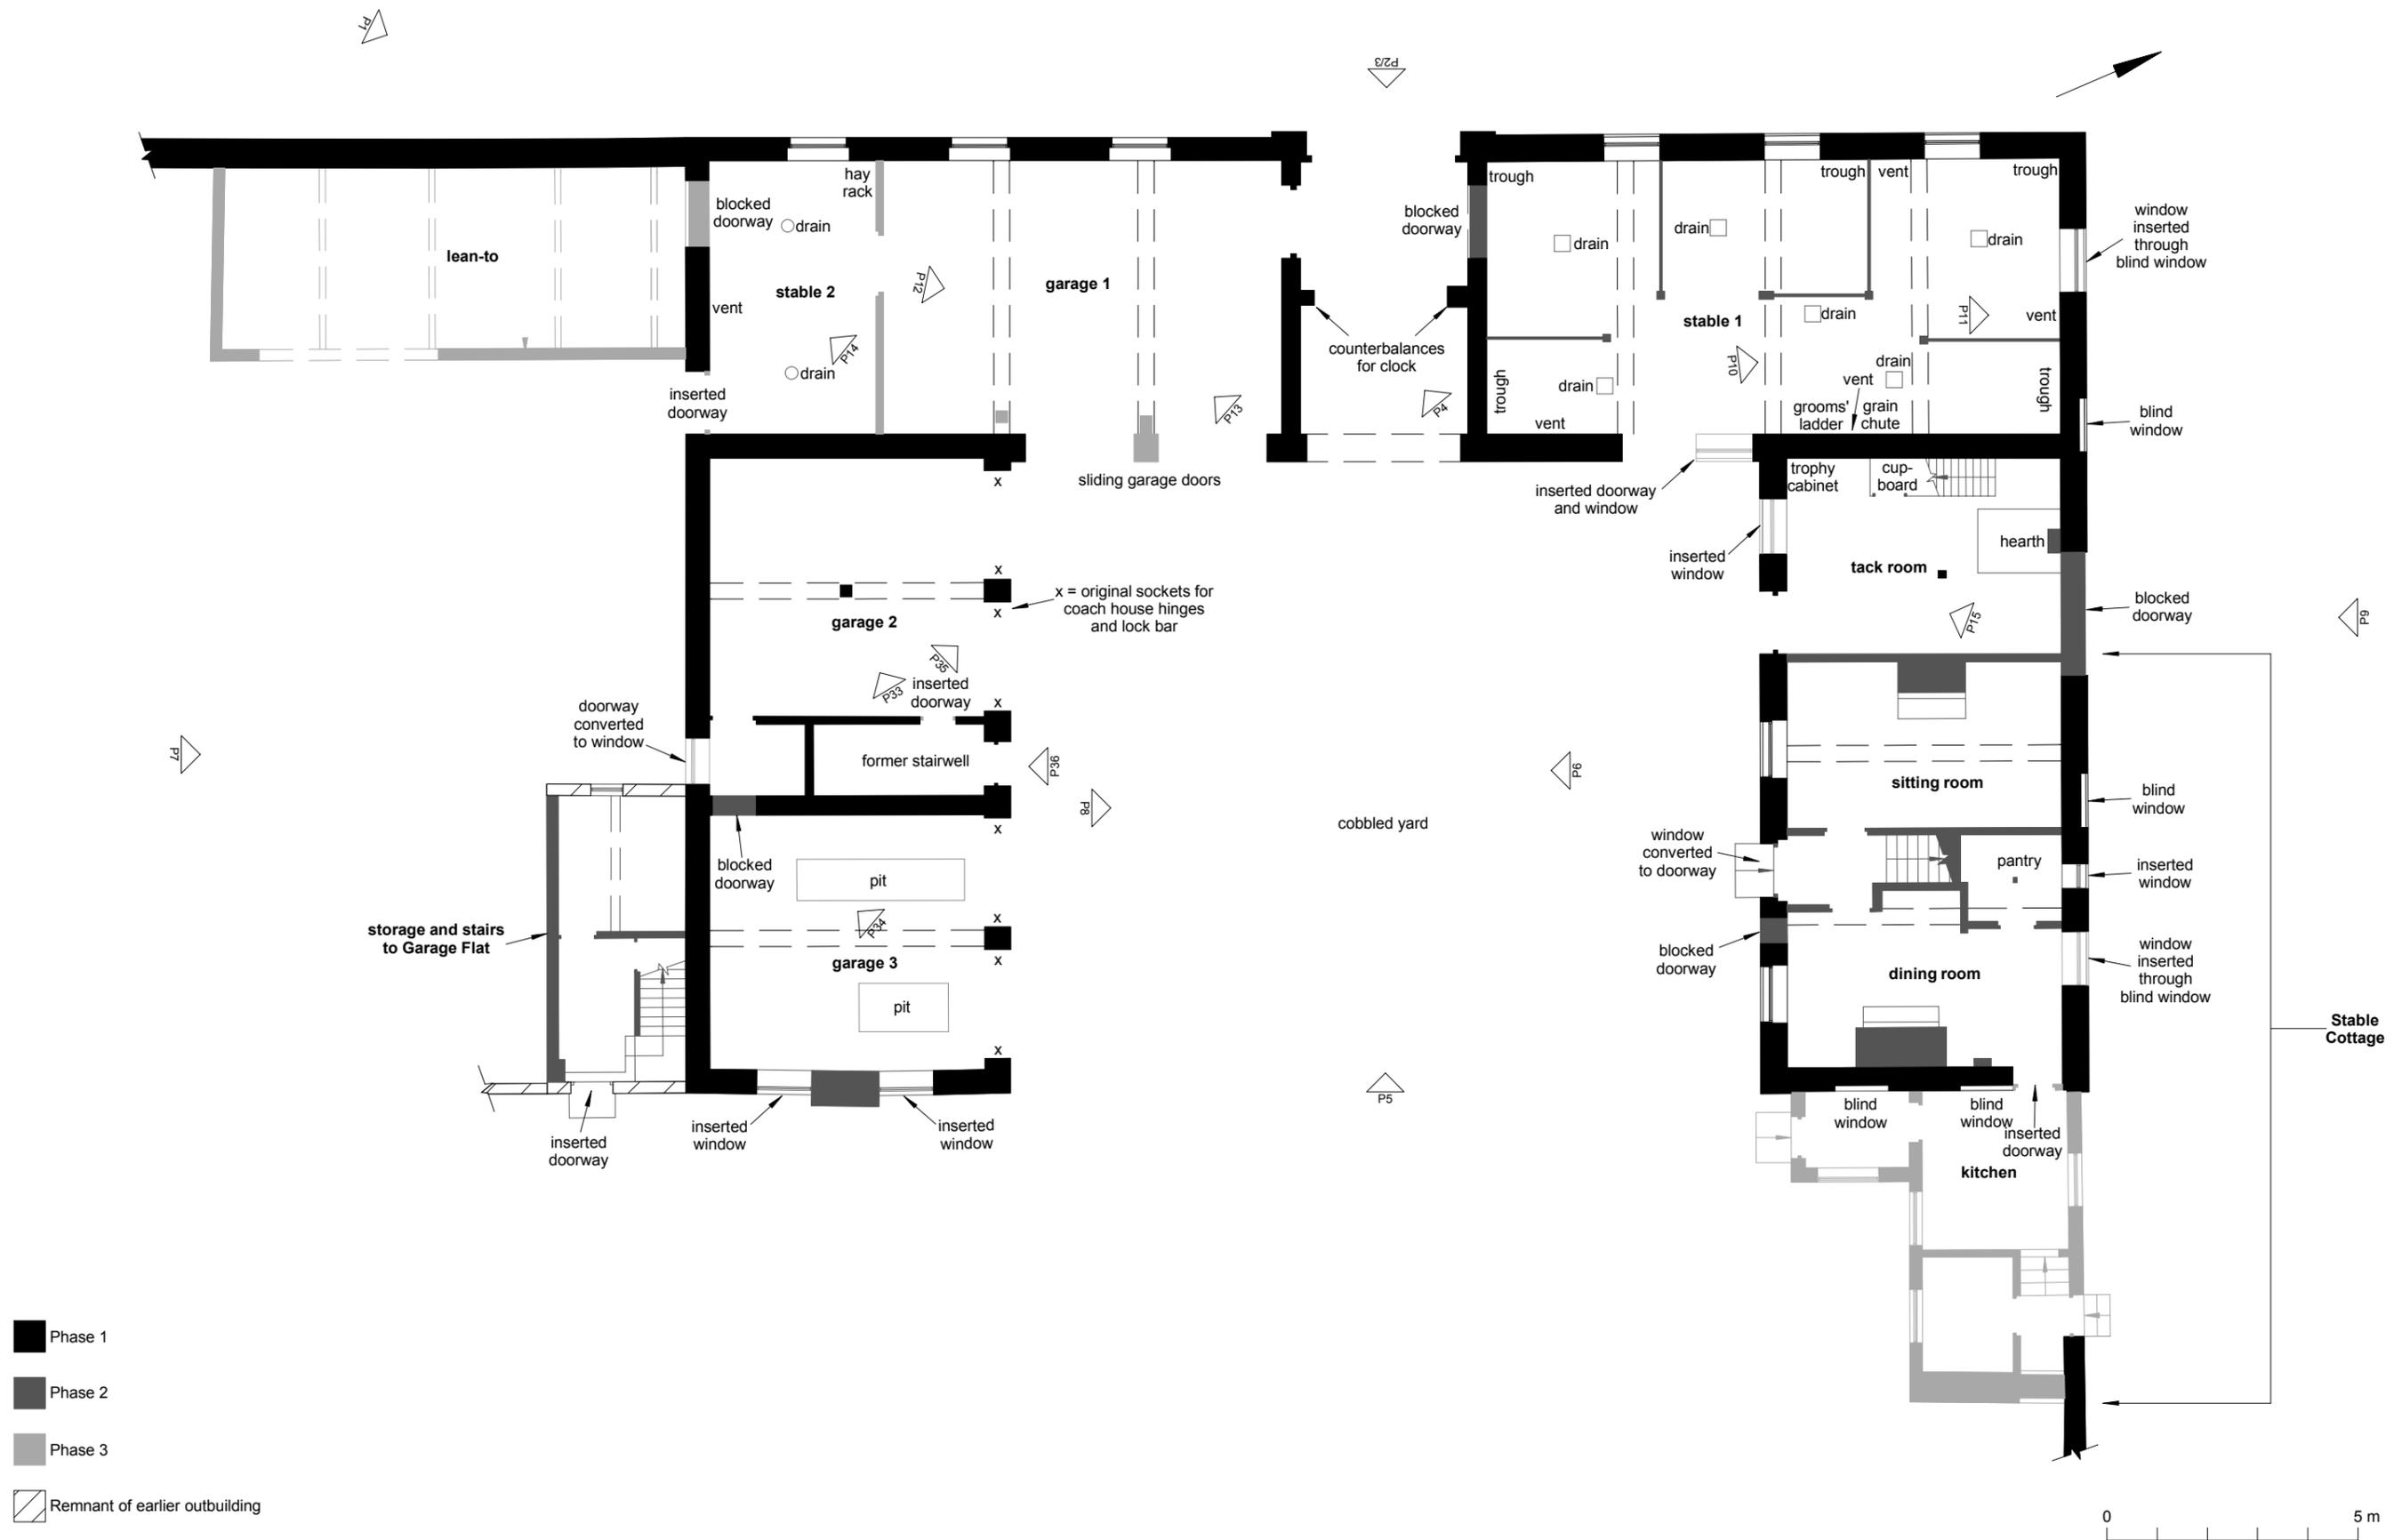
Fig 3 Structure 1/ 2, 18th-century stable block ground floor plan, showing the location and orientation of photographs included in this report.

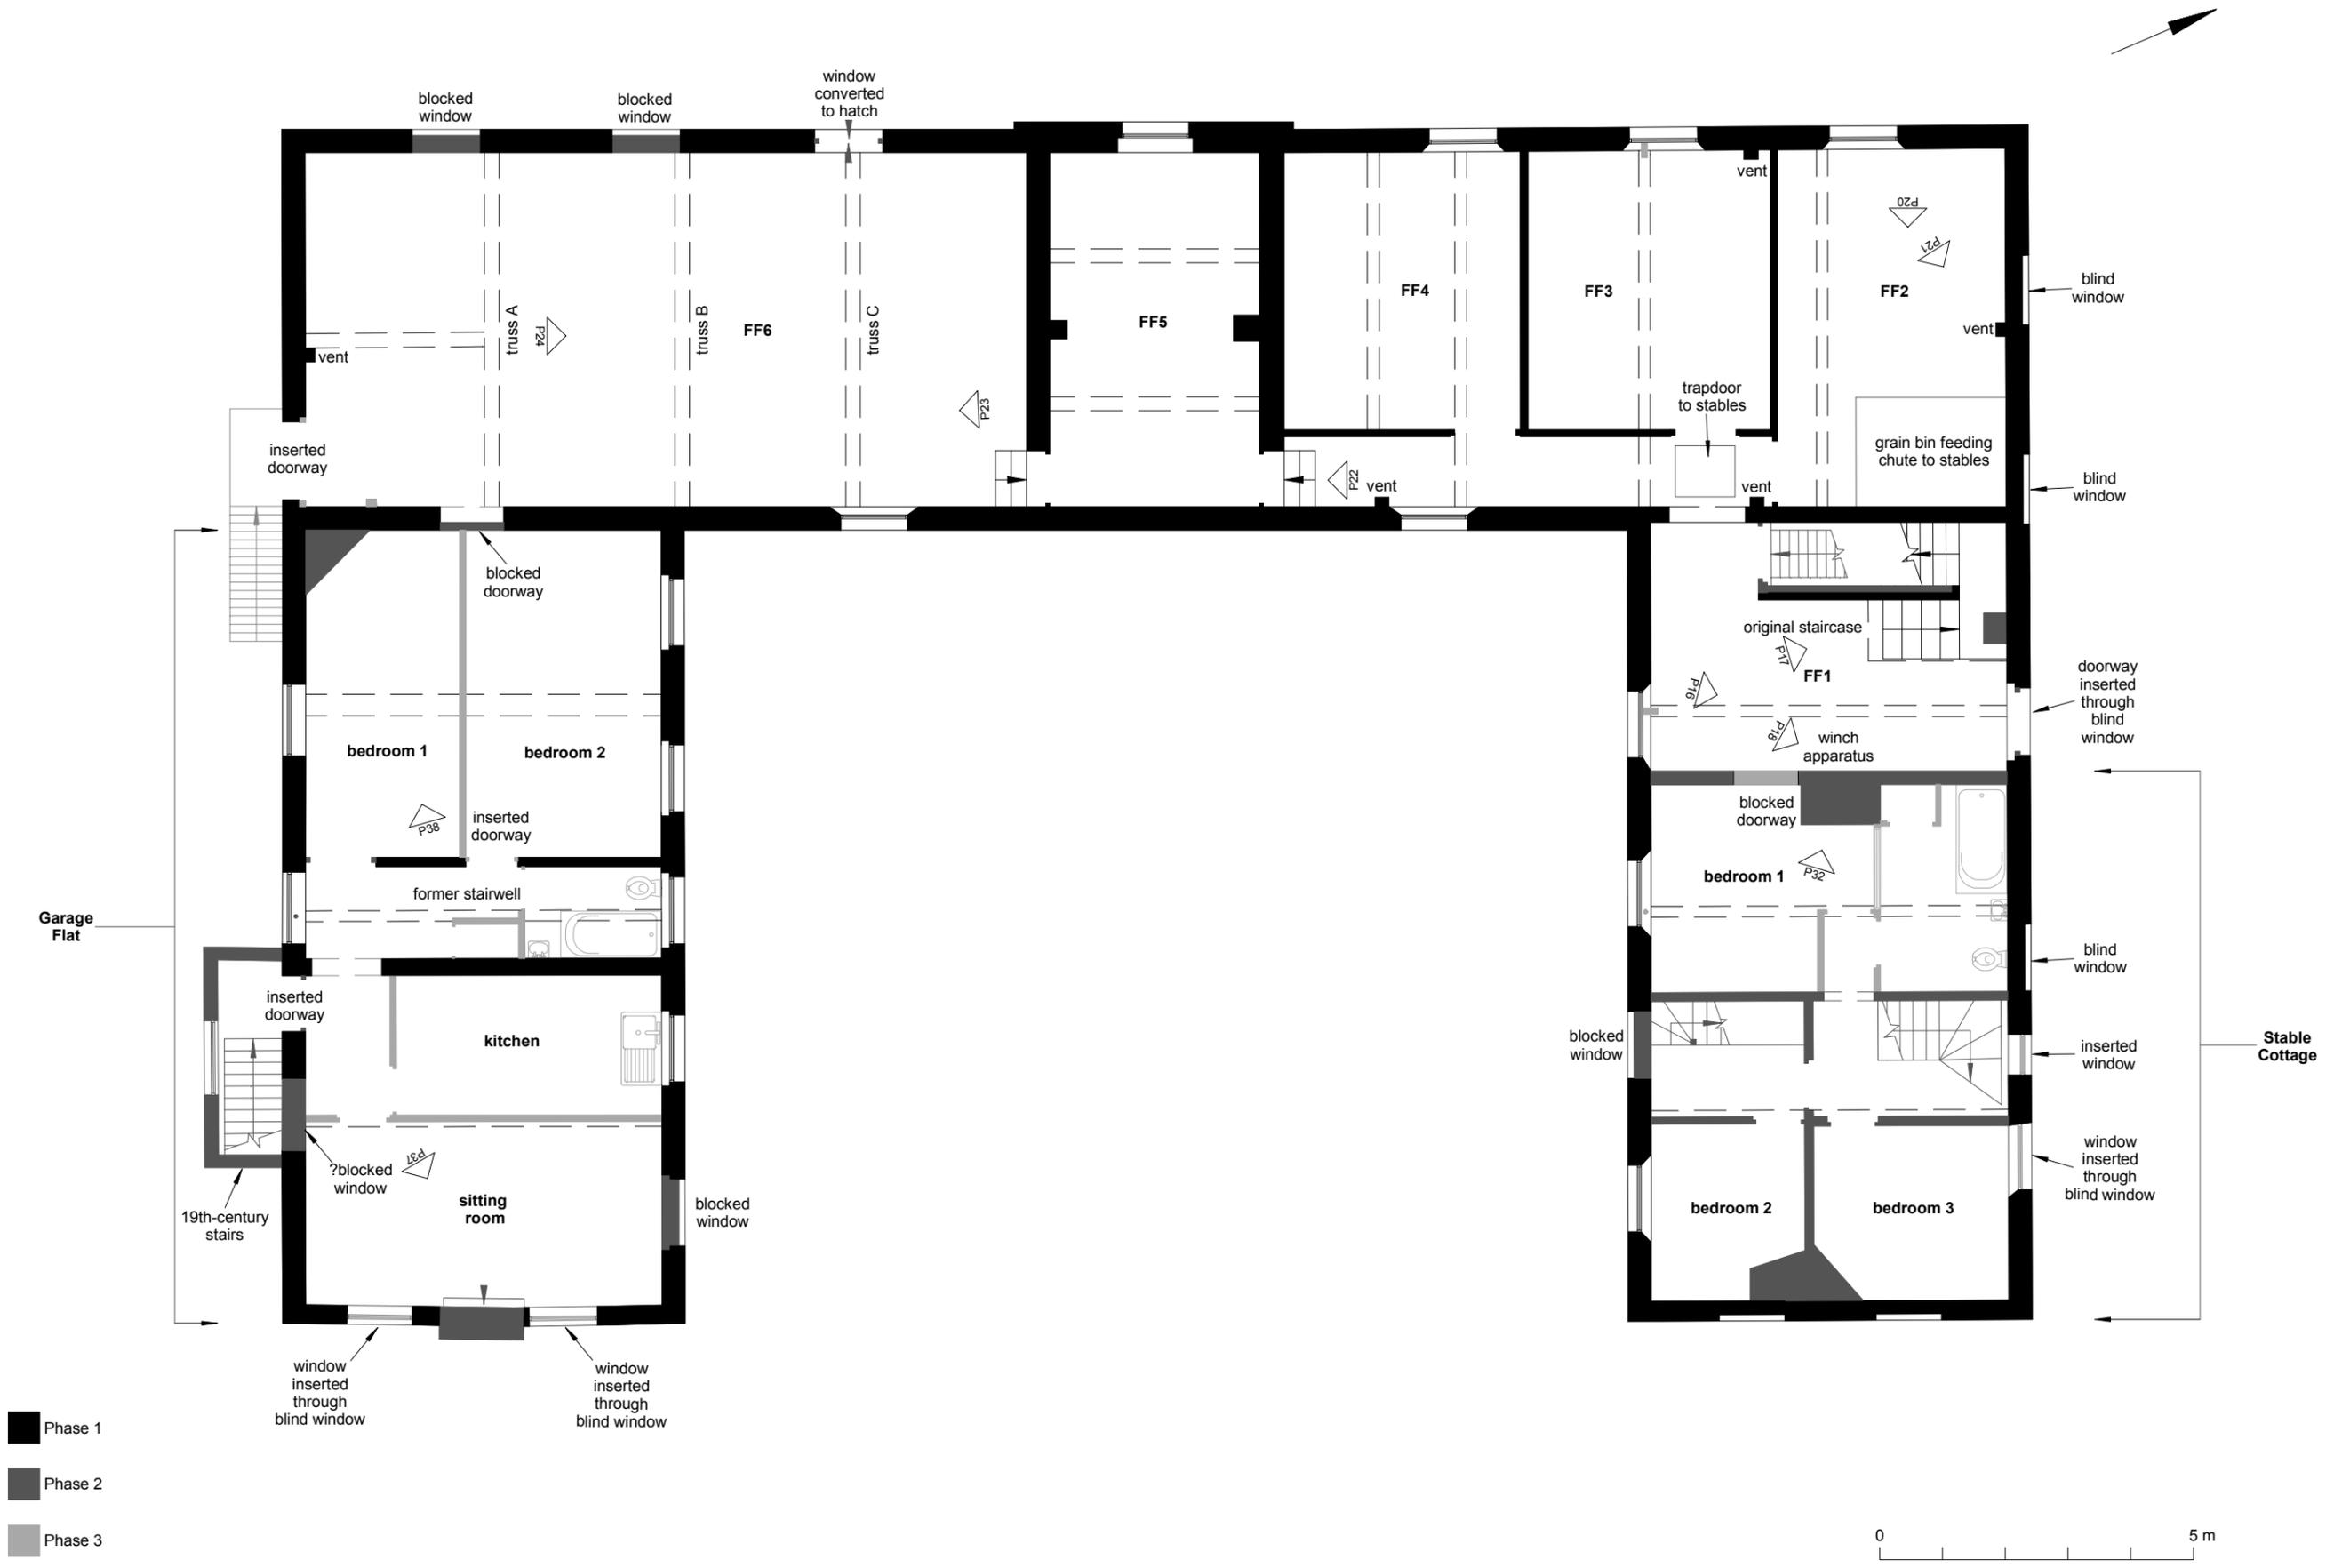
Fig 4 Structure 1/2, 18th-century stable block first floor plan, showing the location and orientation of photographs included in this report.

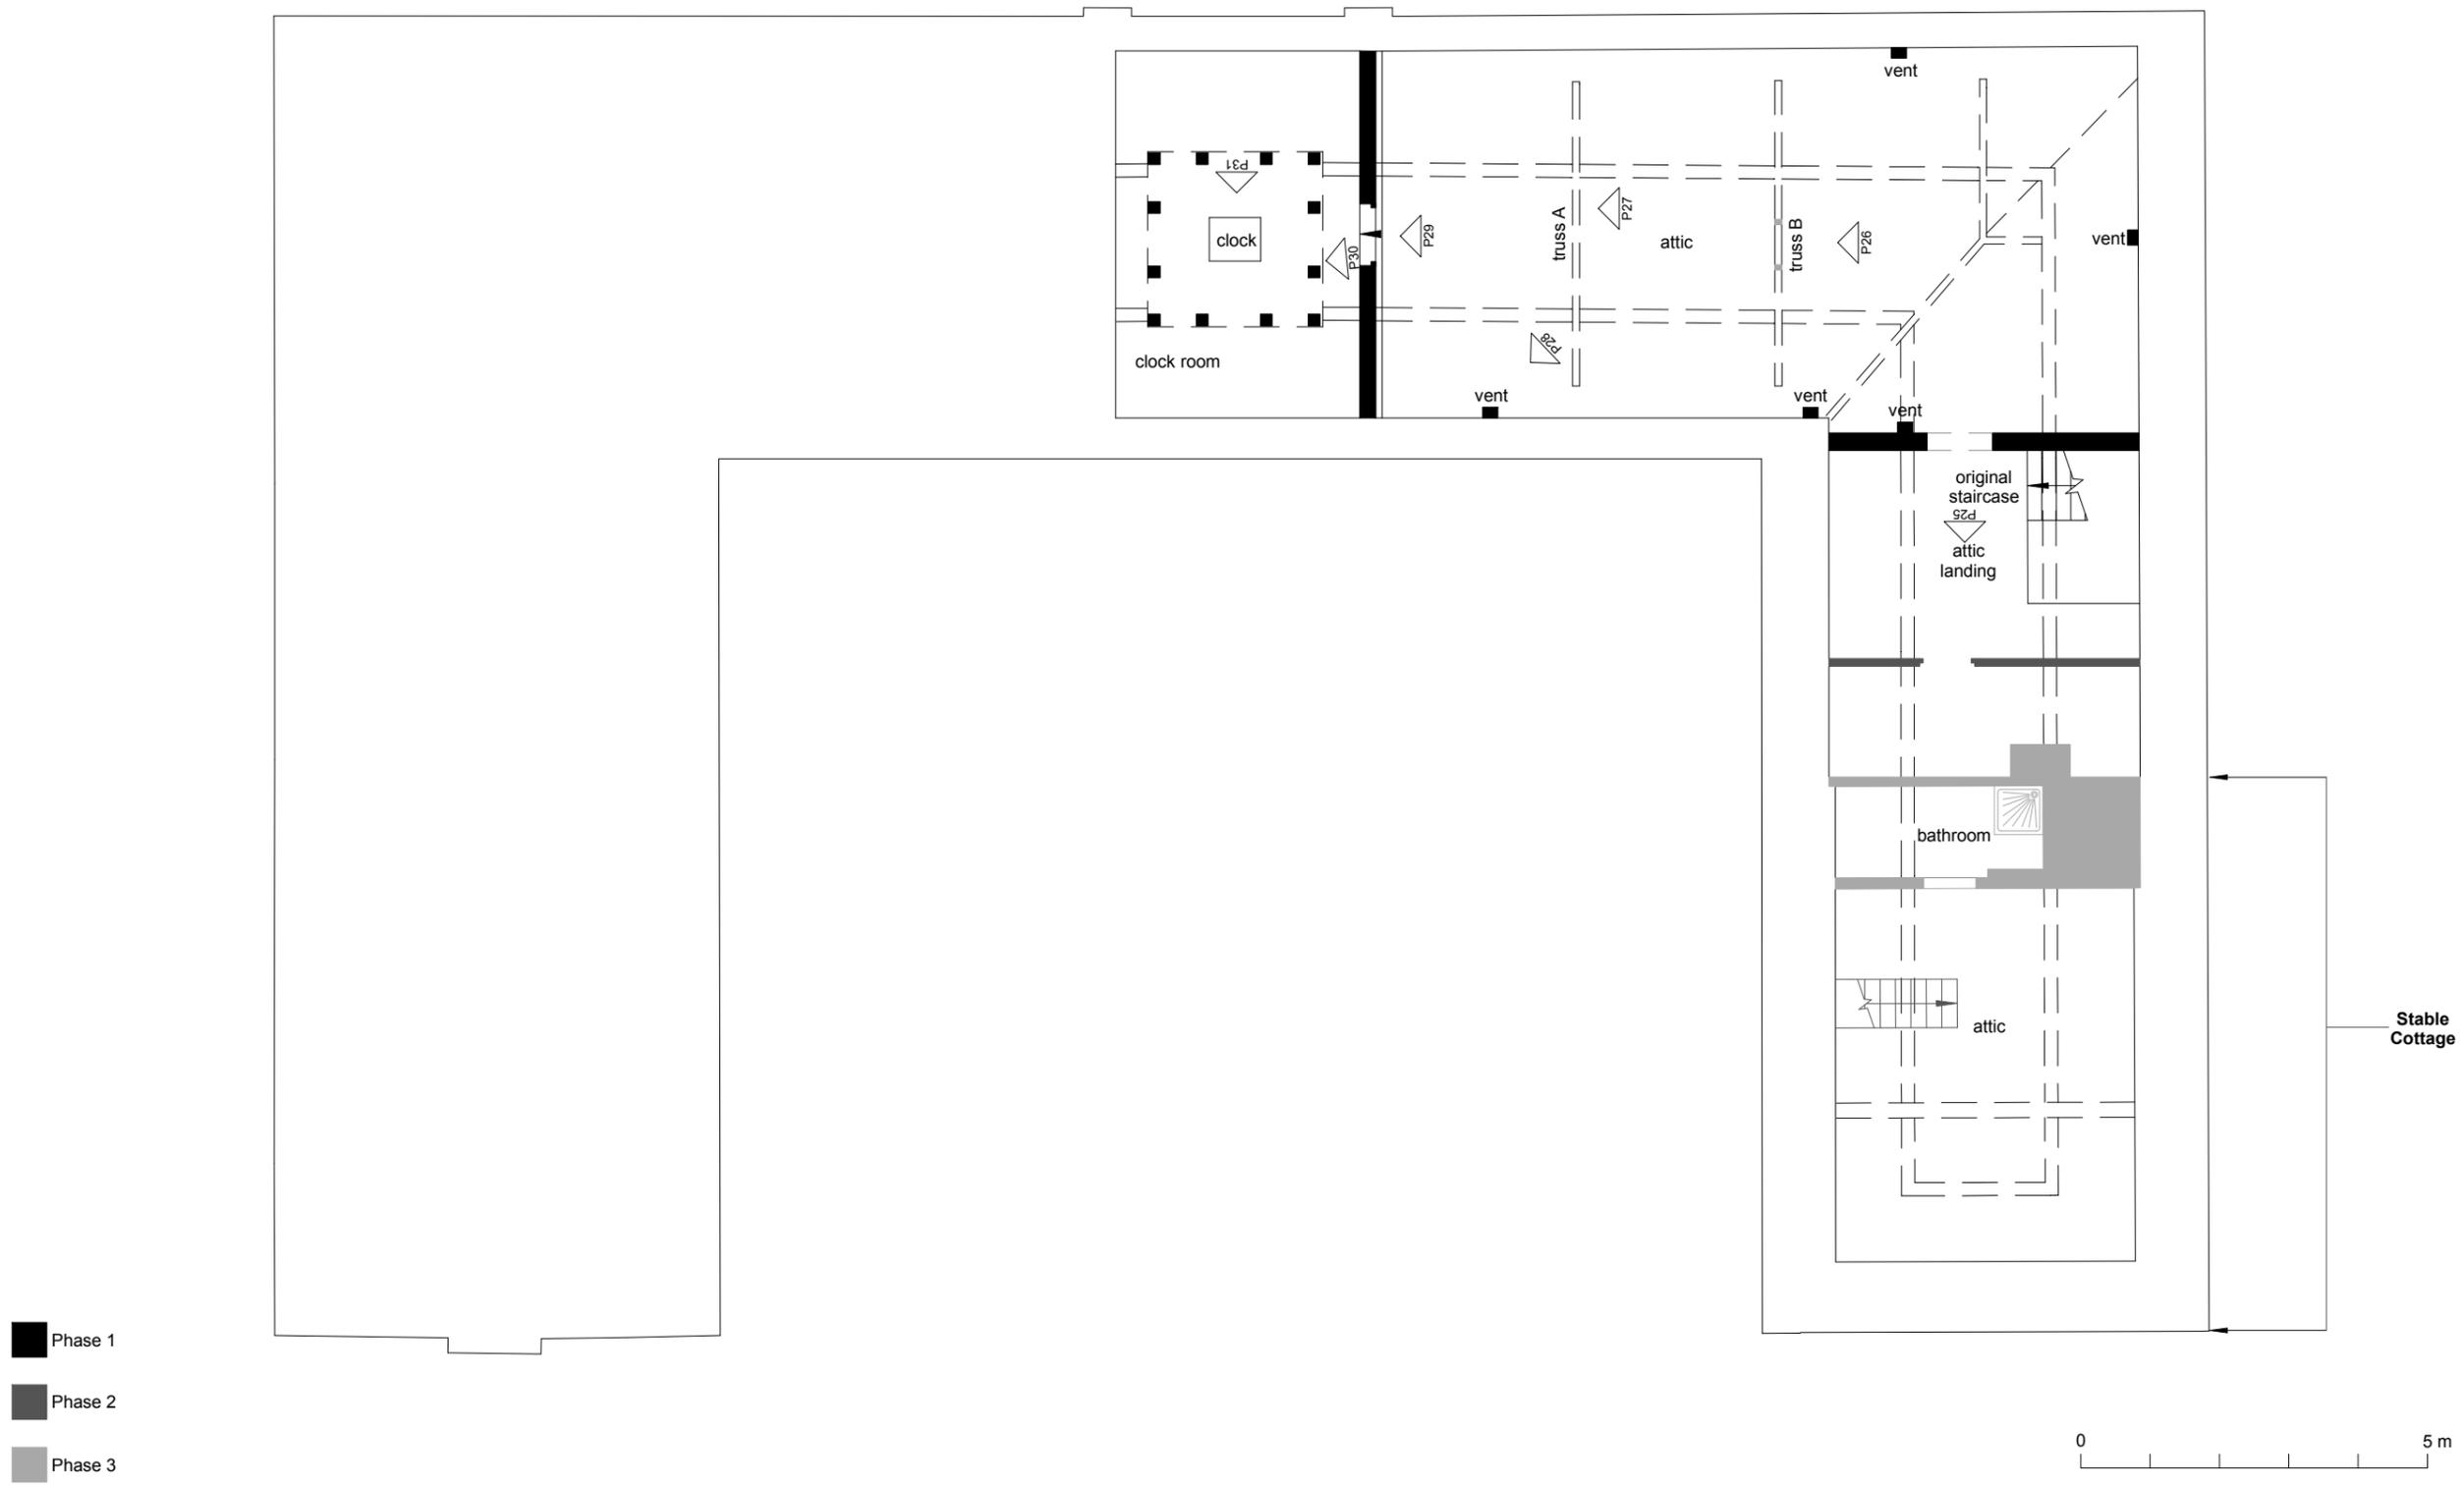
Fig 5 Structure 1/2, 18th-century stable block attic plan, showing the location and orientation of photographs included in this report.

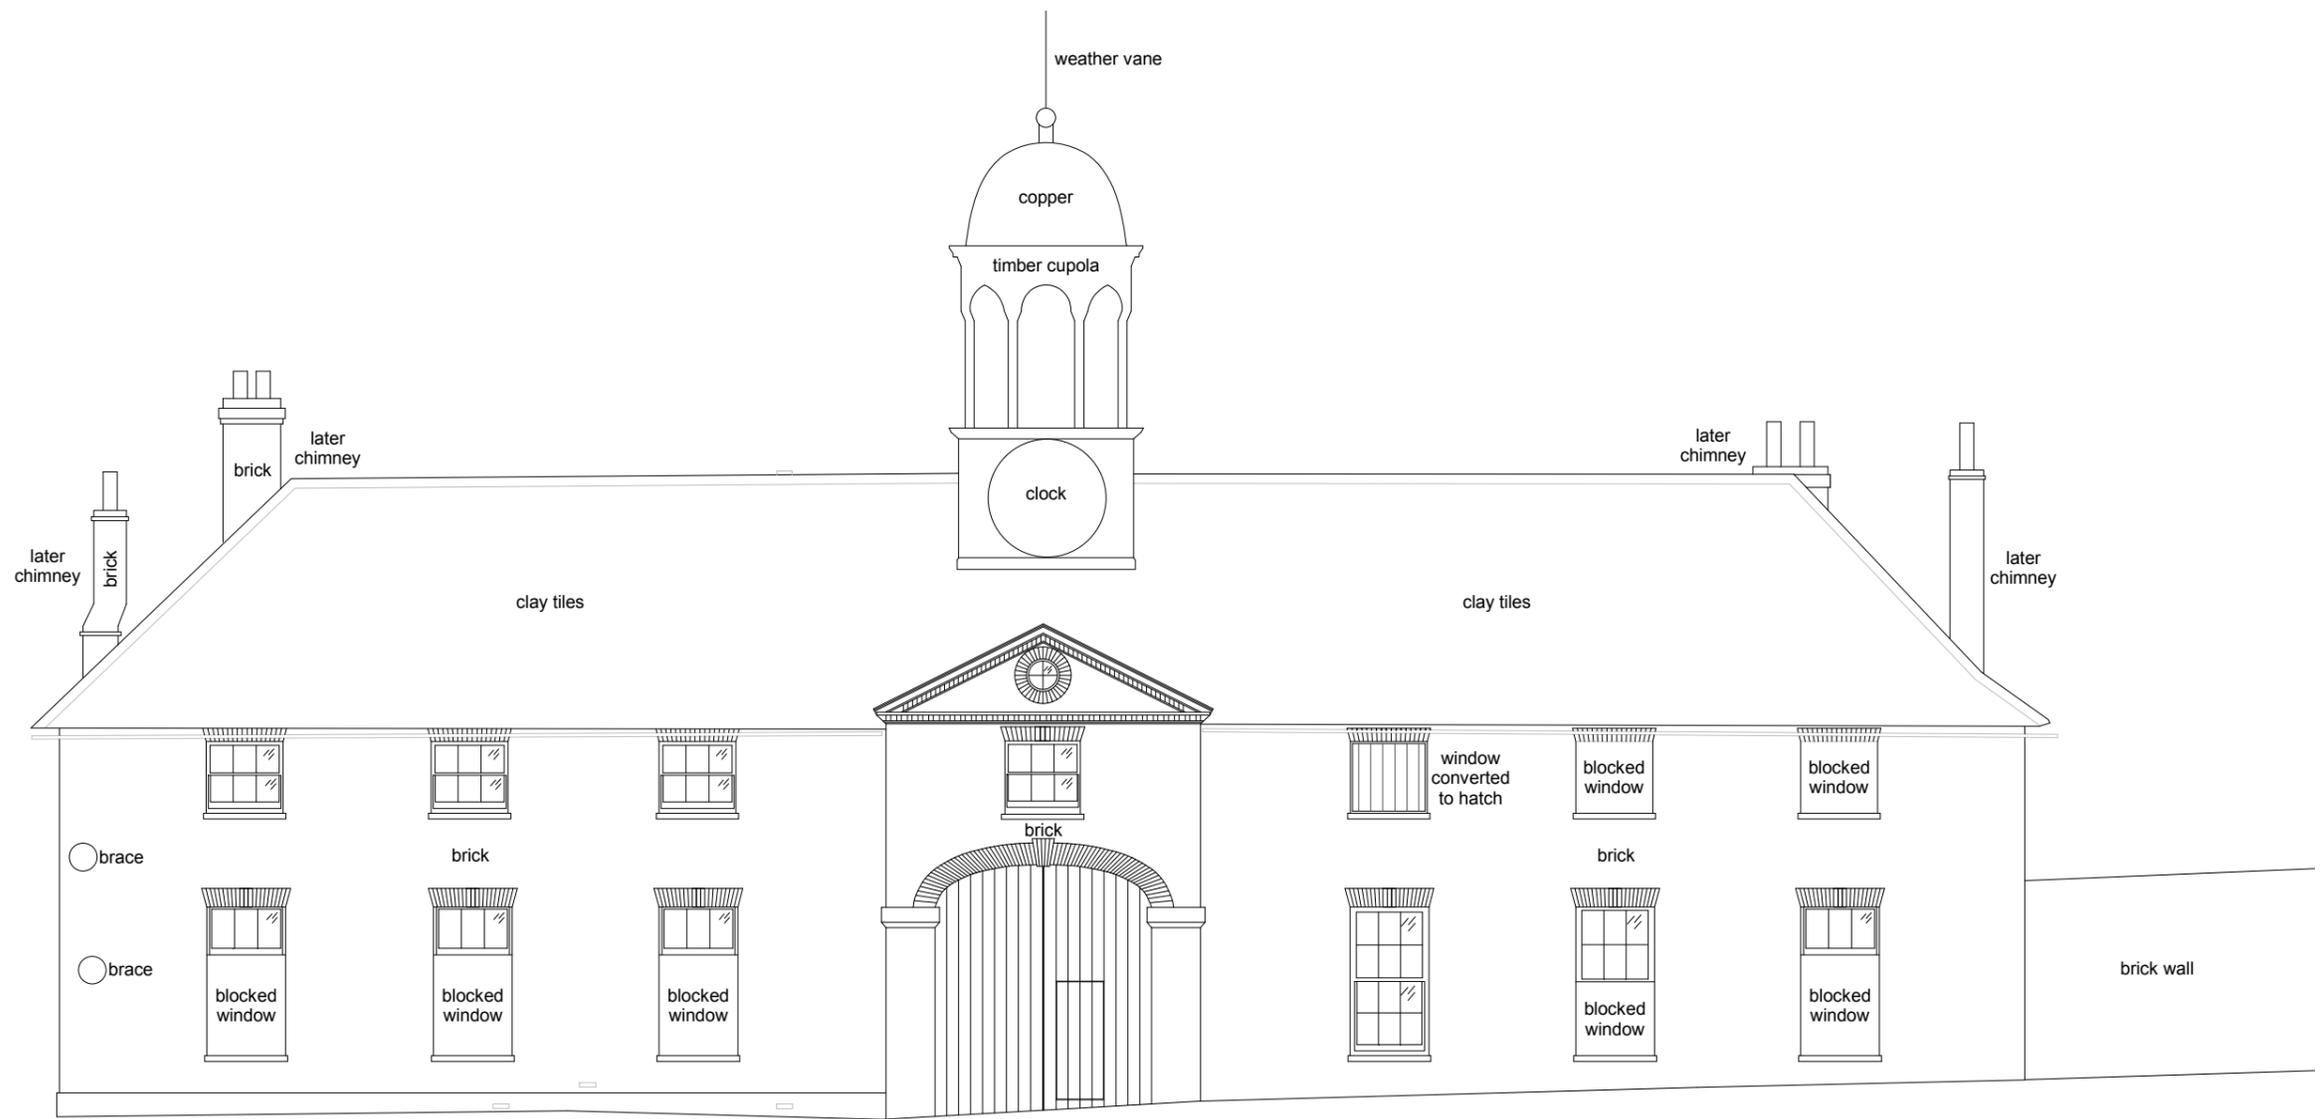
Fig 6 Structure 1/2, 18th-century stable block north-west elevation.

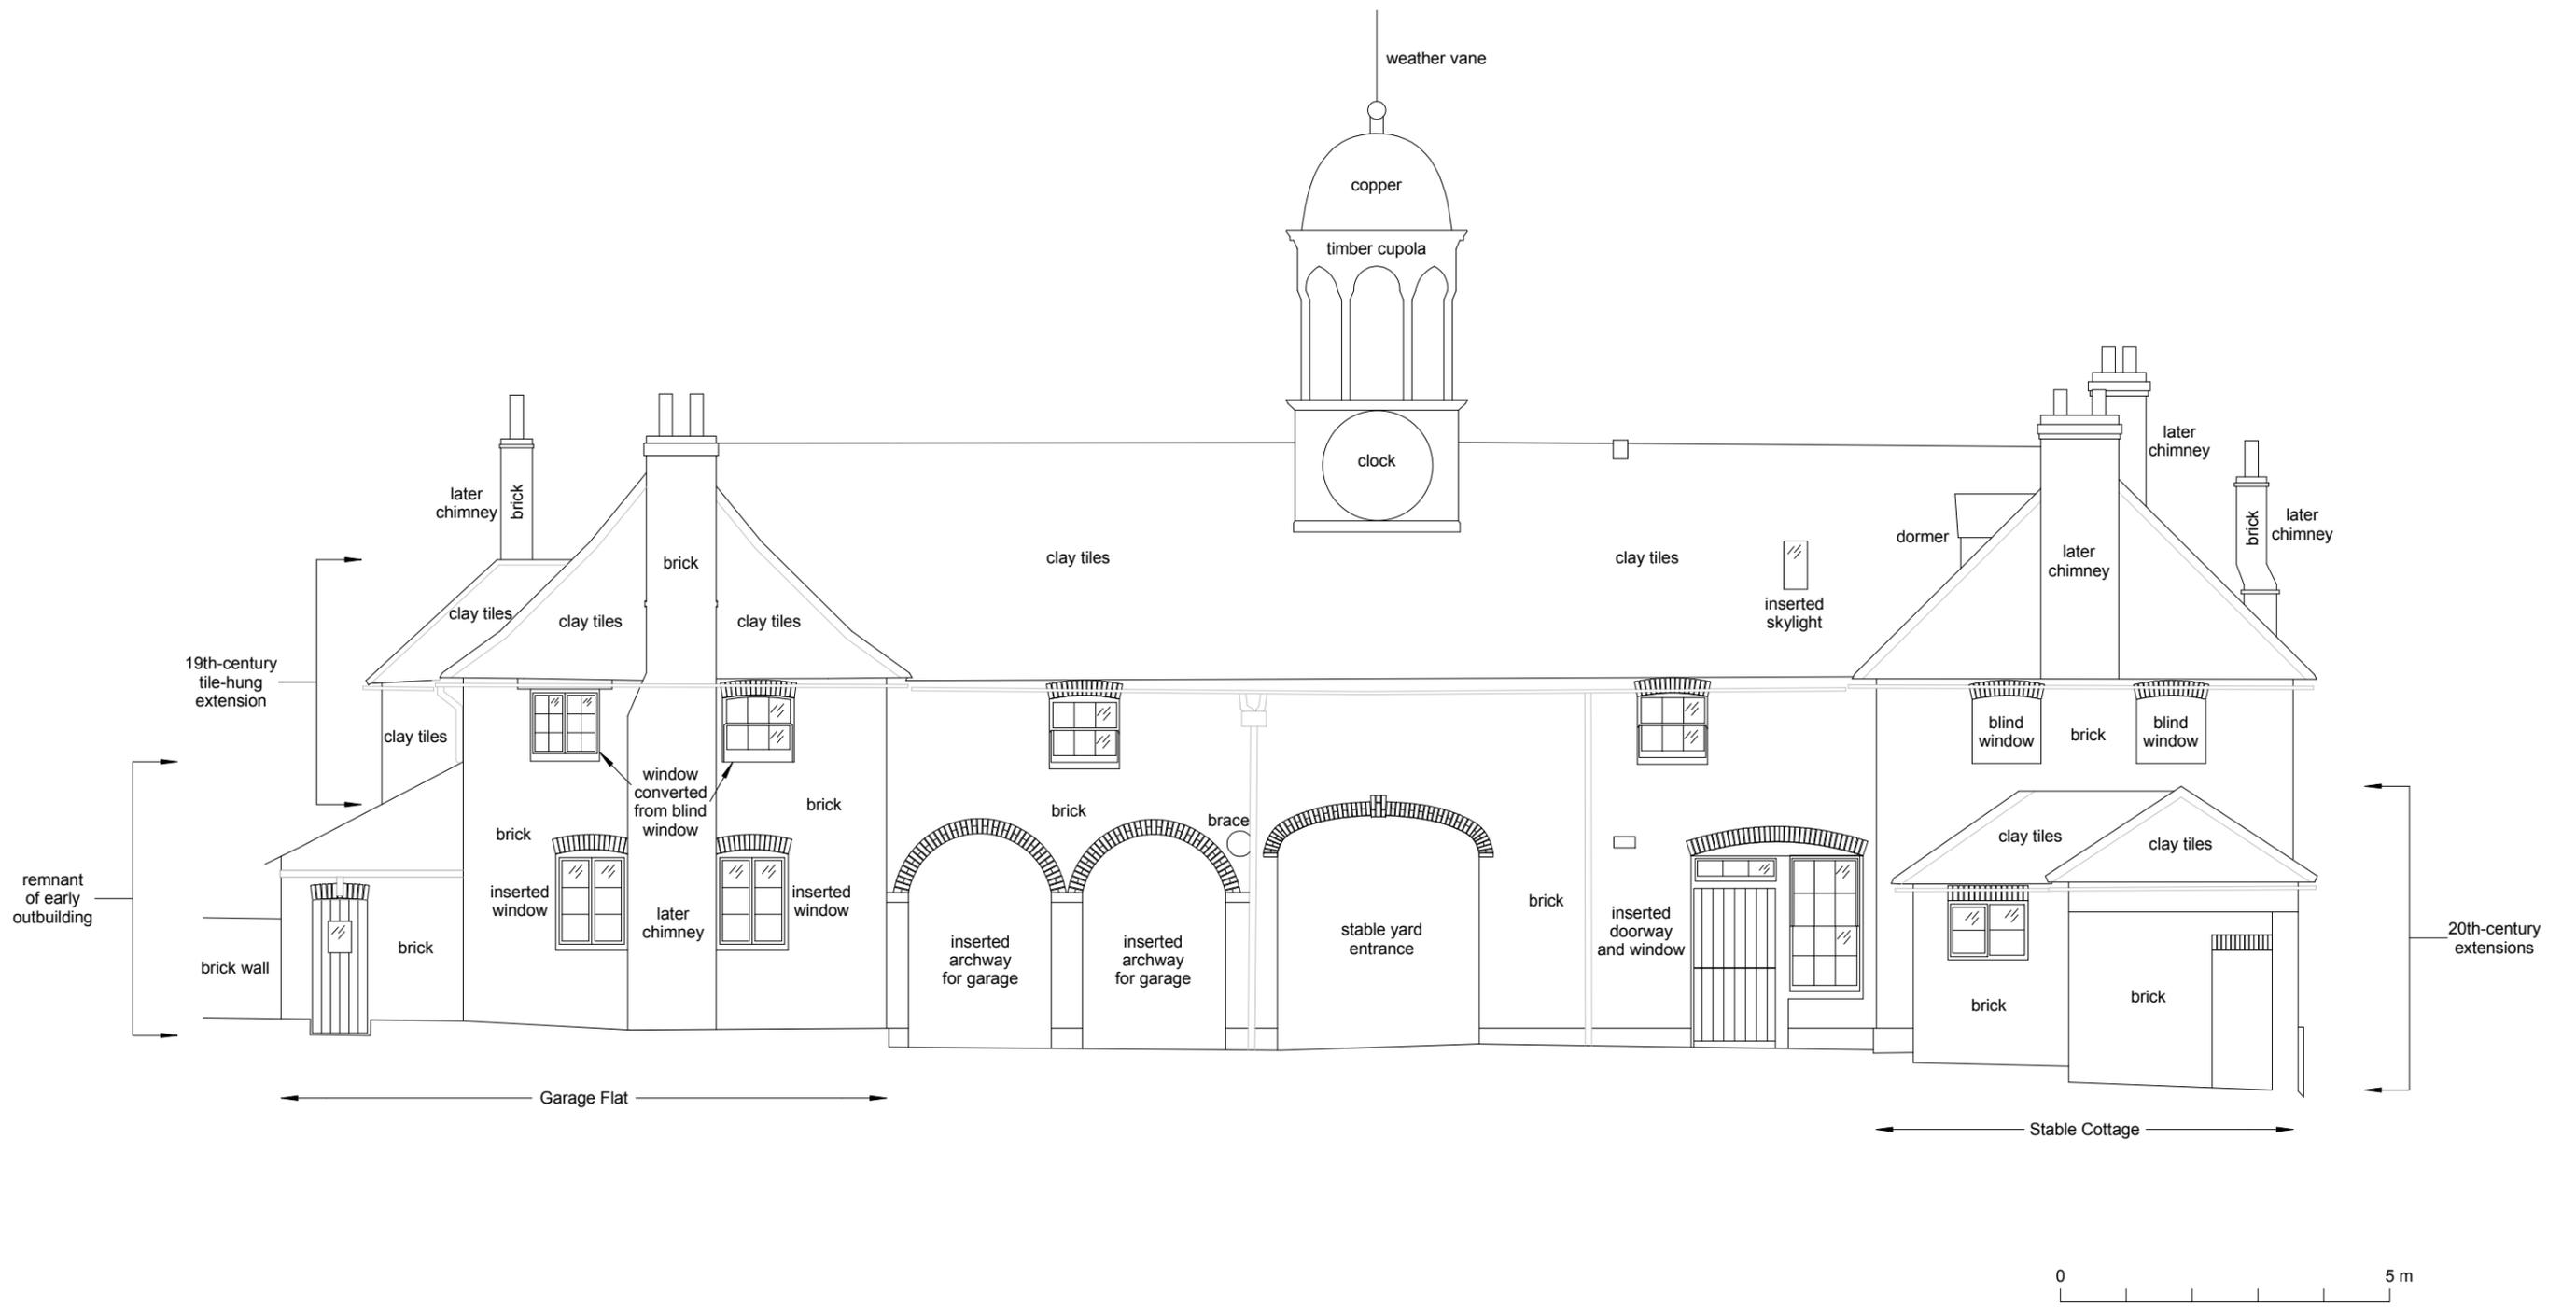
Fig 7 Structure 1/2, 18th-century stable block south-east elevation.

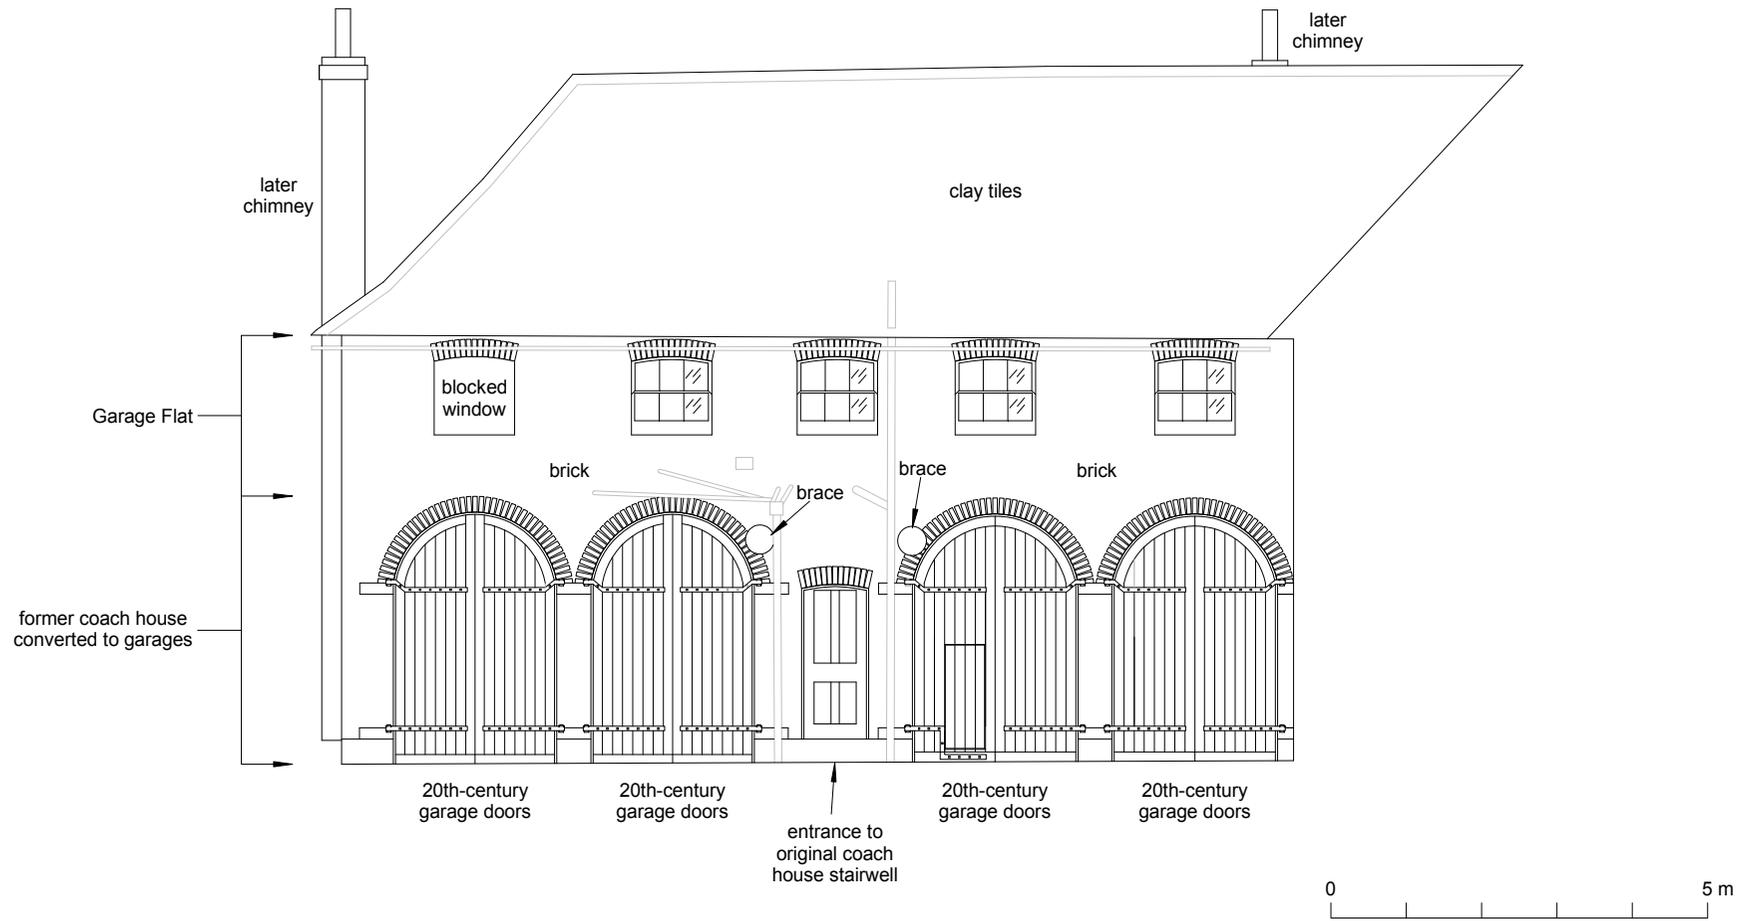
Fig 8 Structure 1/2, 18th-century stable block north-east elevation.
