**Building recording
at Home Farm, Moor Place,
Much Hadham, Hertfordshire
October 2013**

**report prepared by
Chris Lister**

**commissioned by
Foxley Builders**

CAT Report 735
January 2015

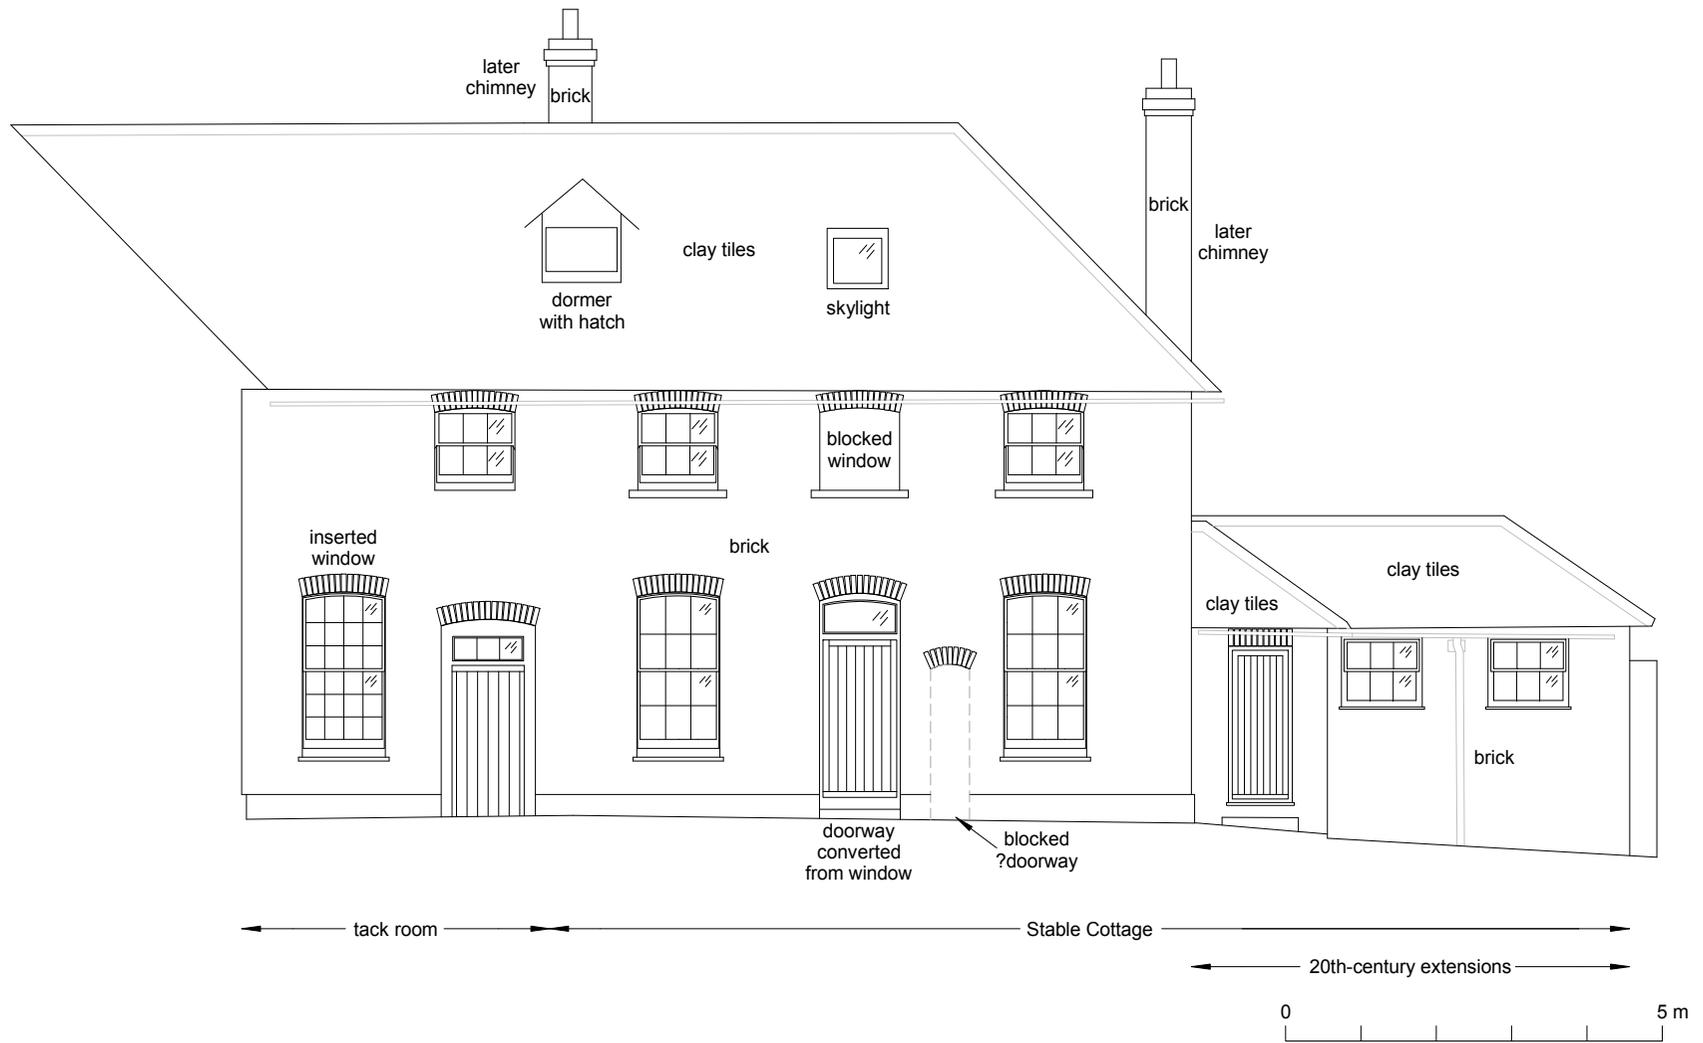
Fig 9 Structure 1/2, 18th-century stable block south-west elevation.

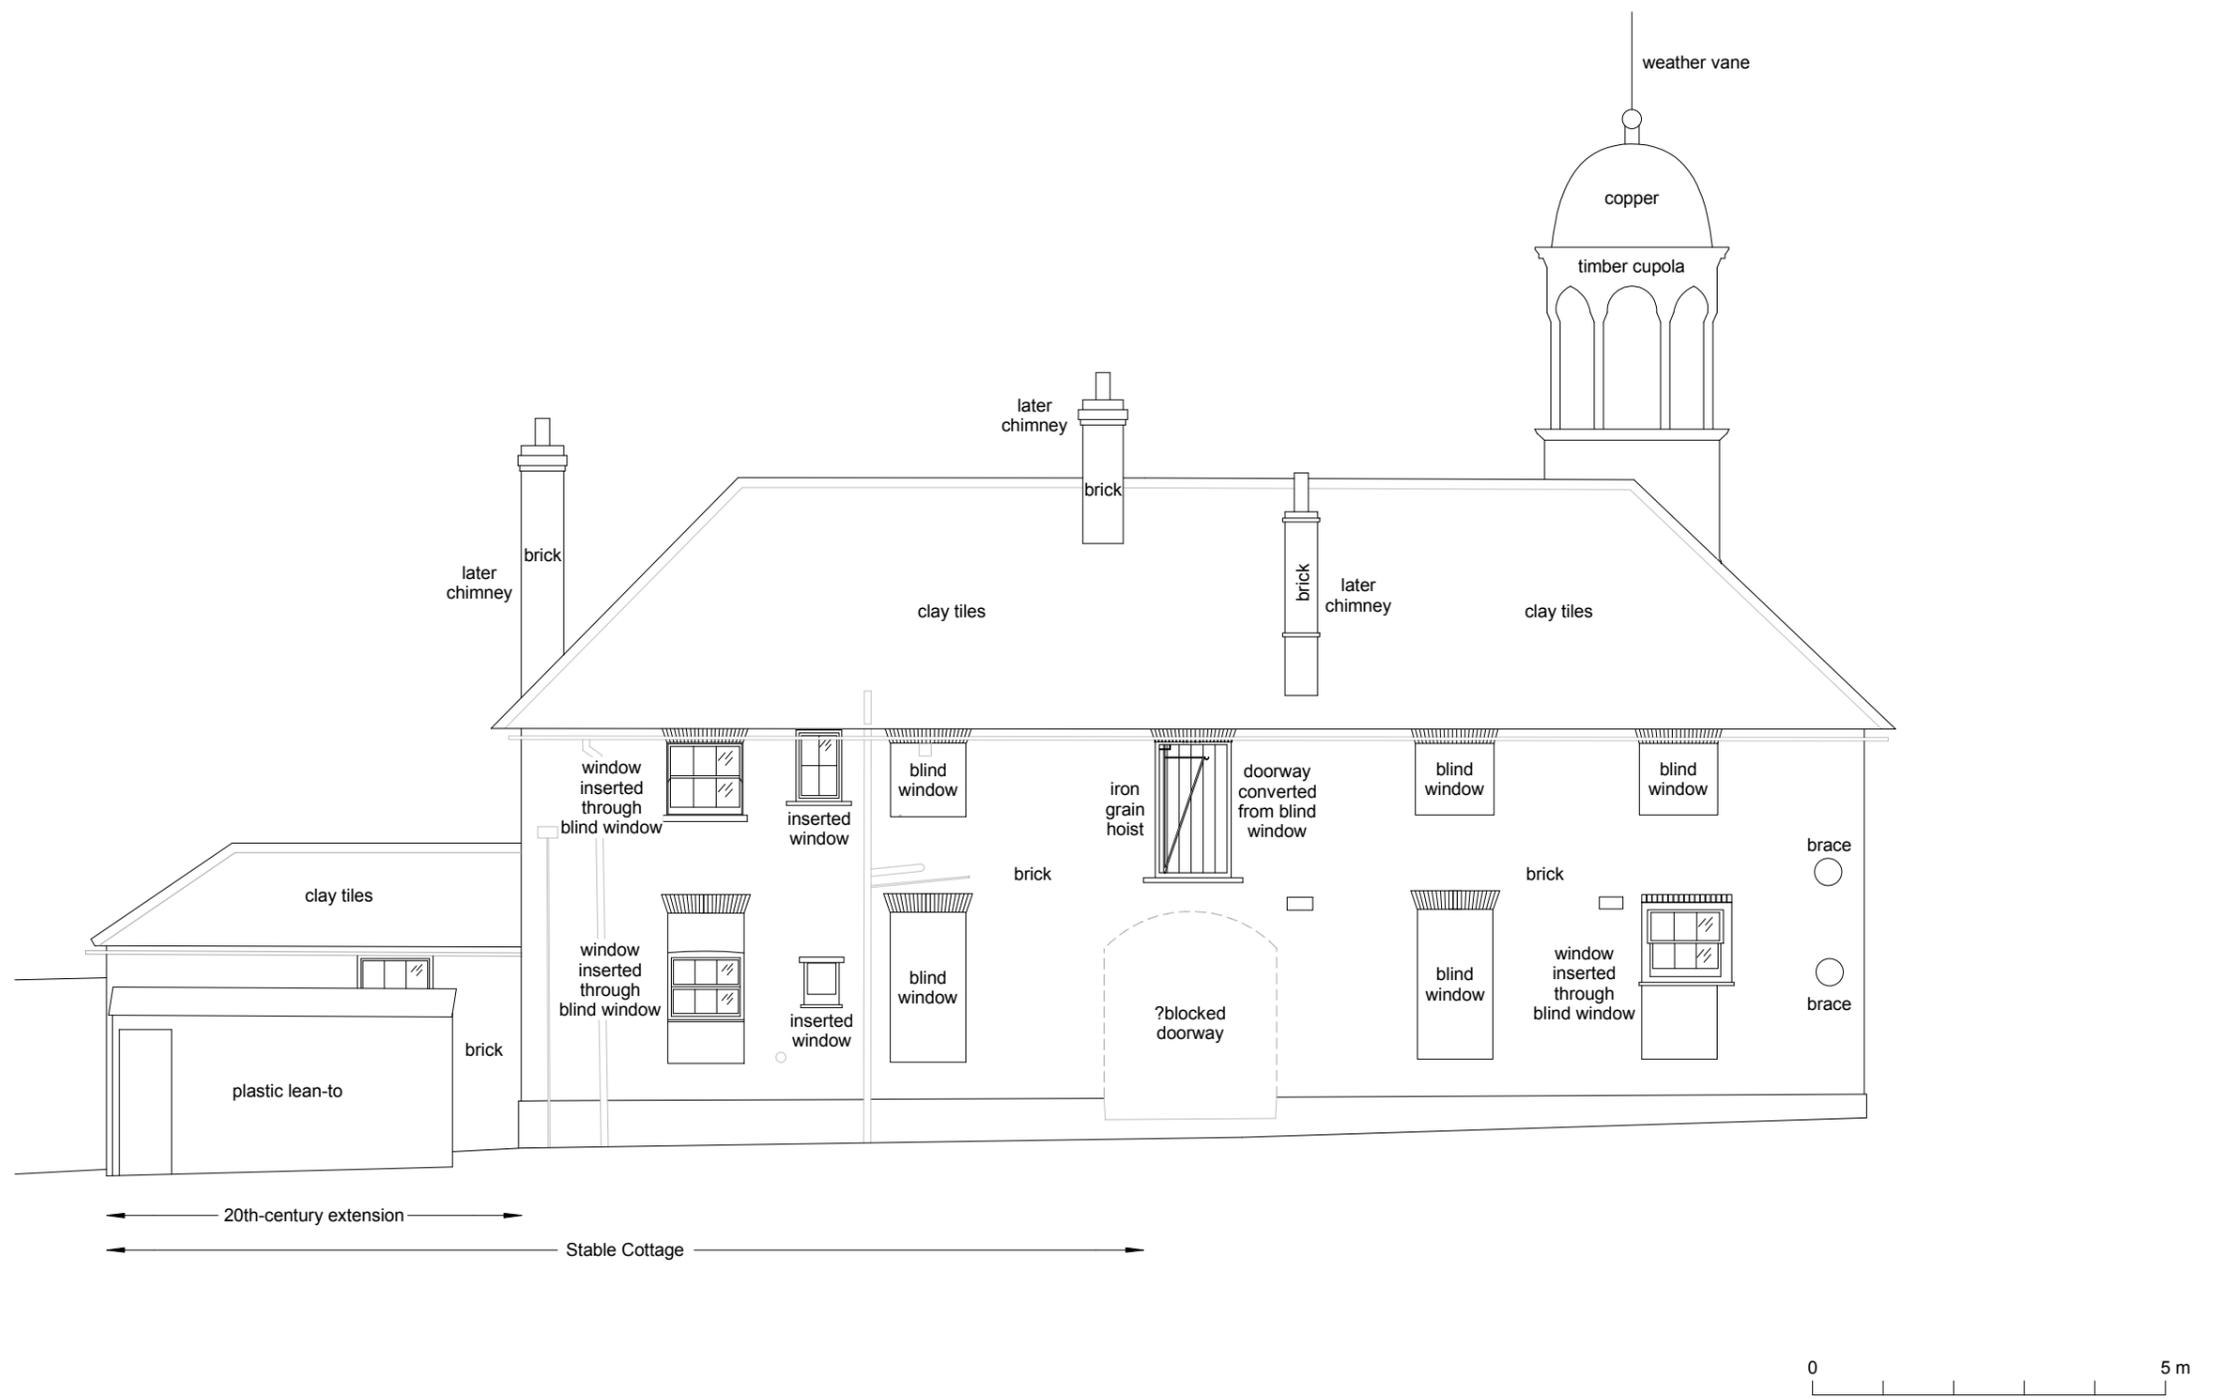
Fig 10 Structure 1/2, 18th-century stable block south-west elevation.

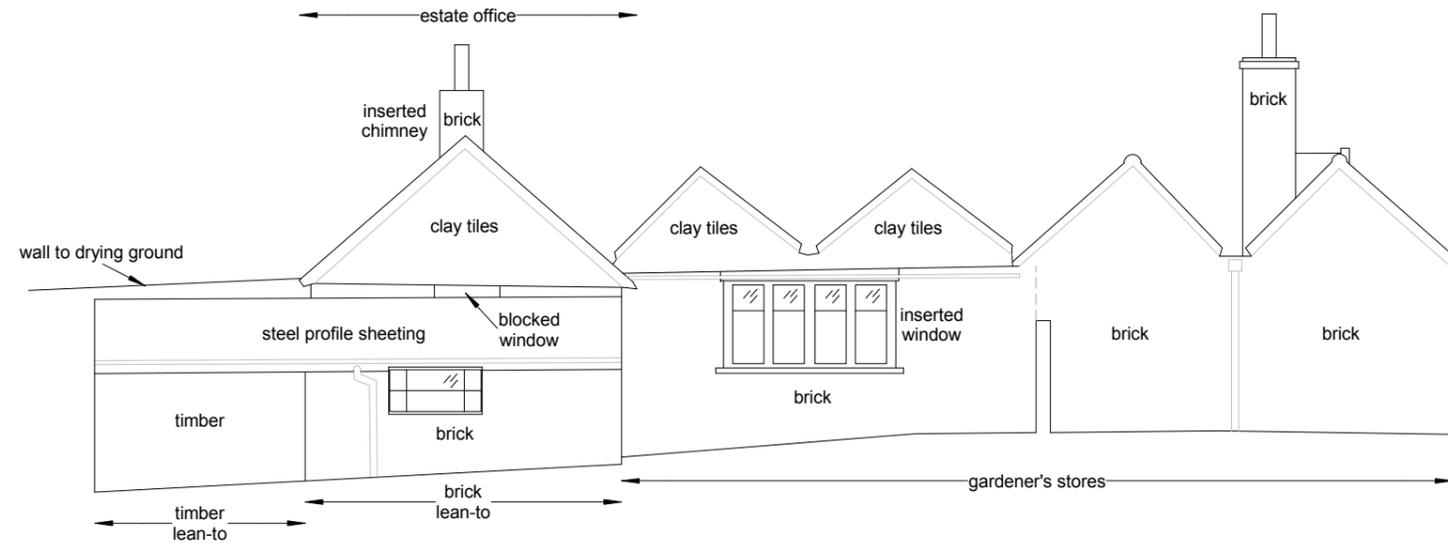
Fig 12 Plan of structures 3 & 3a, 18th-century estate office and gardener's stores, showing the location and orientation of photographs included in this report.

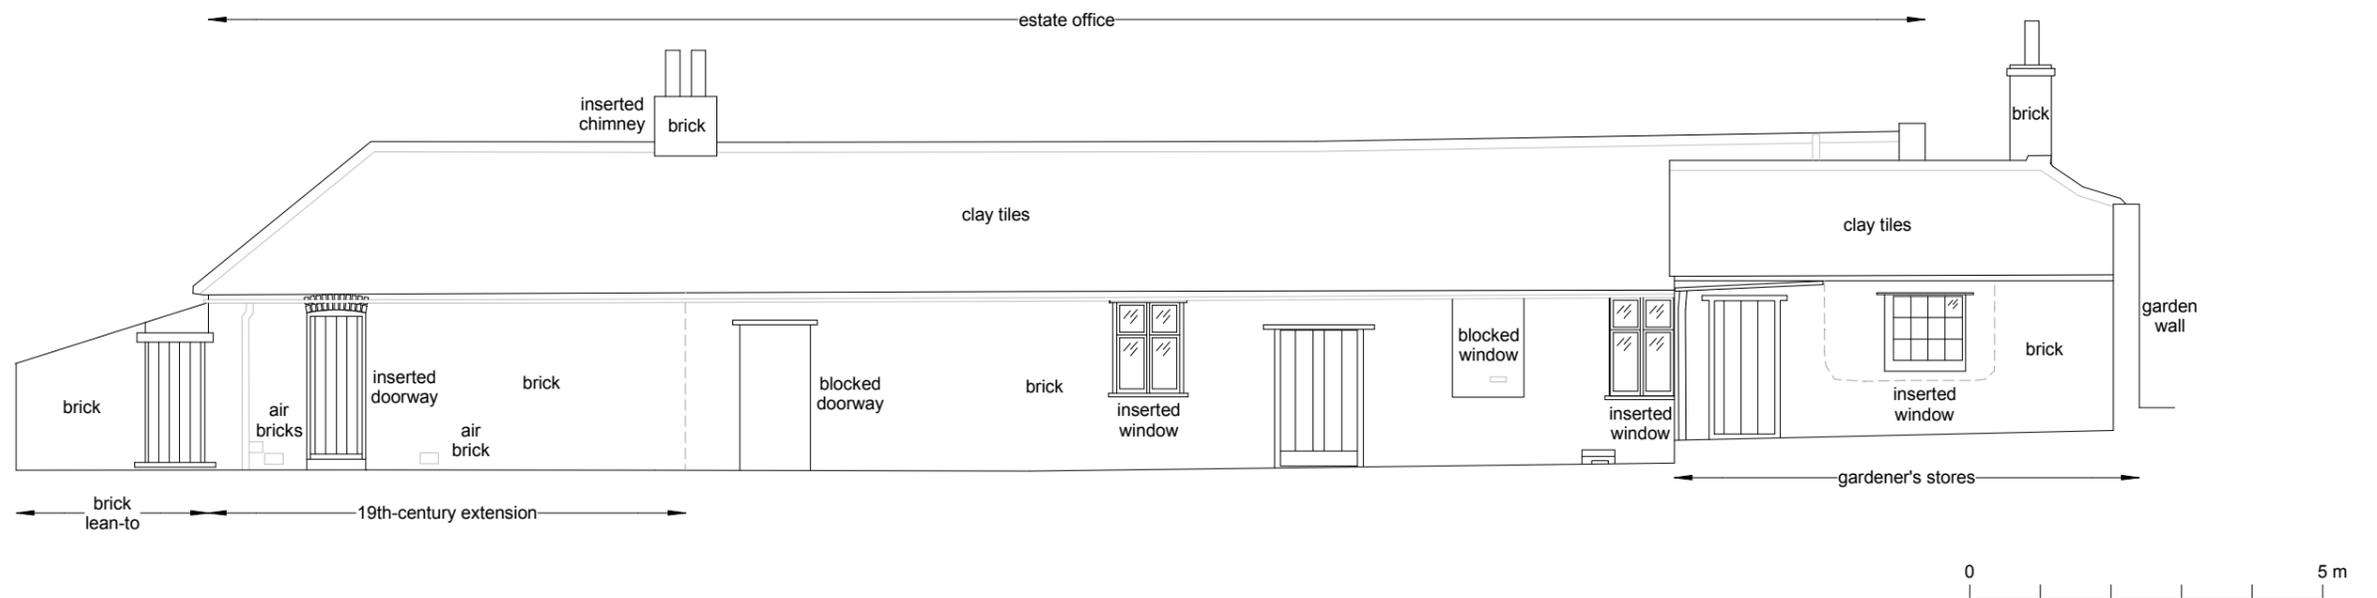
Fig 13 Structures 3 & 3a, 18th-century estate office and gardener's stores north-east elevation.

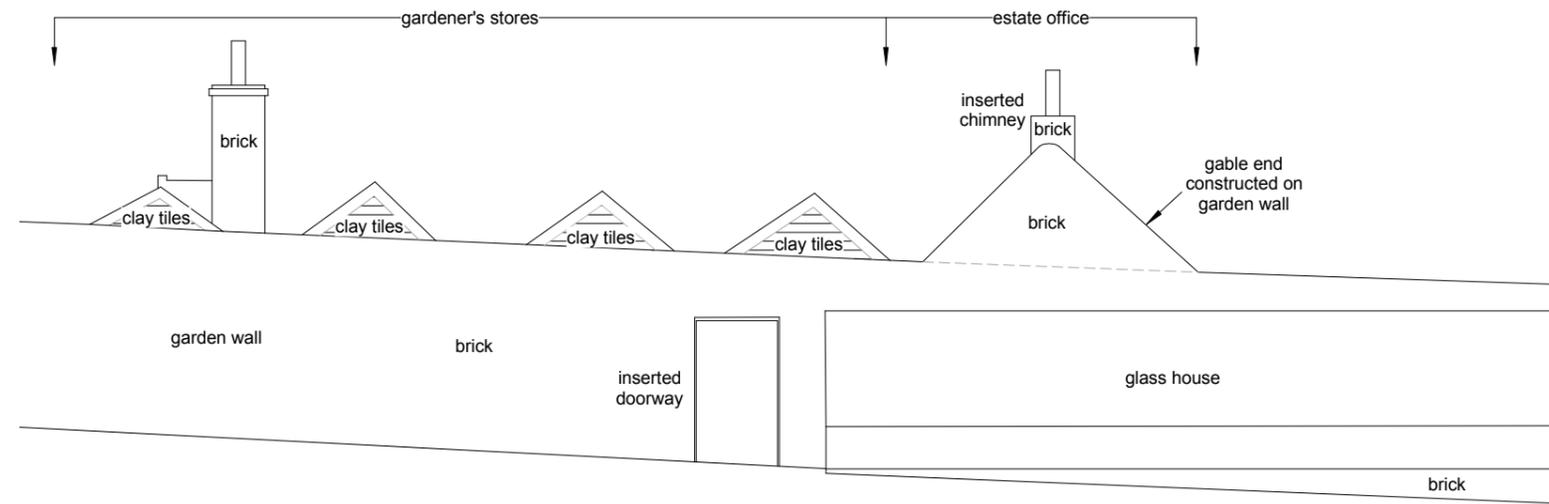
Fig 14 Structures 3 & 3a, 18th-century estate office and gardener's stores north-west elevation.

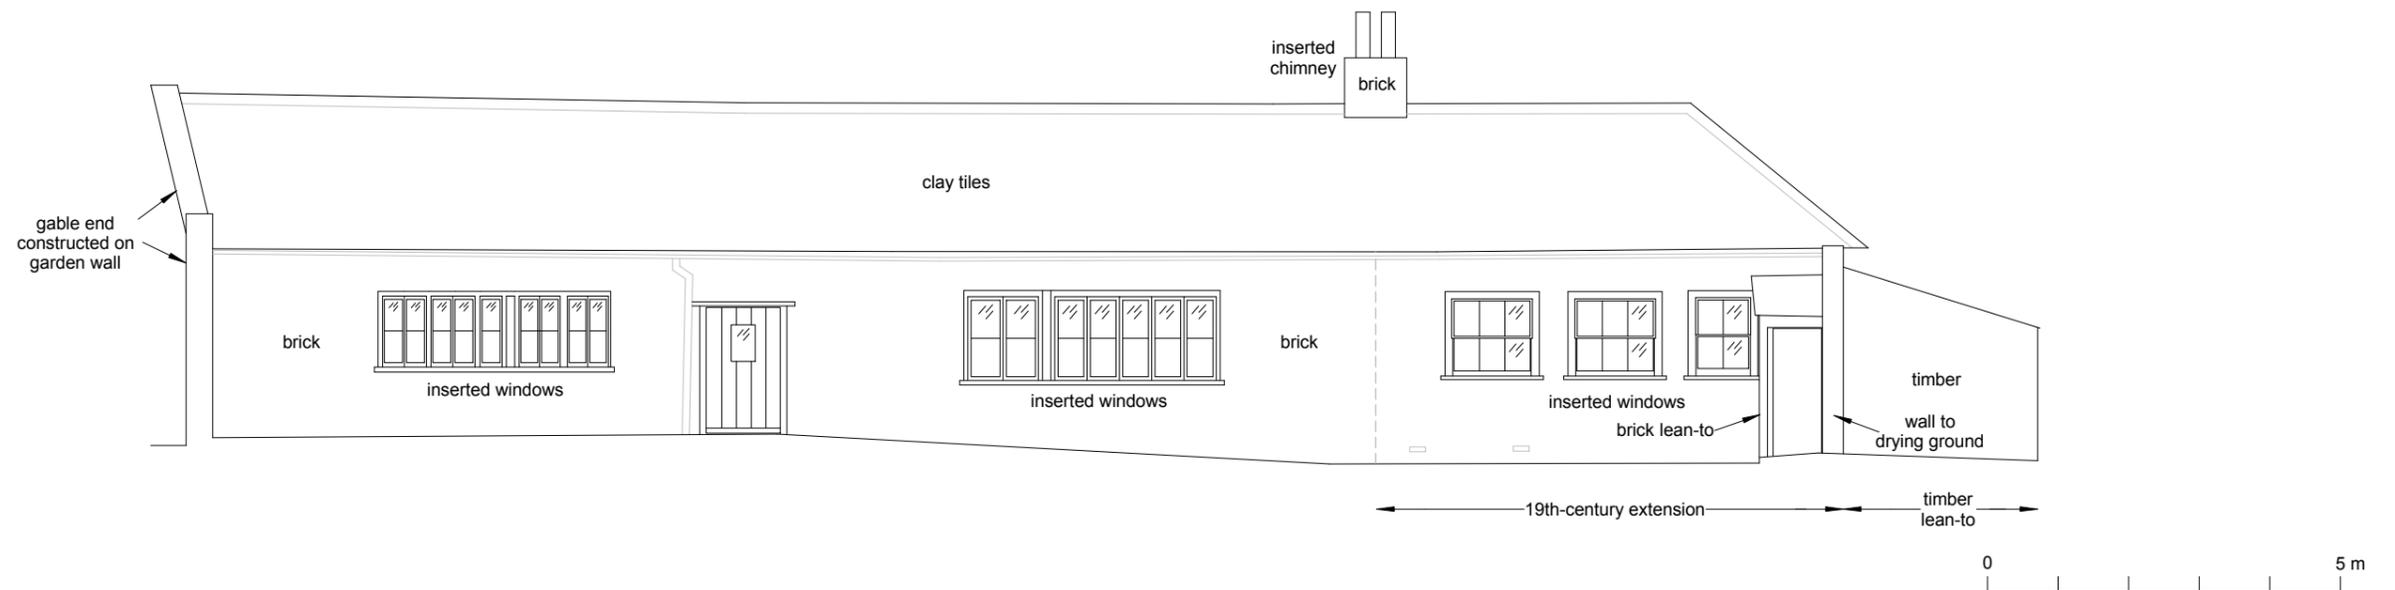
Fig 15 Structures 3 & 3a, 18th-century estate office and gardener's stores south-west elevation.

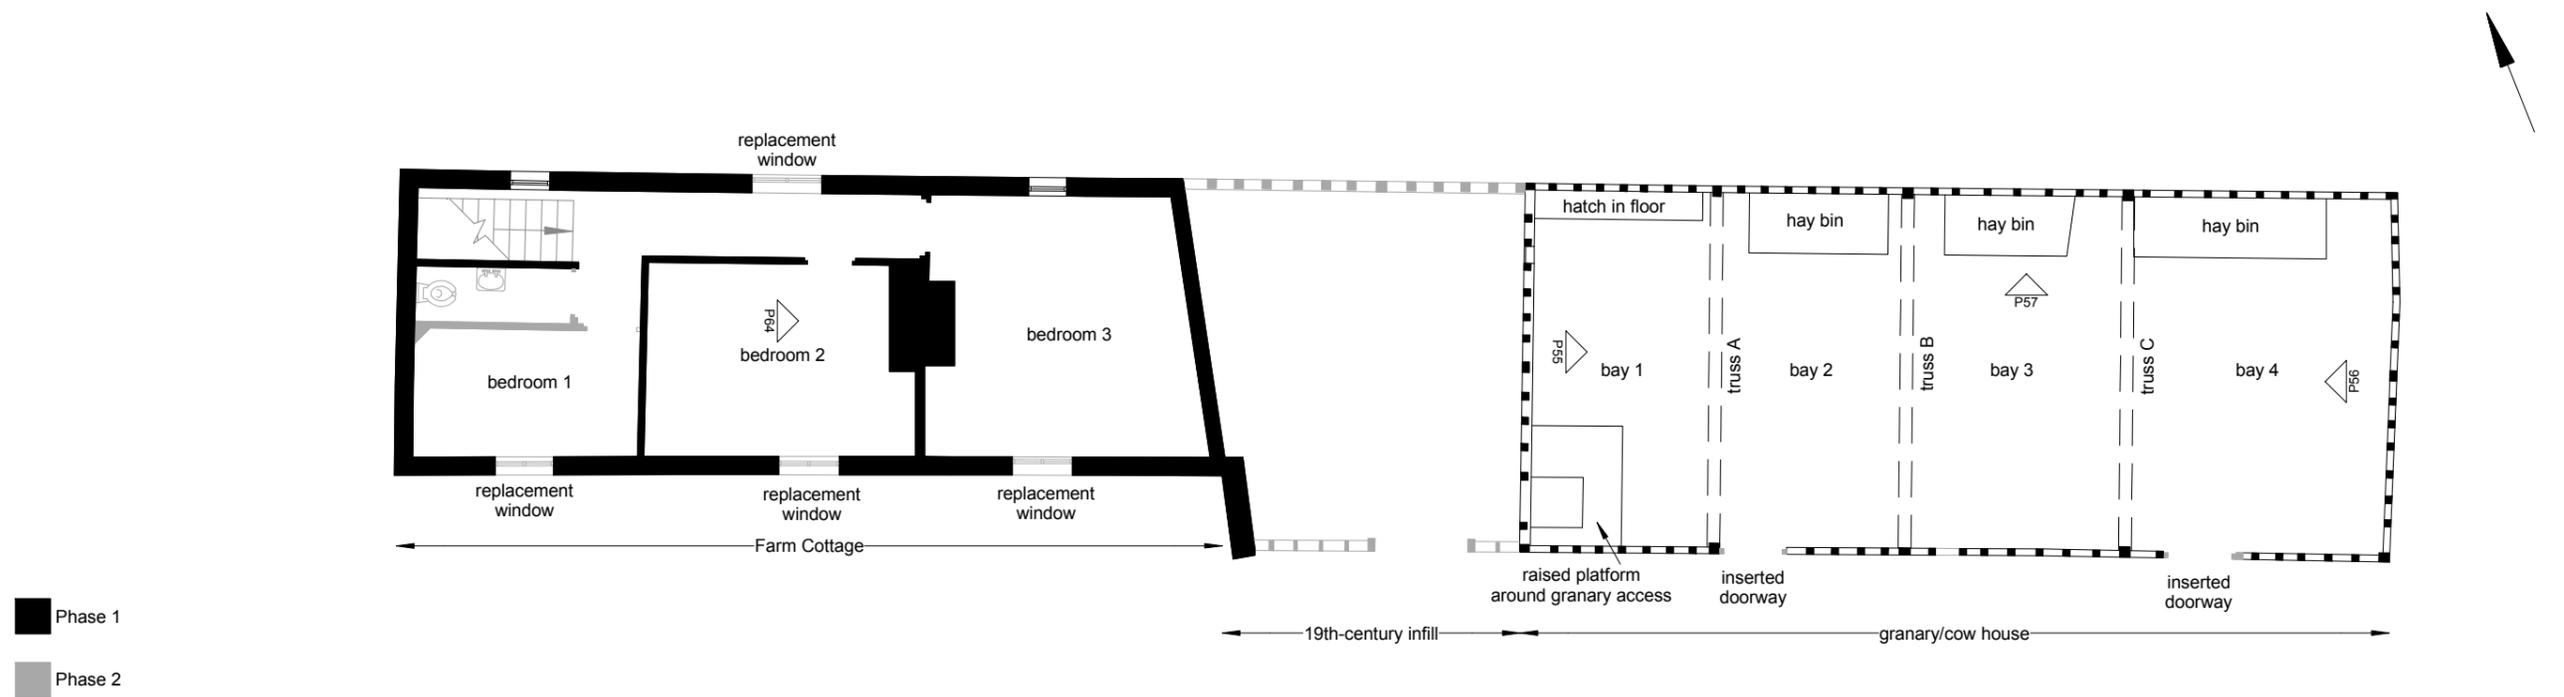
Fig 17 Structures 4 & 4a, 18th-century granary/cow house and 19th-century Farm Cottage ground floor plan, showing the location and orientation of photographs included in this report.

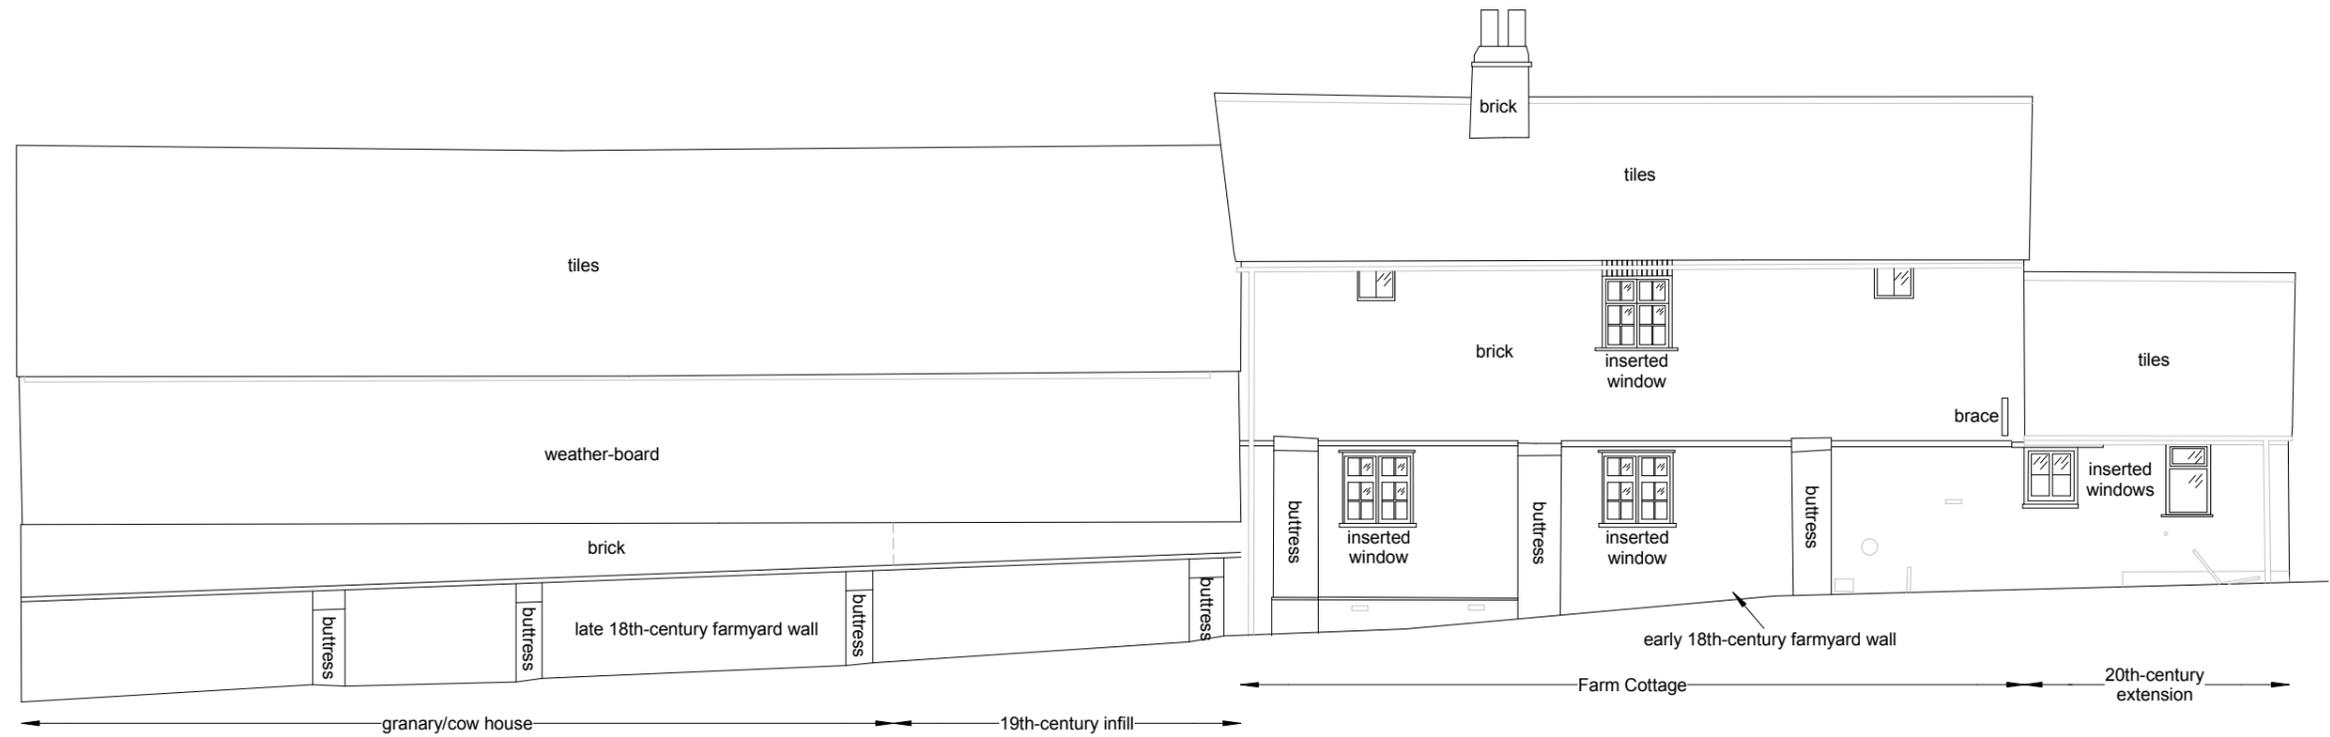
Fig 19 Structures 4 & 4a, 18th-century granary/cow house and 19th-century Farm Cottage south-west elevation.

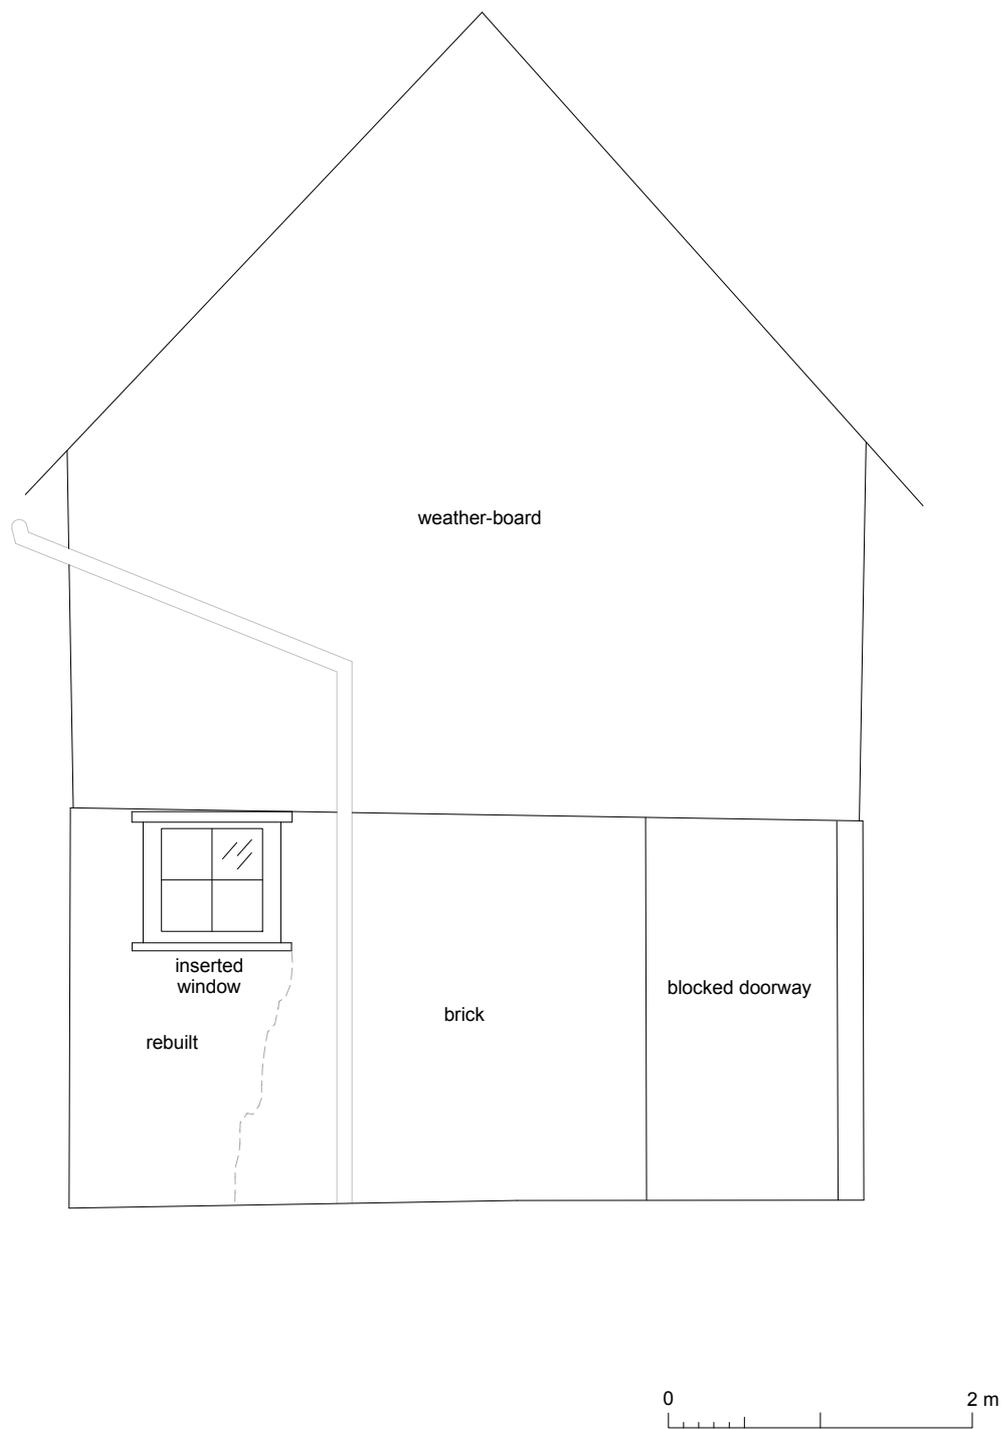
Fig 20 Structures 4 & 4a, 18th-century granary/cow house and 19th-century Farm Cottage north-east elevation.

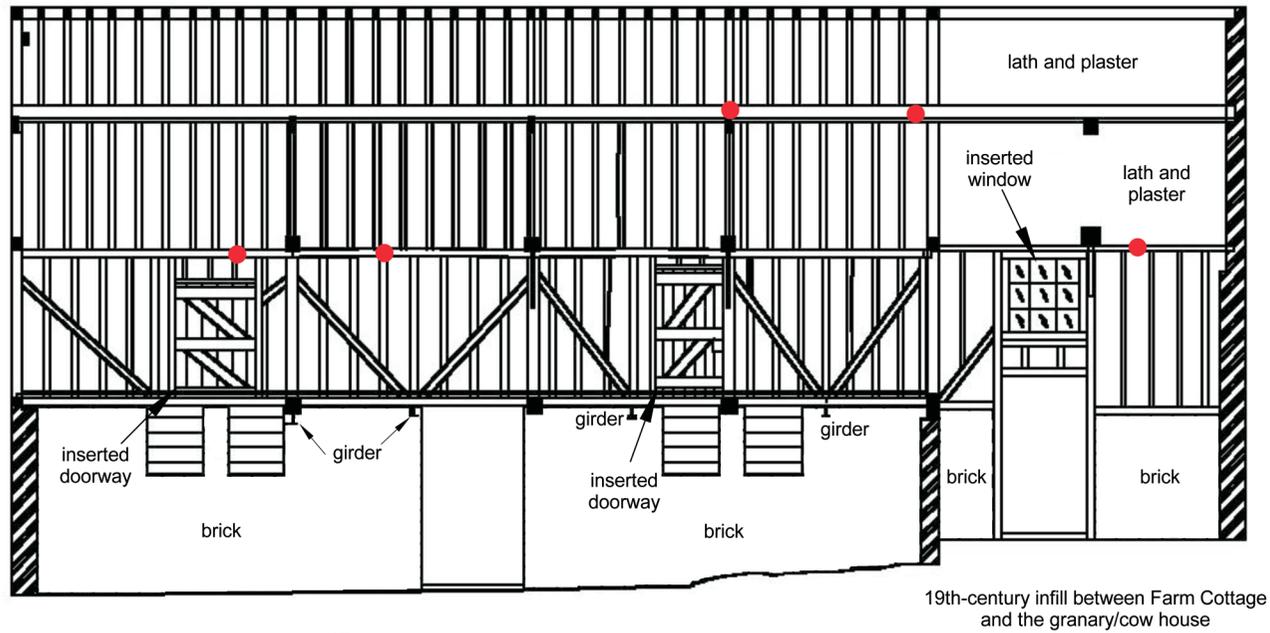
Fig 21 Structure 4, 18th-century granary/cow house south-east elevation.

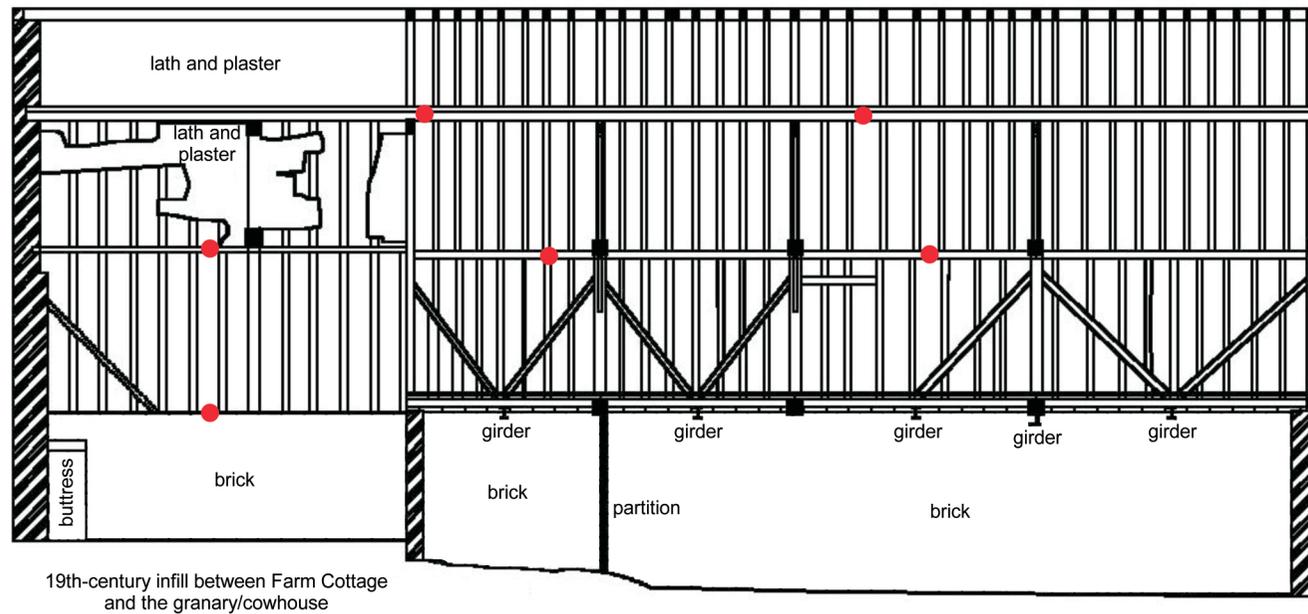
Fig 23 Structure 4, 18th-century granary/cow house south-west frame.

● = scarf joint

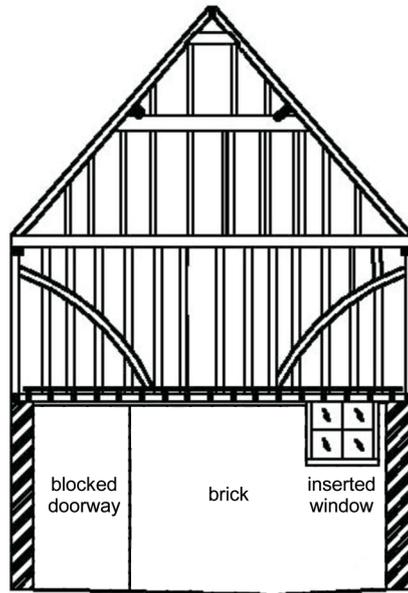
Fig 24 Structure 4, 18th-century granary/cow house north-east frame.

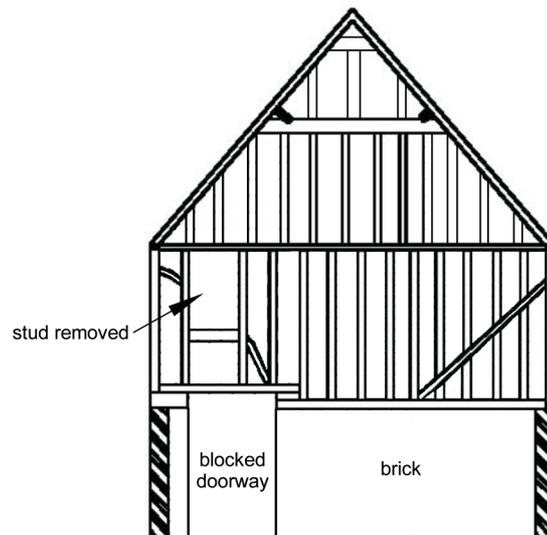
Fig 25 Structure 4, 18th-century granary/cow house south-east frame.

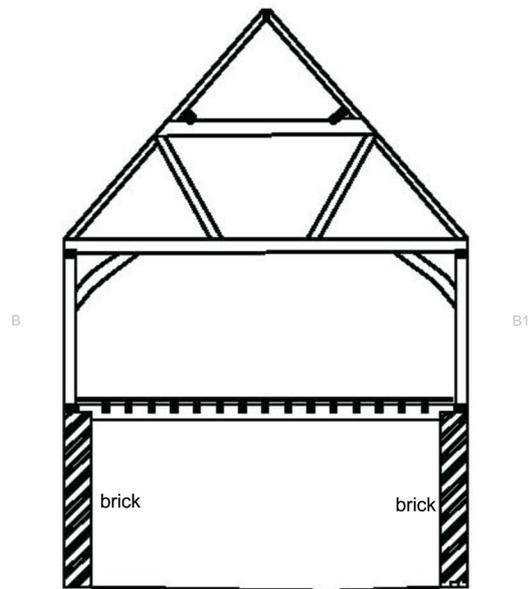
Fig 26 Structure 4, 18th-century granary/cow house north-west frame.

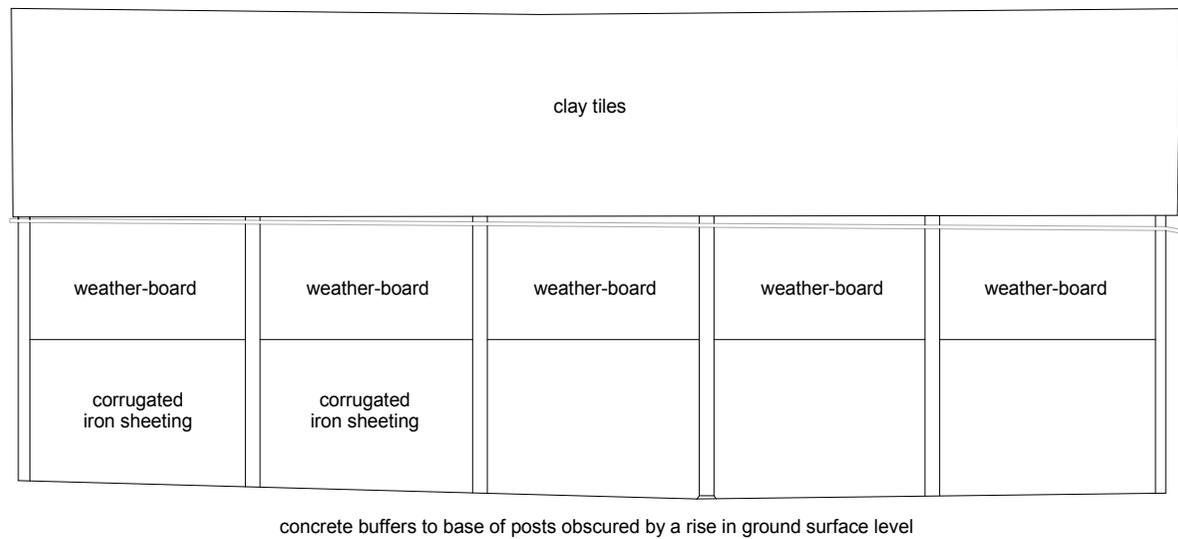
Fig 29 Structure 5, 1898-1918 Dutch barn north-east elevation.

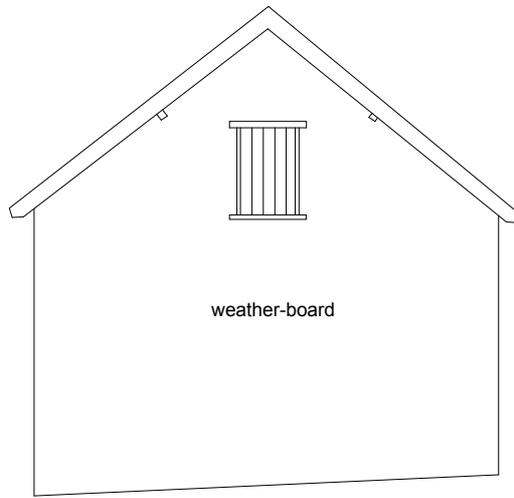
Fig 30 Structure 5, 1898-1918 Dutch barn south-west elevation.

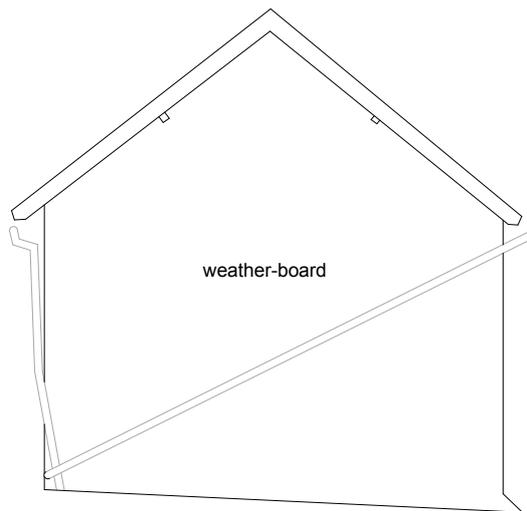
Fig 31 Structure 5, 1898-1918 Dutch barn north-west elevation.

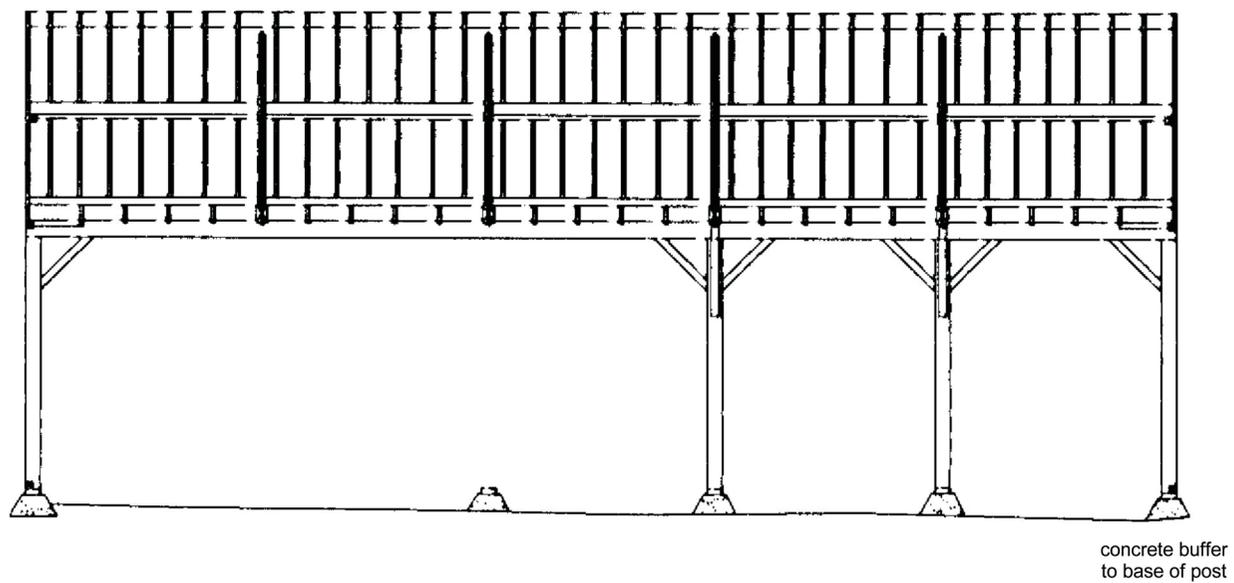
Fig 32 Structure 5, 1898-1918 Dutch barn south-east elevation.

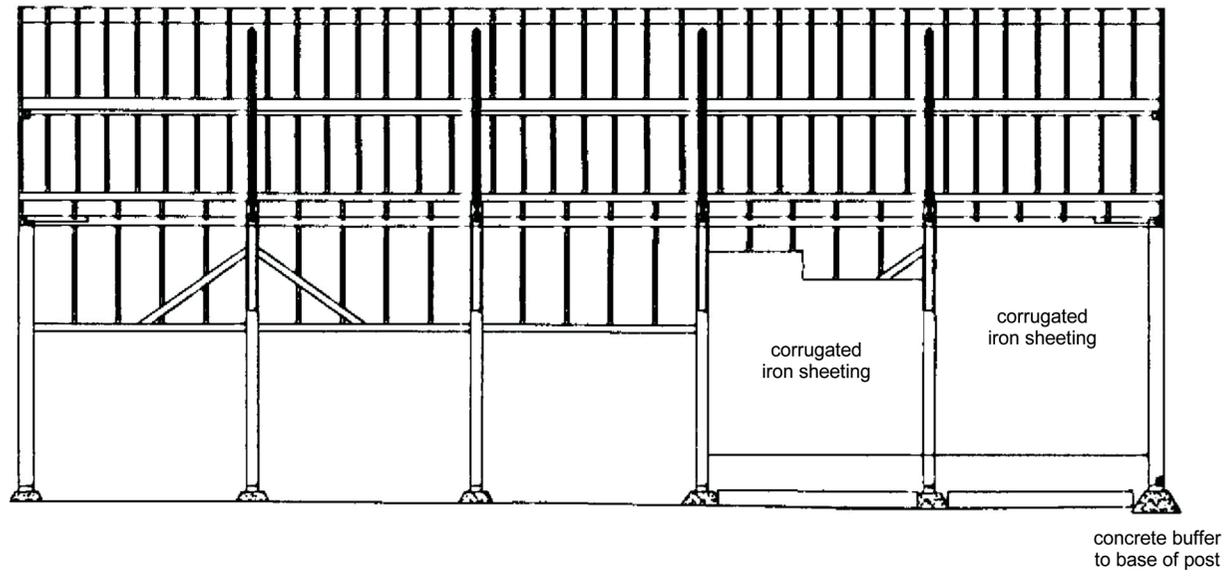
Fig 33 Structure 5, 1898-1918 Dutch barn north-east frame.

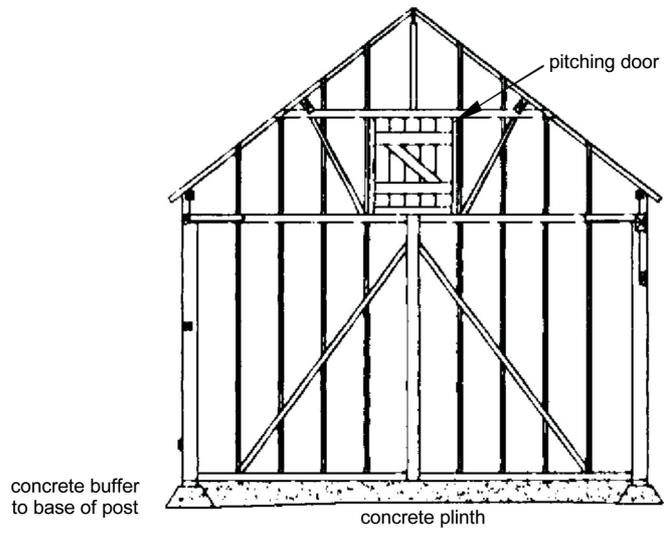
Fig 34 Structure 5, 1898-1918 Dutch barn south-west frame.

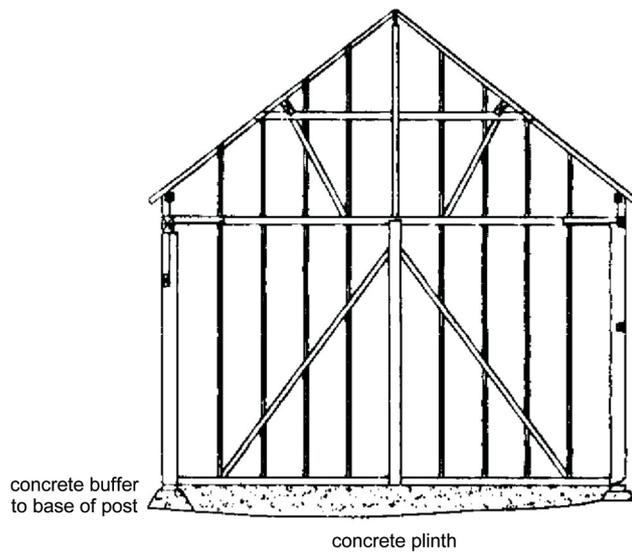
Fig 35 Structure 5, 1898-1918 Dutch barn north-west frame.

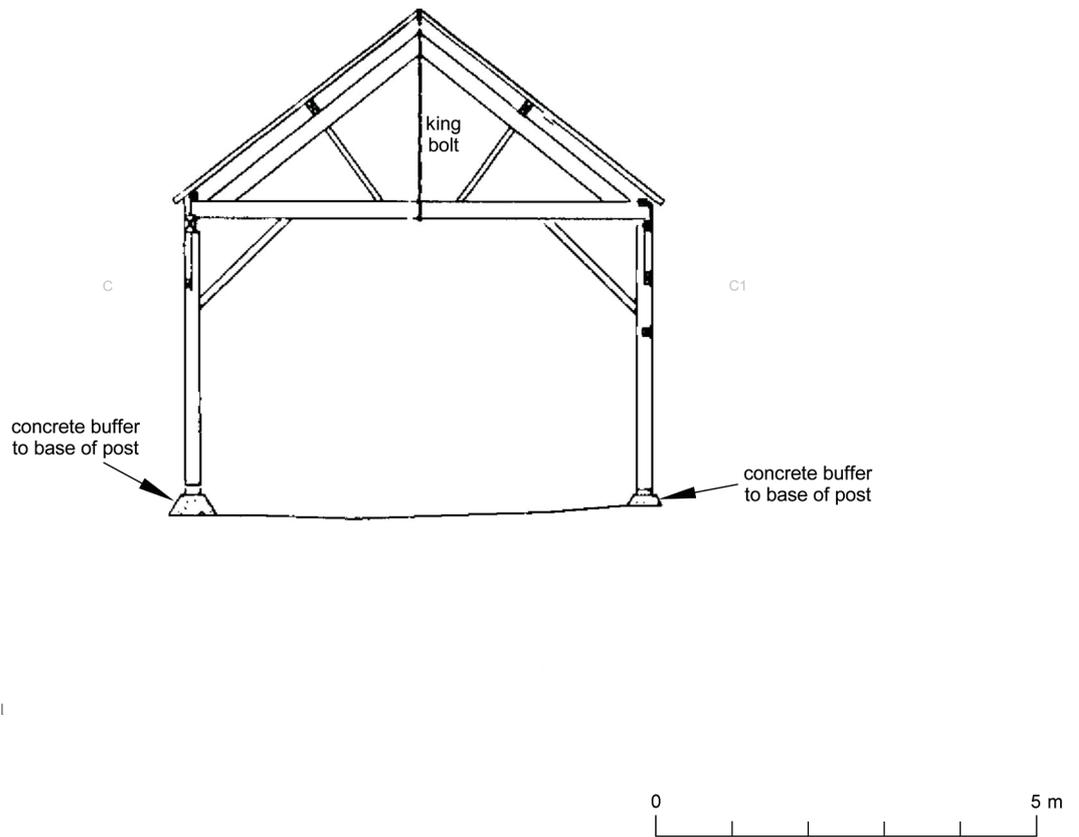
Fig 36 Structure 5, 1898-1918 Dutch barn south-east frame.

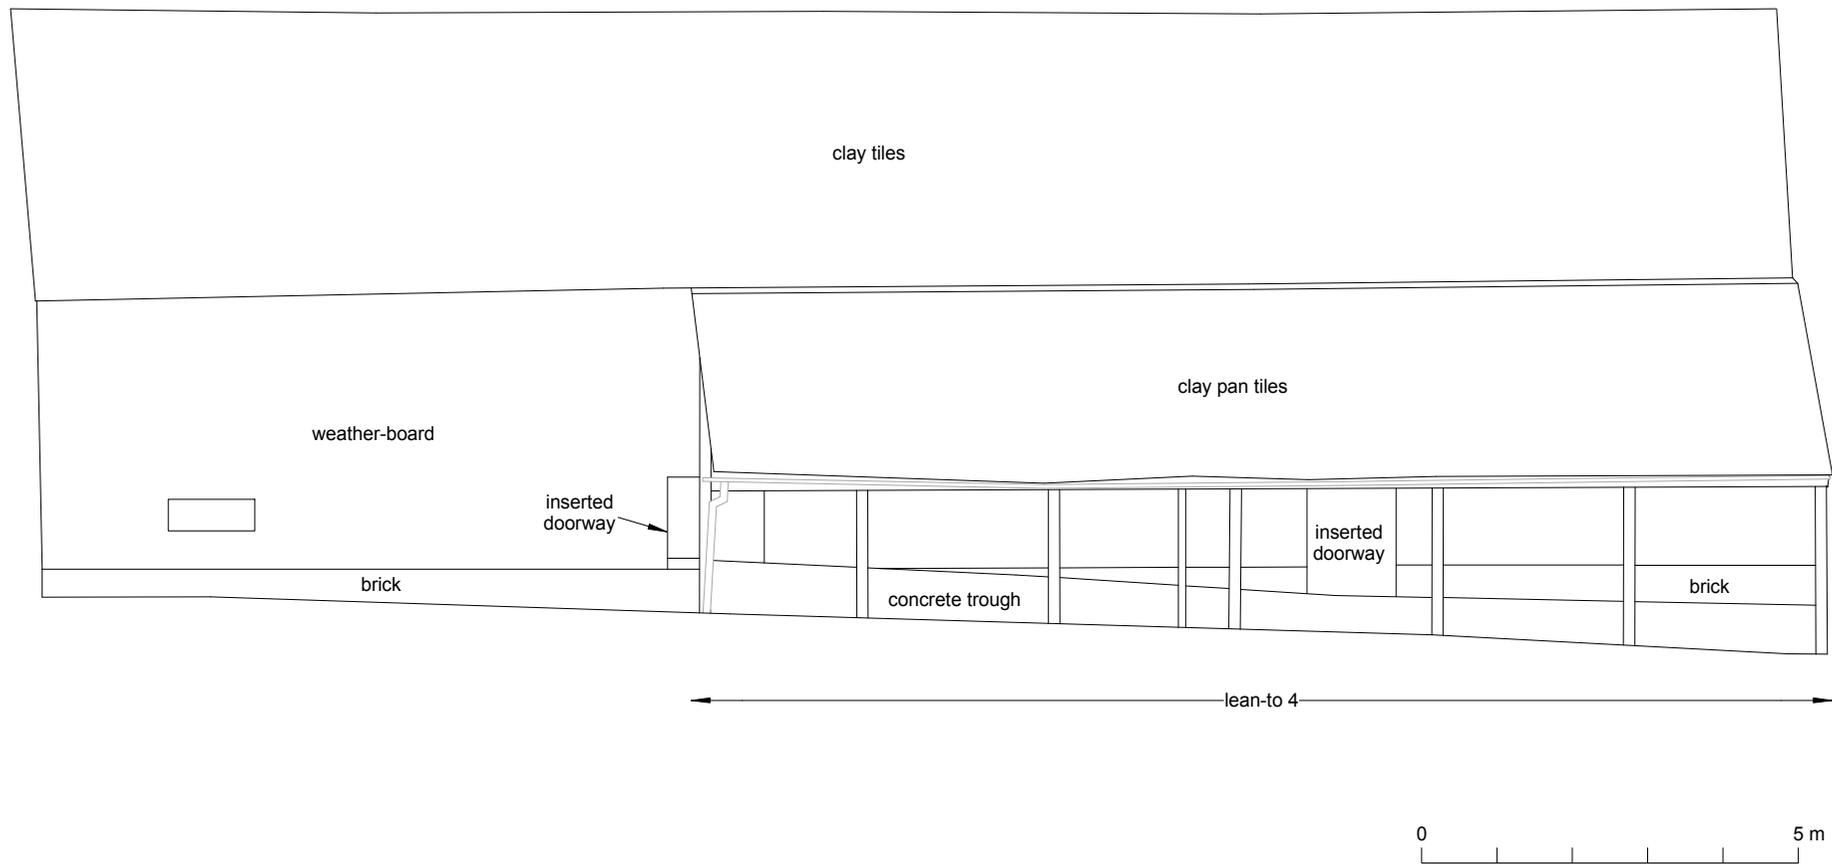
Fig 39 Structure 6, 17th-century barn north-east elevation.
