**Building recording
at Home Farm, Moor Place,
Much Hadham, Hertfordshire
October 2013**

**report prepared by
Chris Lister**

**commissioned by
Foxley Builders**

CAT Report 735
January 2015

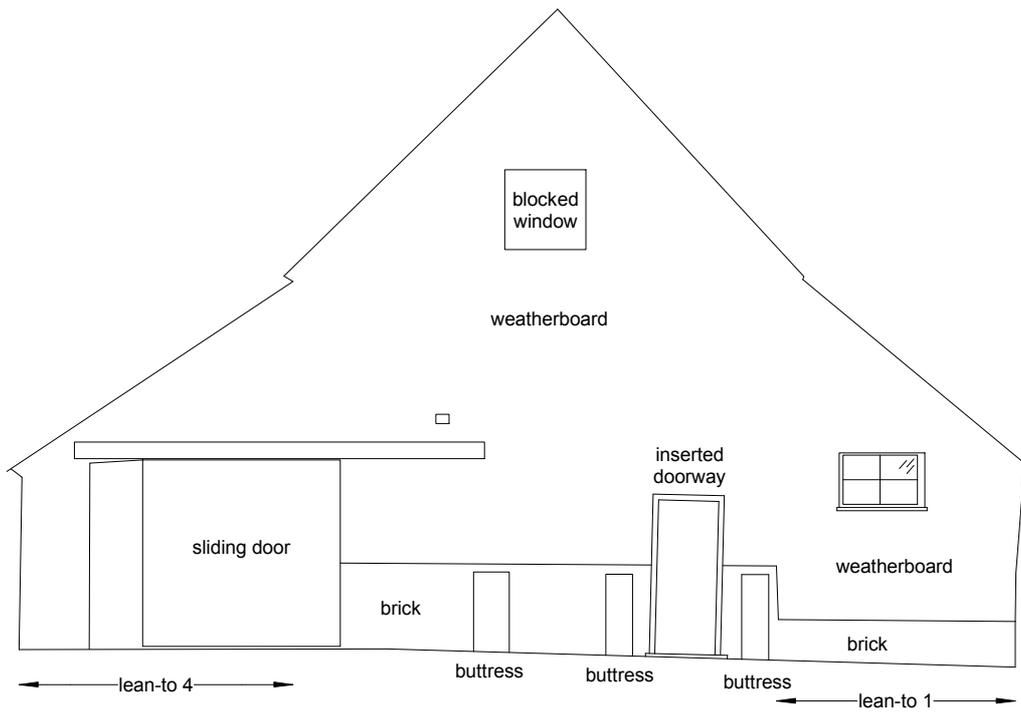
Fig 40 Structure 6, 17th-century barn south-west elevation.

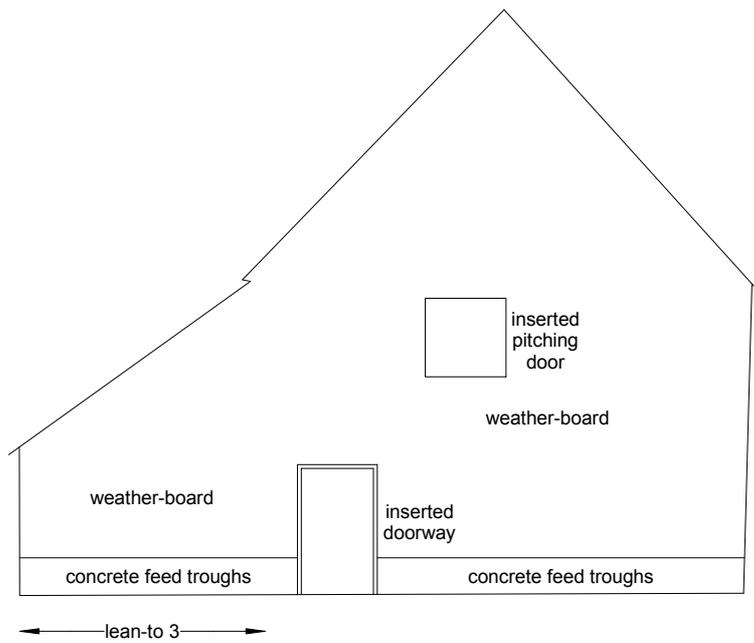
Fig 41 Structure 6, 17th-century barn east elevation.

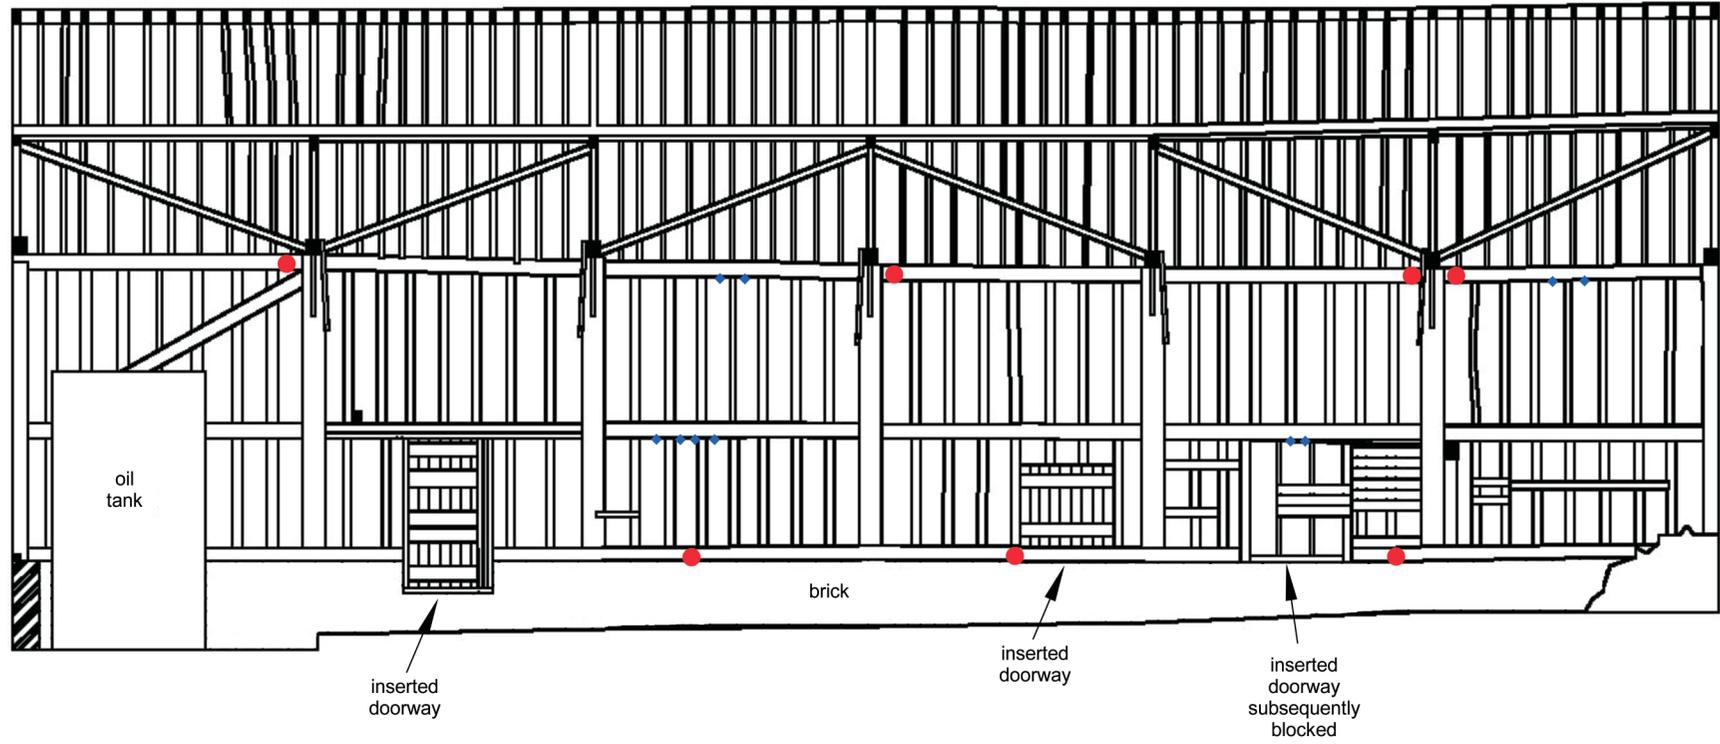
Fig 42 Structure 6, 17th-century barn north-west elevation.

- = scarf joint
- ◆ = mortice for diamond-section mullion in underside of beam

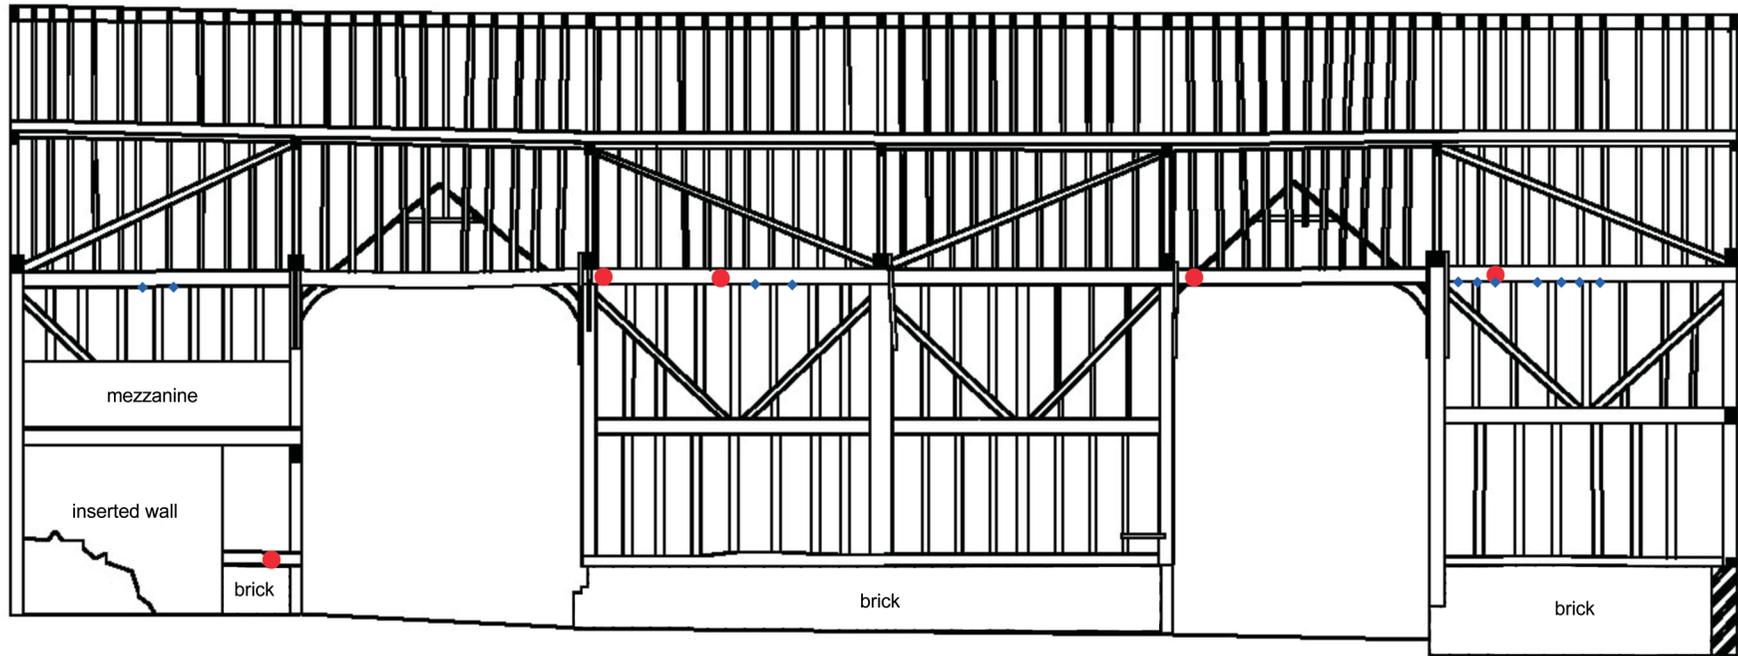
Fig 43 Structure 6, 17th-century barn south-west frame.

- = scarf joint
- ◆ = mortice for diamond-section mullion in underside of beam

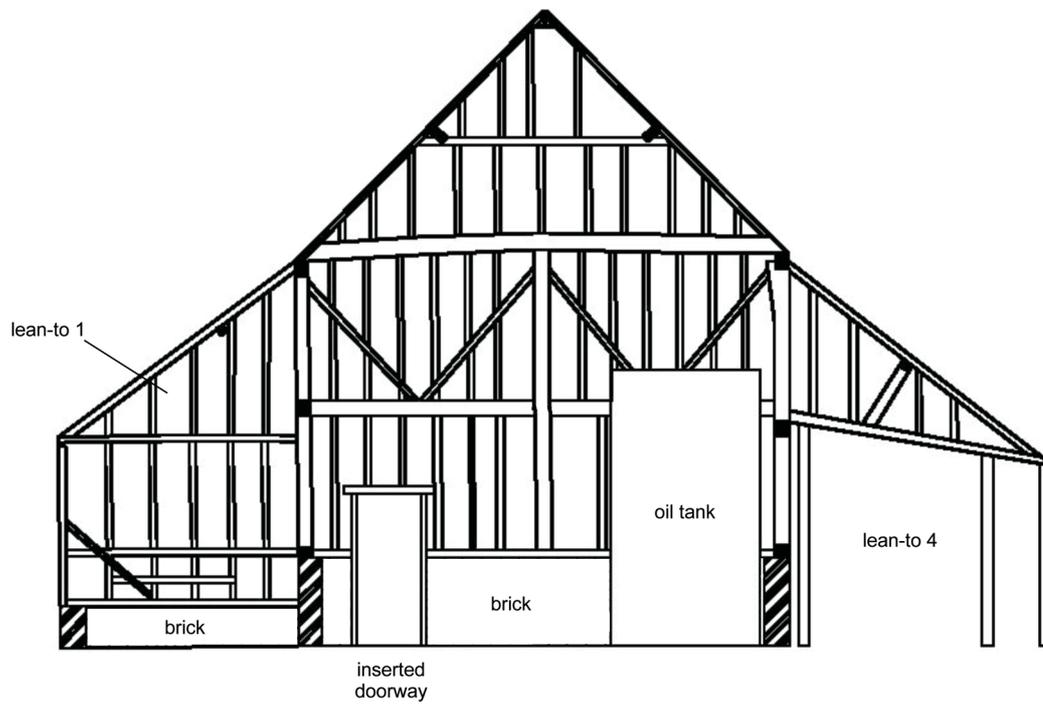
Fig 44 Structure 6, 17th-century barn north-east frame.

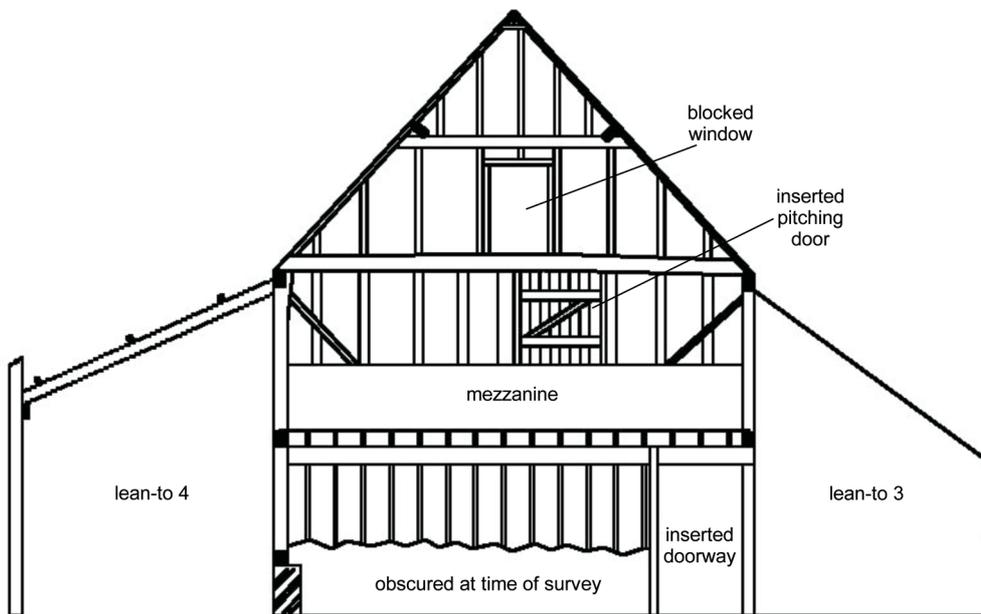
Fig 45 Structure 6, 17th-century barn east frame.

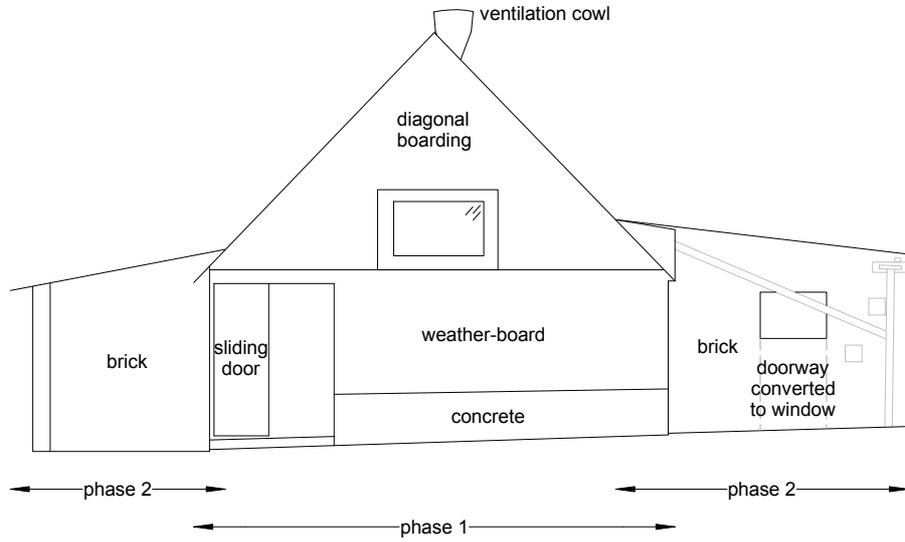
Fig 51 Structure 10, 1898-1918 milking shed north elevation.

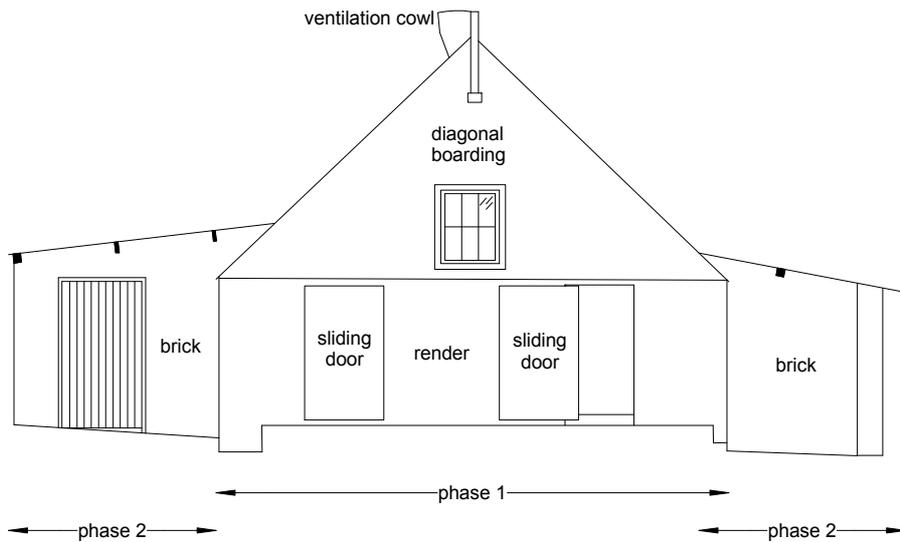
Fig 52 Structure 10, 1898-1918 milking shed south elevation.

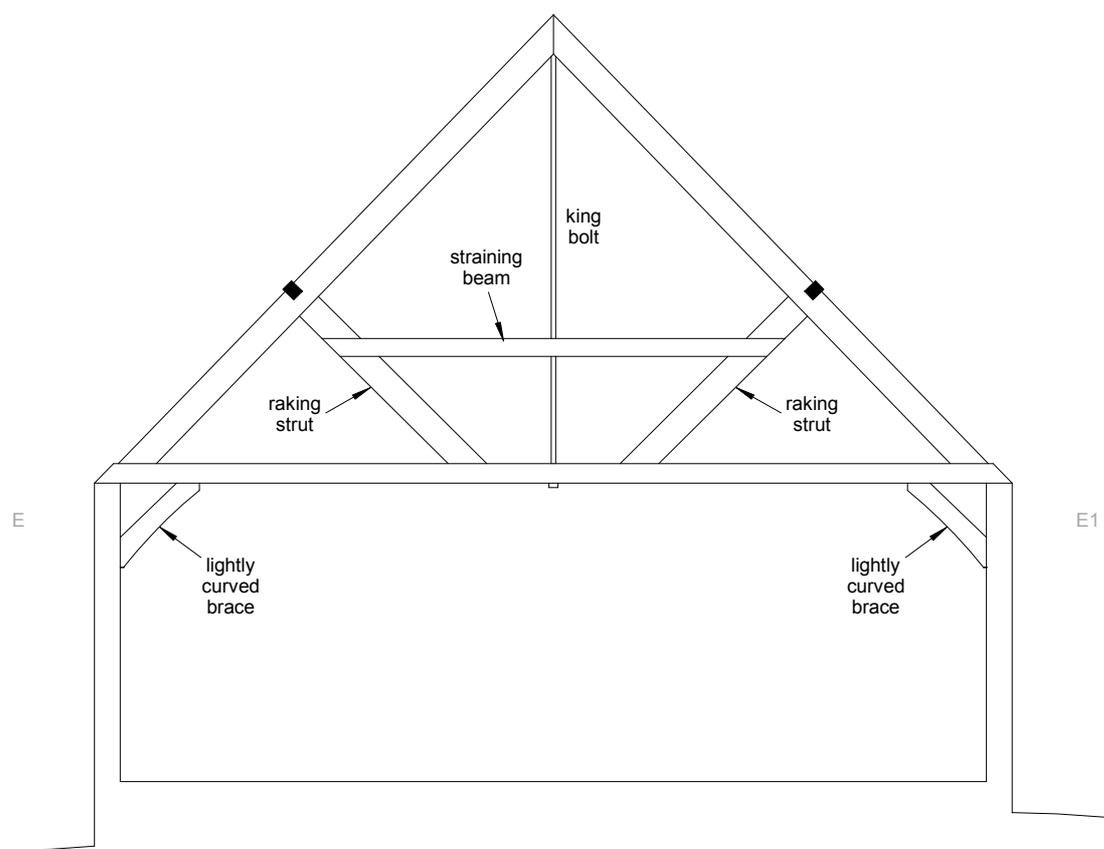
Fig 53 Structure 10, 1898-1918 milking shed cross-section of truss E.

The interior of the main range has been substantially altered. The first phase of the building comprised an open plan structure of six bays with king bolt trusses and raking struts rising from tie beams (Plate 90; Fig 53). The interior of the timber frame is clad in vertical planking which obscures the posts and studs.

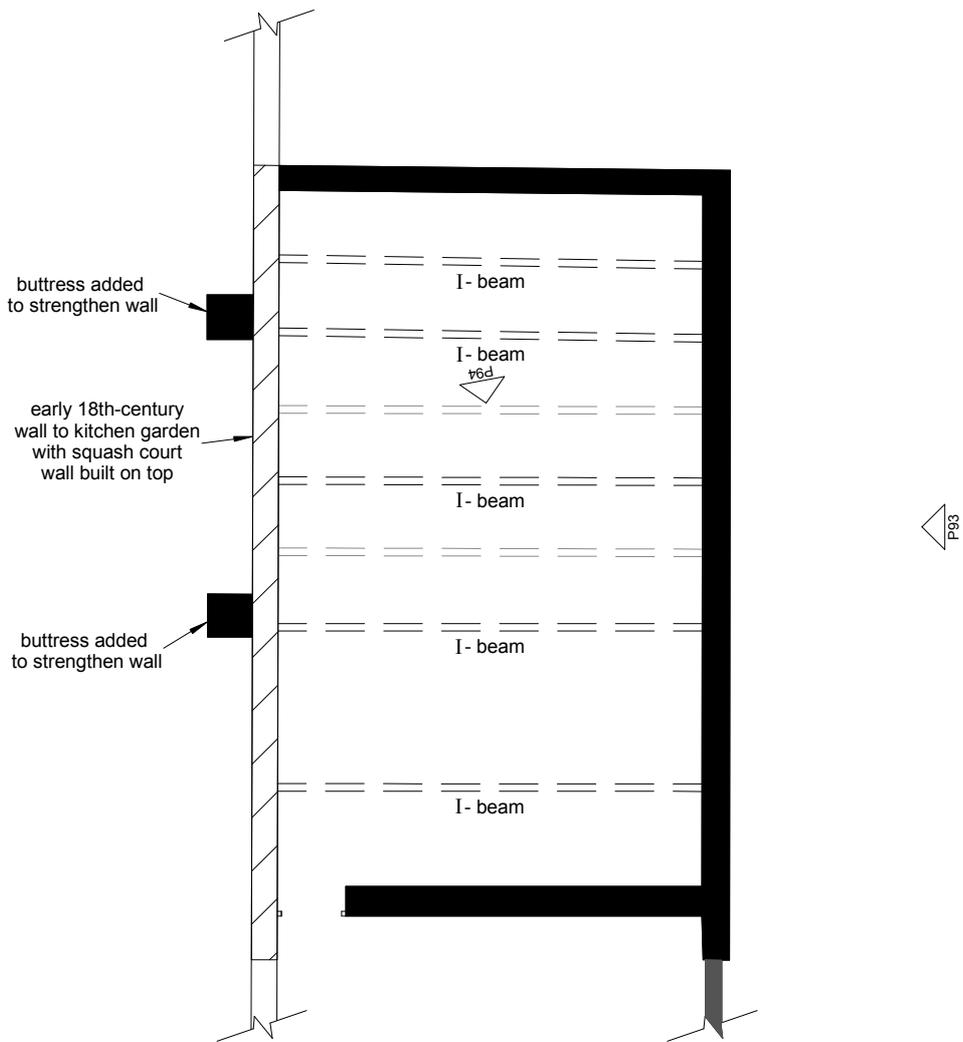
Fig 54 Plan of structure 14, 1886-98 squash court, showing the location and orientation of photographs included in this report.

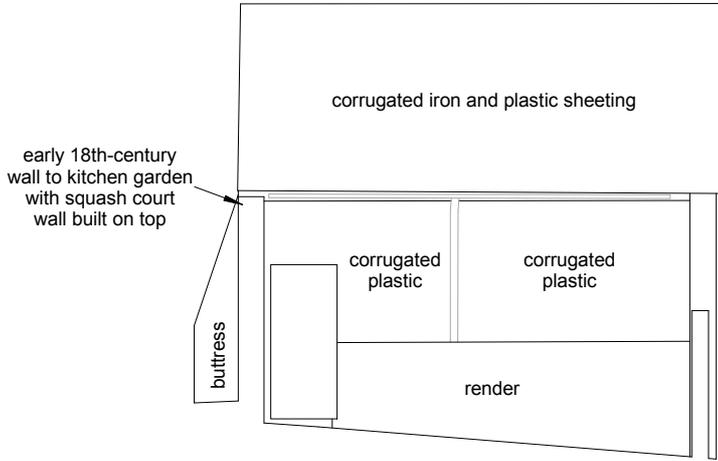
Fig 55 Structure 14, 1886-98 squash court south-west elevation.

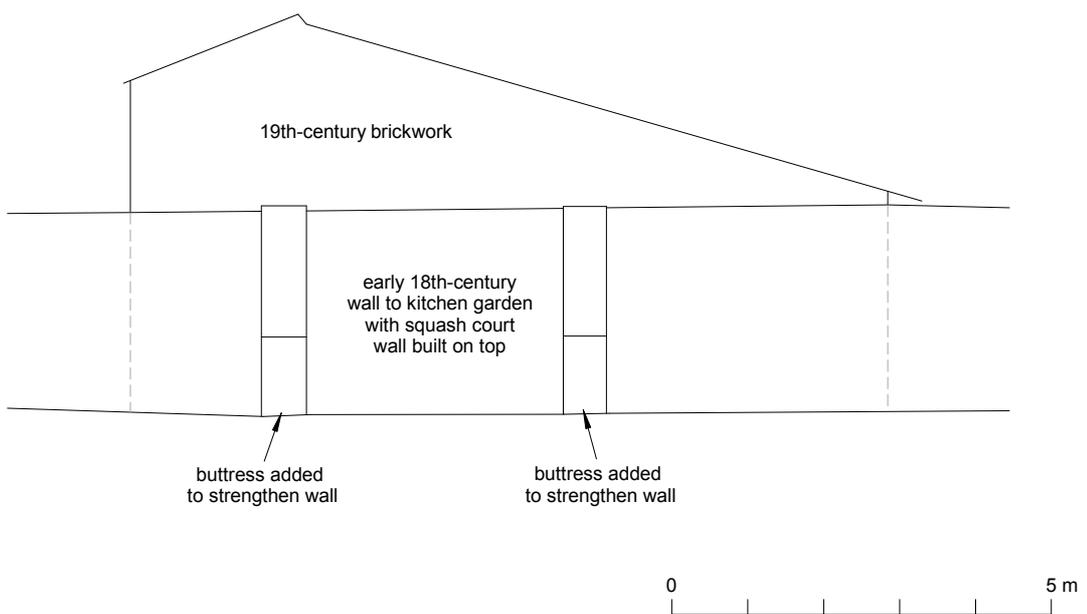
Fig 56 Structure 14, 1886-98 squash court north-west elevation.

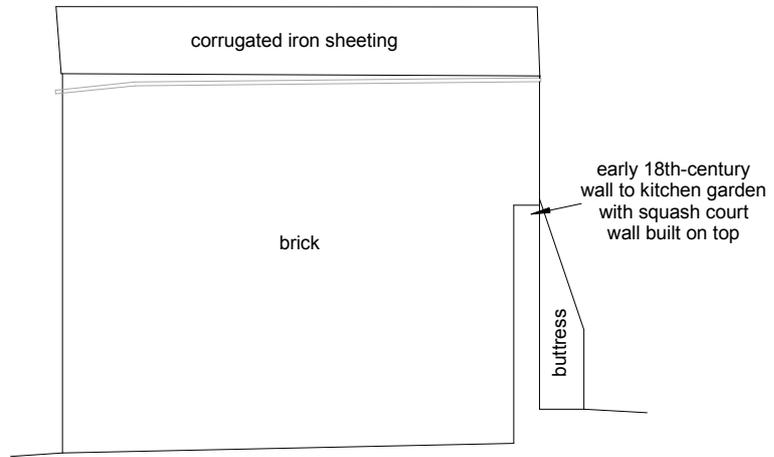
Fig 57 Structure 14, 1886-98 squash court north-east elevation.

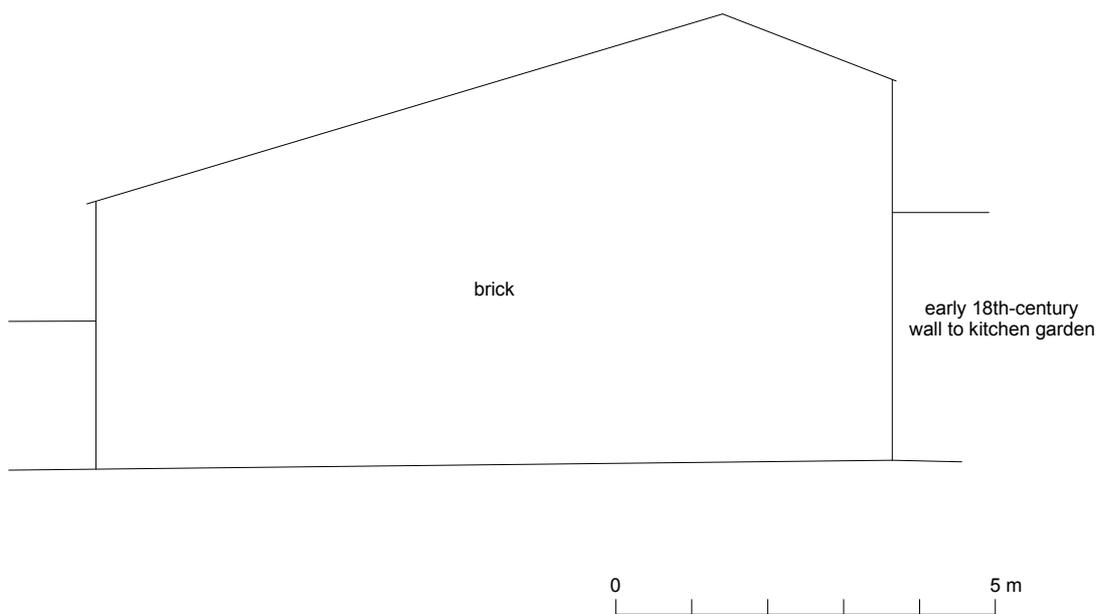
Fig 58 Structure 14, 1886-98 squash court south-east elevation.

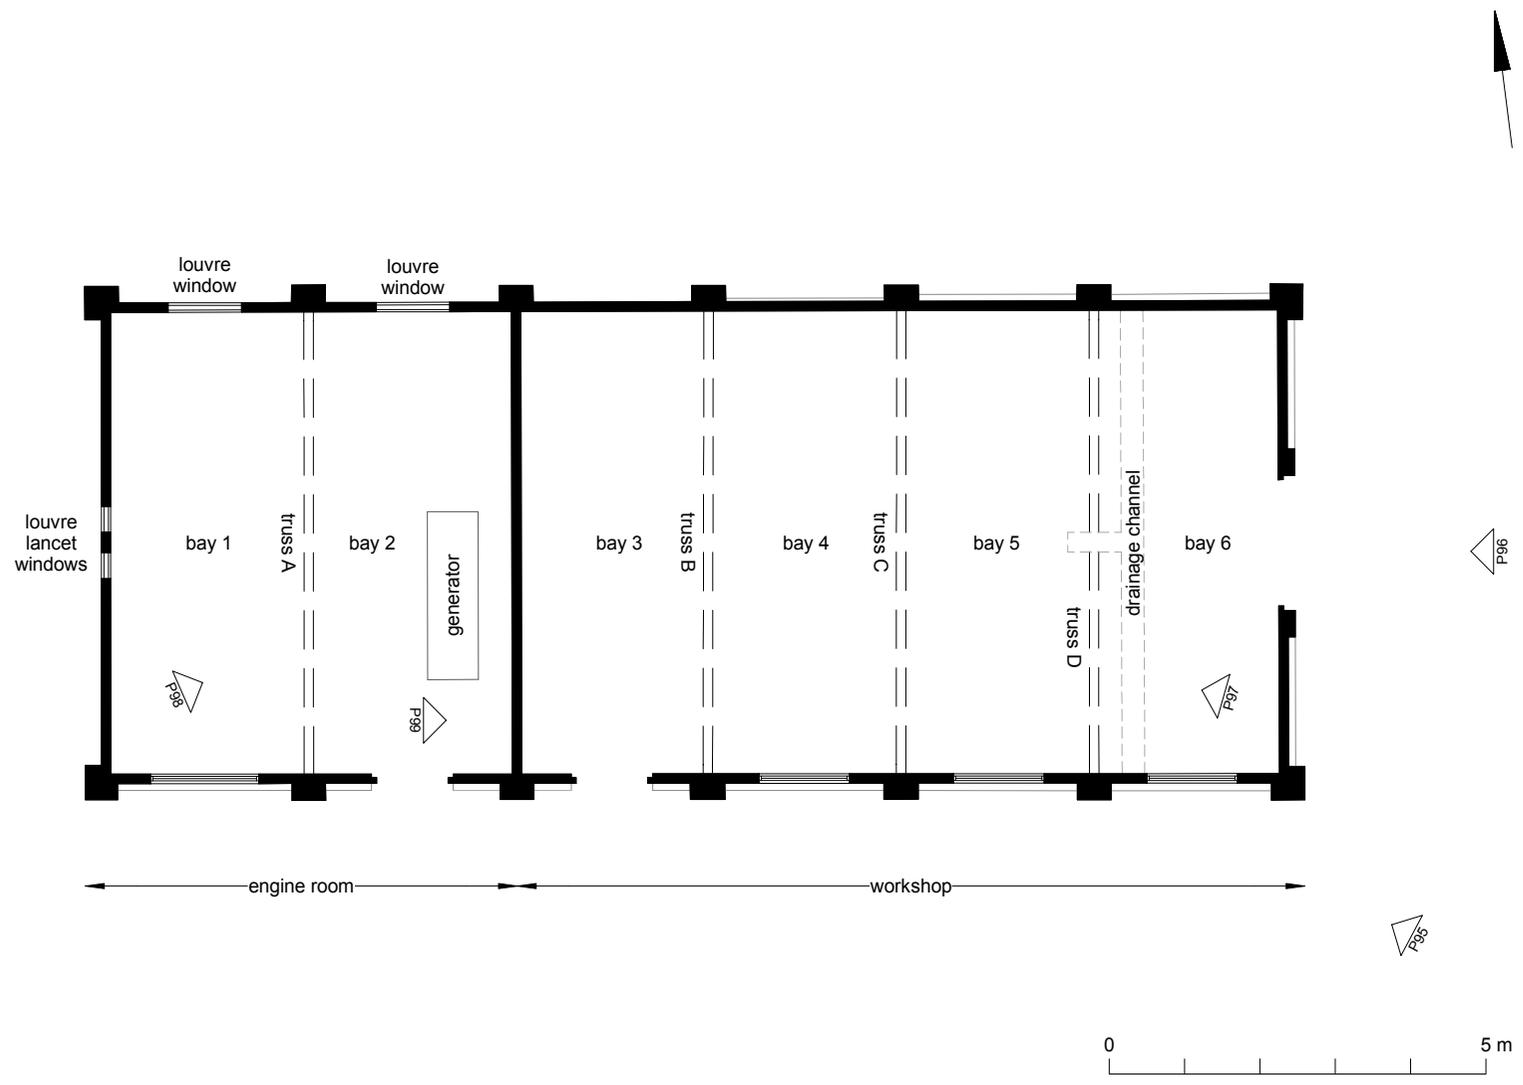
Fig 59 Plan of structure 15, 1911 engine house, showing the location and orientation of photographs included in this report.

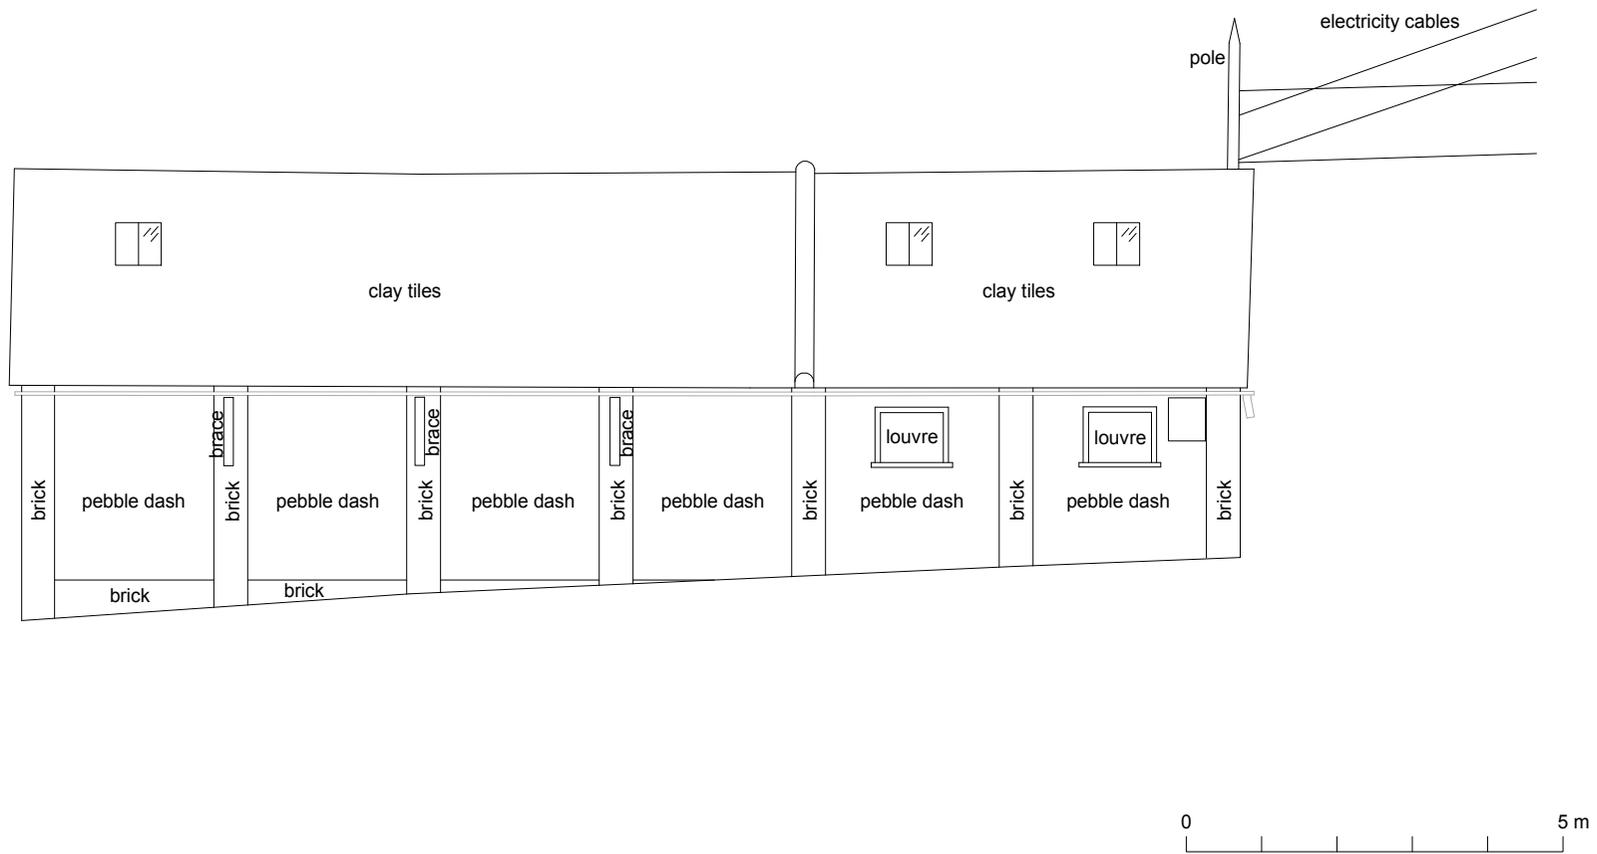
Fig 61 Structure 15, 1911 engine house north elevation.

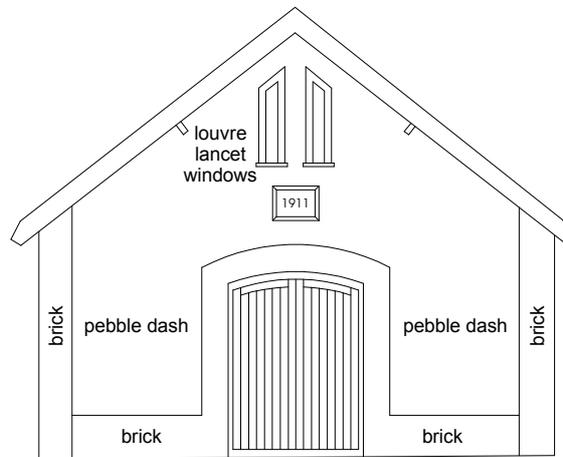
Fig 62 Structure 15, 1911 engine house east elevation.

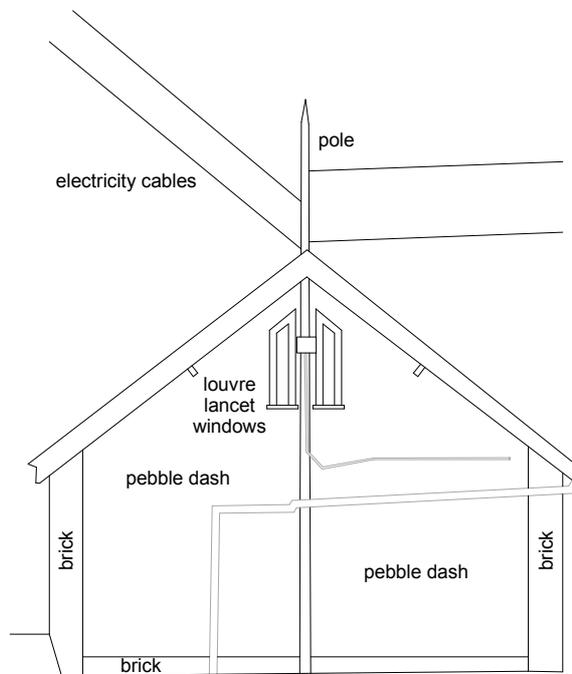
Fig 63 Structure 15, 1911 engine house west elevation.

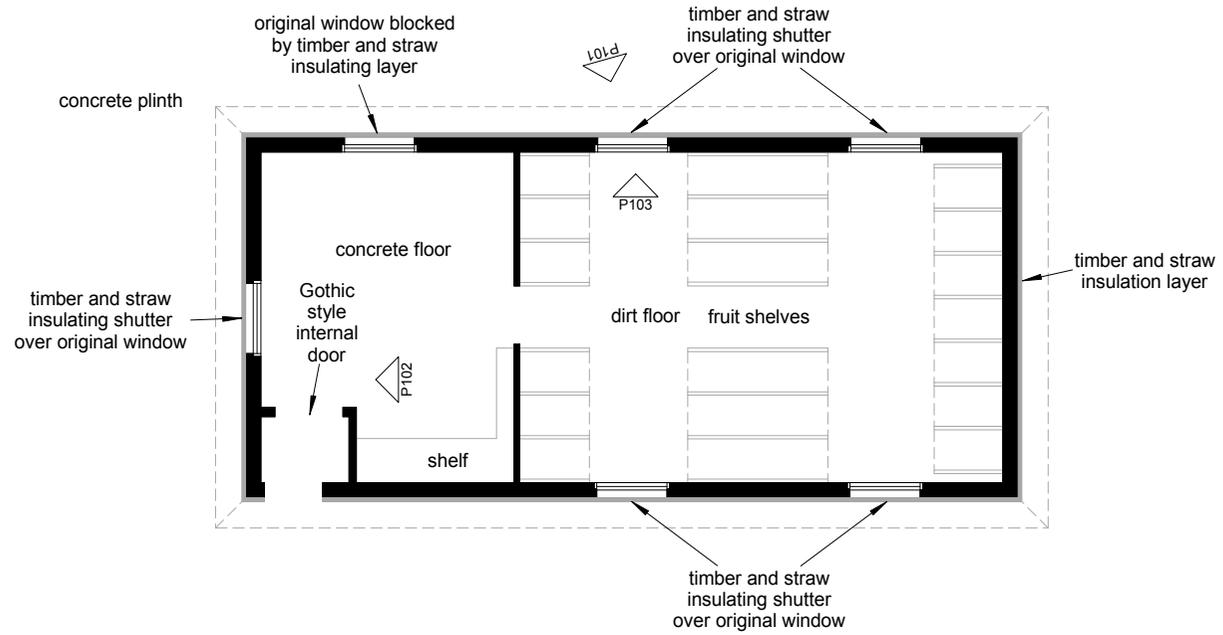
Fig 64 Plan of structure 20, 1918 apple store, showing the location and orientation of photographs included in this report.

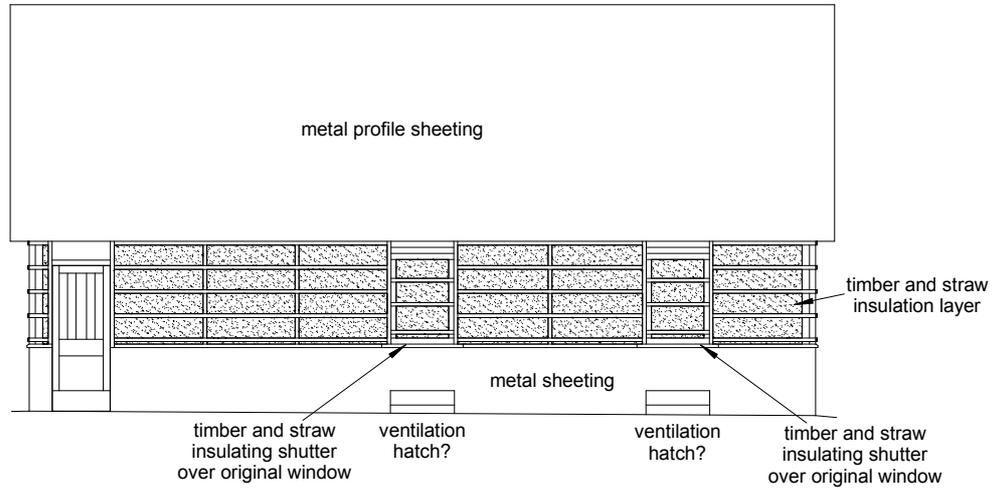
Fig 65 Structure 20, 1918 apple store north-west elevation.

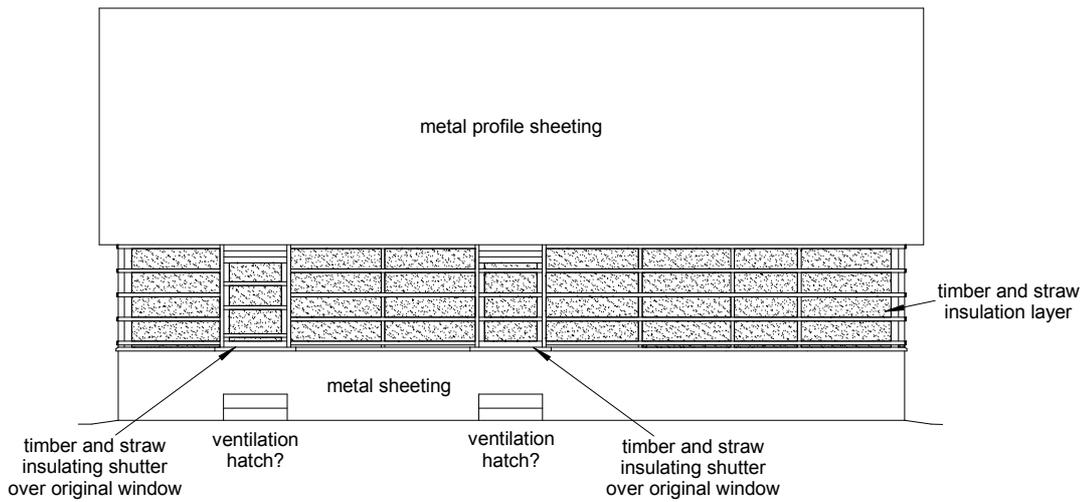
Fig 66 Structure 20, 1918 apple store south-east elevation.

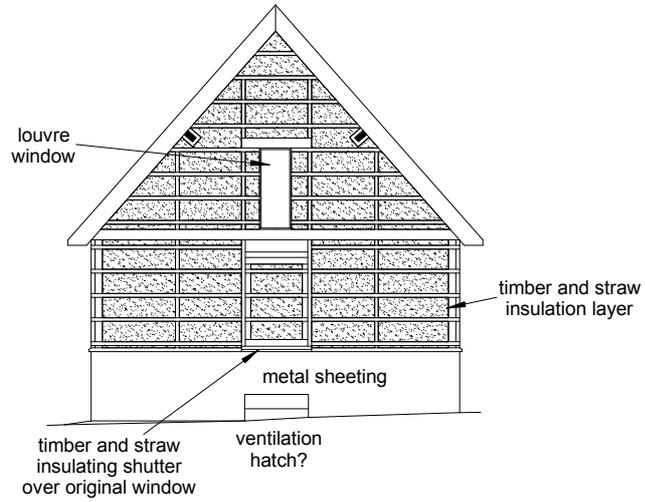
Fig 67 Structure 20, 1918 apple store north-east elevation.

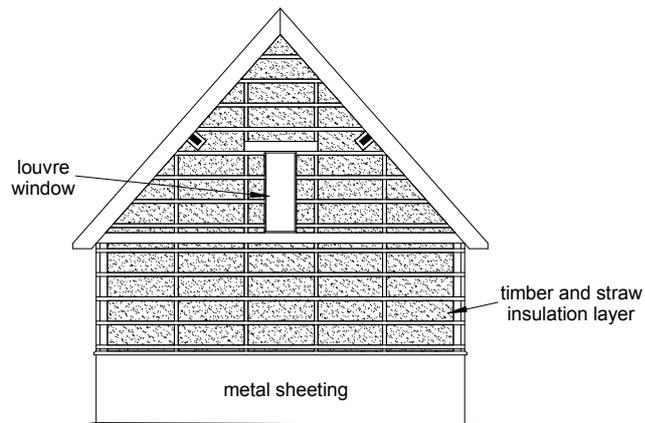
Fig 68 Structure 20, 1918 apple store south-west elevation.

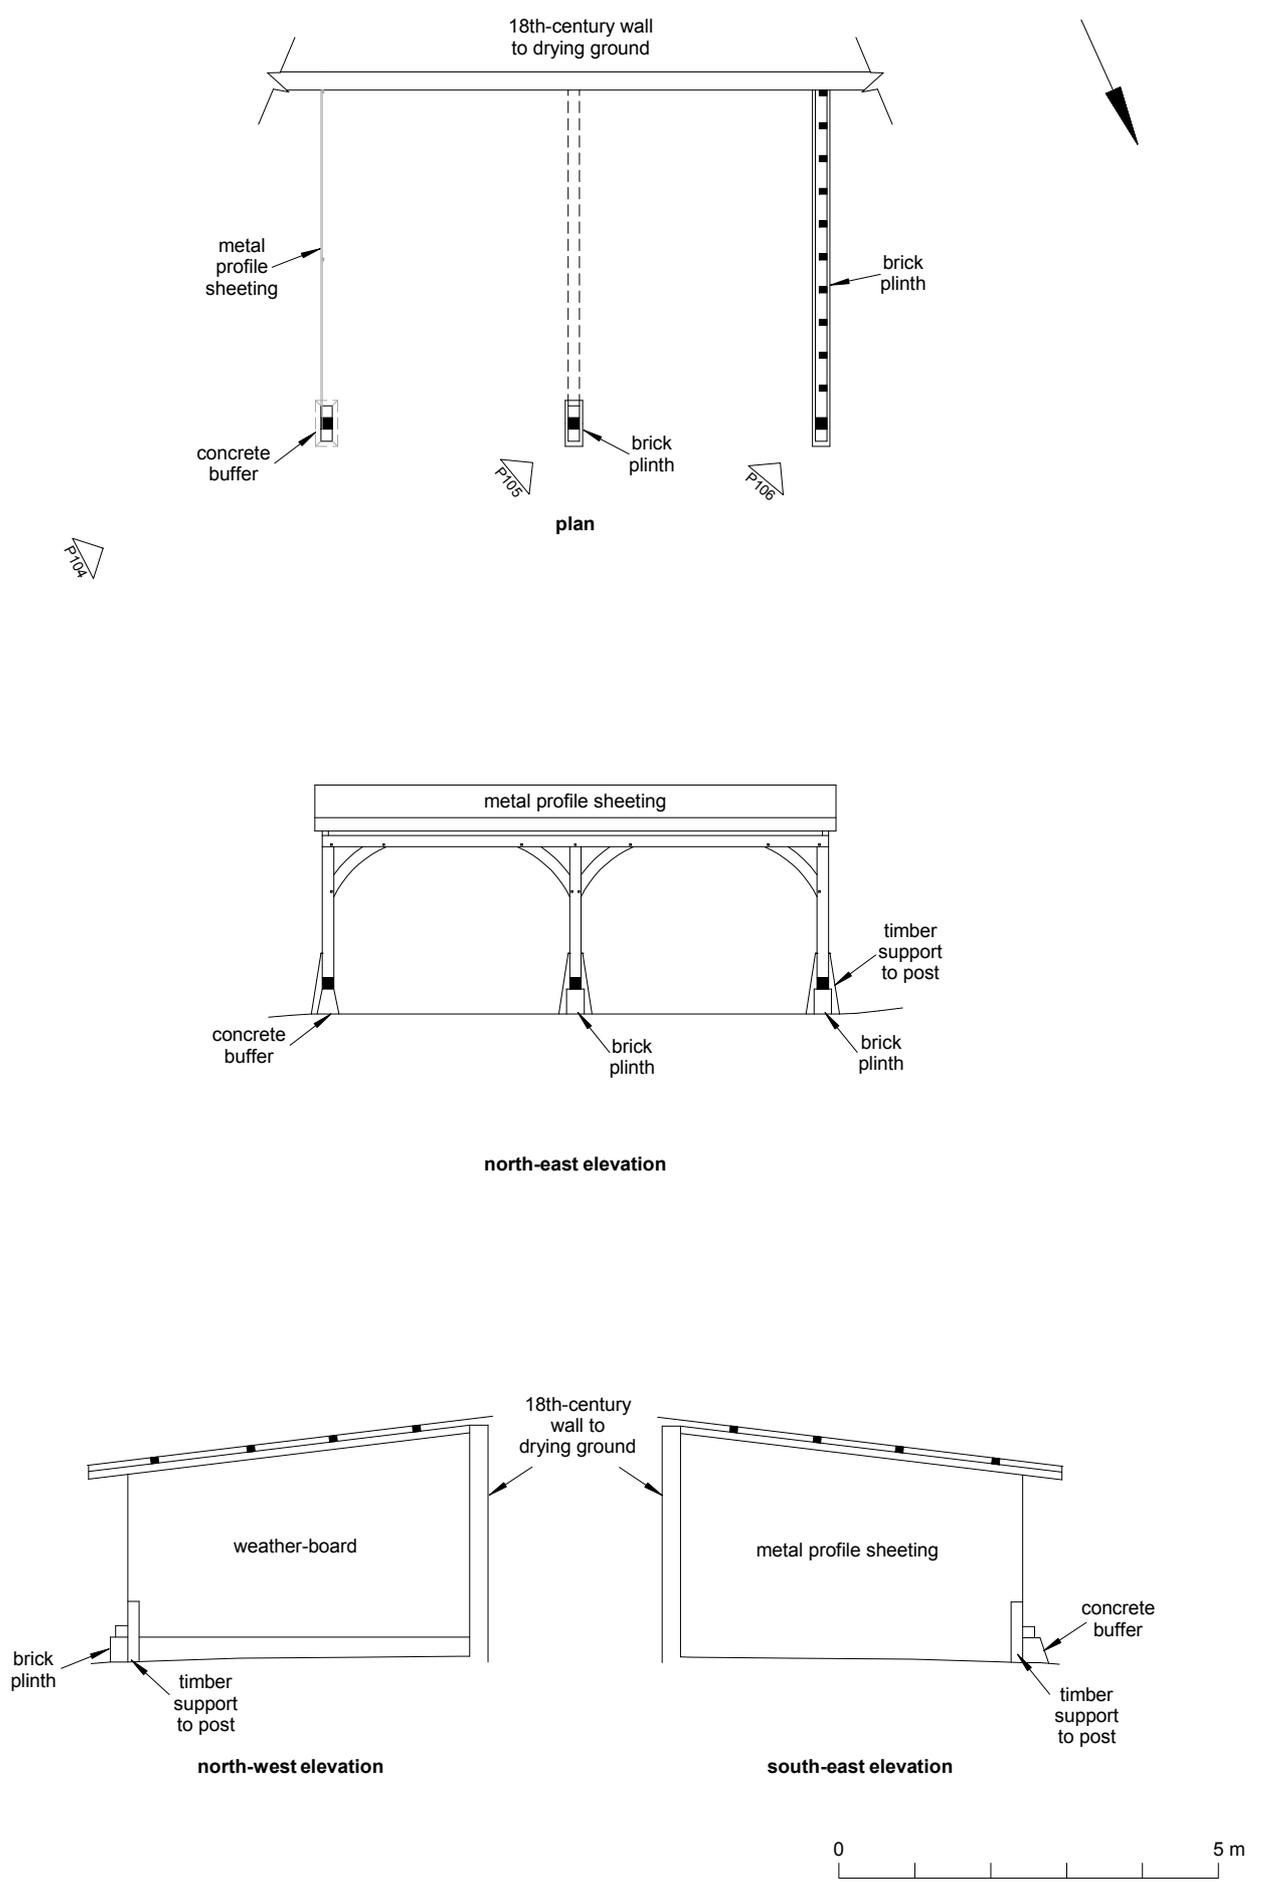
Fig 69 Structure 22, 19th-century tool shed opposite Farm Cottage, plan and elevations.

This is a single-storey, timber-framed and open-fronted structure aligned north-west to south-east, built up against the north wall of the laundry drying ground (Plate 104; Fig 69). It is of two bays, each 3.1m wide x 4.7m deep, but has been truncated to the south-east. The north-west wall is clad in weatherboard, whilst the south-east wall and the roof are covered with metal profile sheeting. The north-west wall is constructed from hand-sawn oak studs with dimensions of approximately 80mm x 100mm rising from a sill beam of 150mm x 150mm which sits on a brick plinth. The corner post and the posts to the bays (also of oak) rise to a wall plate (all 150mm x 150mm) and are strengthened by lightly arched braces, single-pegged to post and wall plate. The posts to the bays are carried on brick plinths and short sections of sill beam and have side bracing timbers which appear to be a later addition (Plate 105). There are carpenter's marks located on the braces and the posts: the north-west post and brace are marked 'IX'; the central post and brace are marked 'VIII' and 'VII'; and the south-east post and brace are marked 'VI' (Plate 106). The brick plinth of the south-east post has either been replaced by or obscured by a concrete buffer.
