Archaeological evaluation at Writtle Mill, Chelmsford Road, Writtle, Essex, CM1 3ET

Colchester Archaeological Trust

CAT Report 964

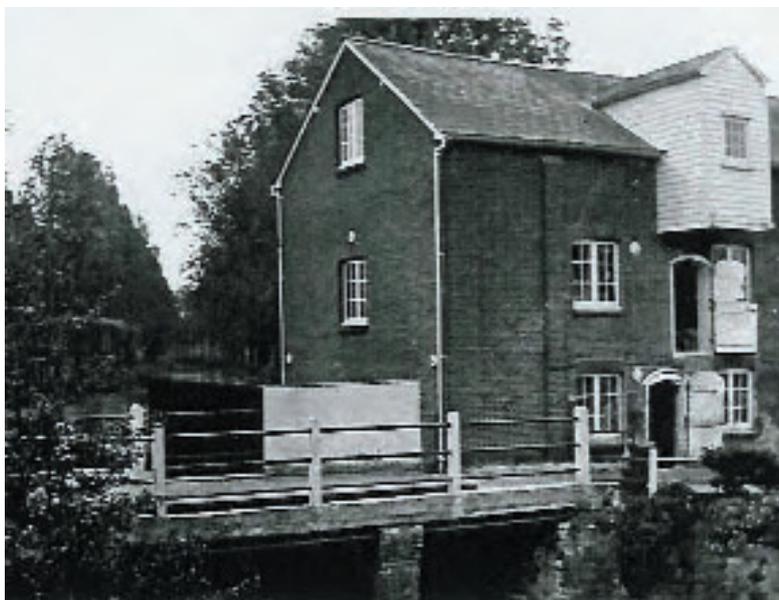
Photograph 2 Writtle watermill, c 1936, looking N
(owned at the time by the Southgate family)

The 10ft (3m) water-wheel pit as described by Large was not uncovered during excavation. Historic photographs (Photographs 2-3) appear to show that the wheel was located within its own separate, probably timber, structure located on the north-east side of the mill. So, it should be located further to the north-east of the end of T2.

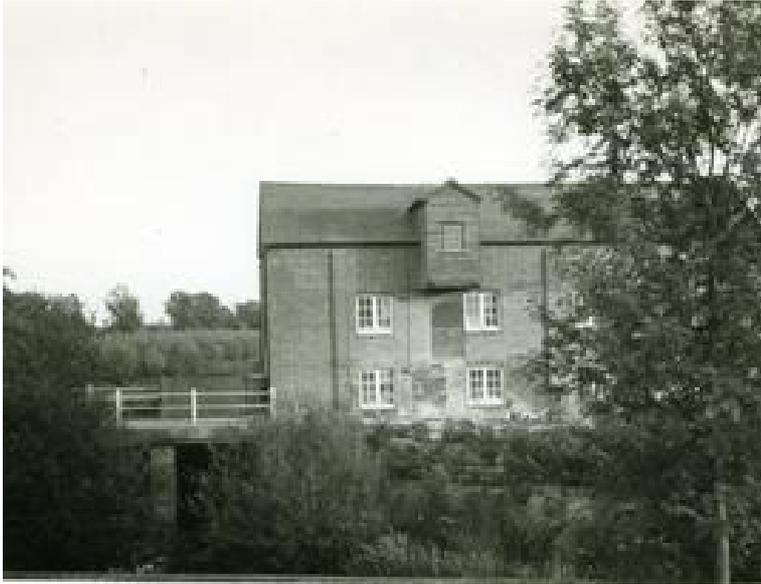
Photograph 3 Writtle watermill, taken sometime after c 1936 as the two doors have been bricked-up, looking SE

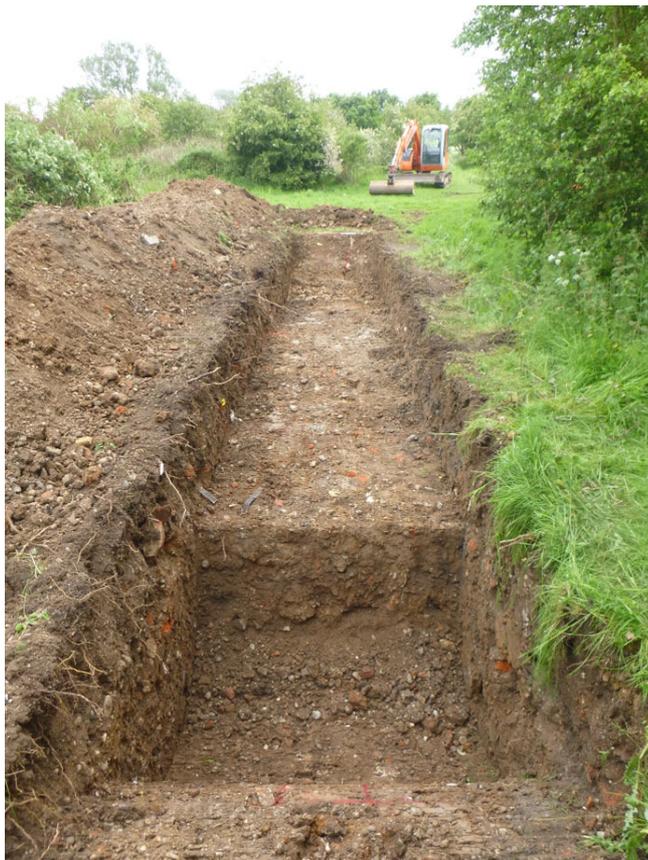
Photograph 4 T1, looking SE

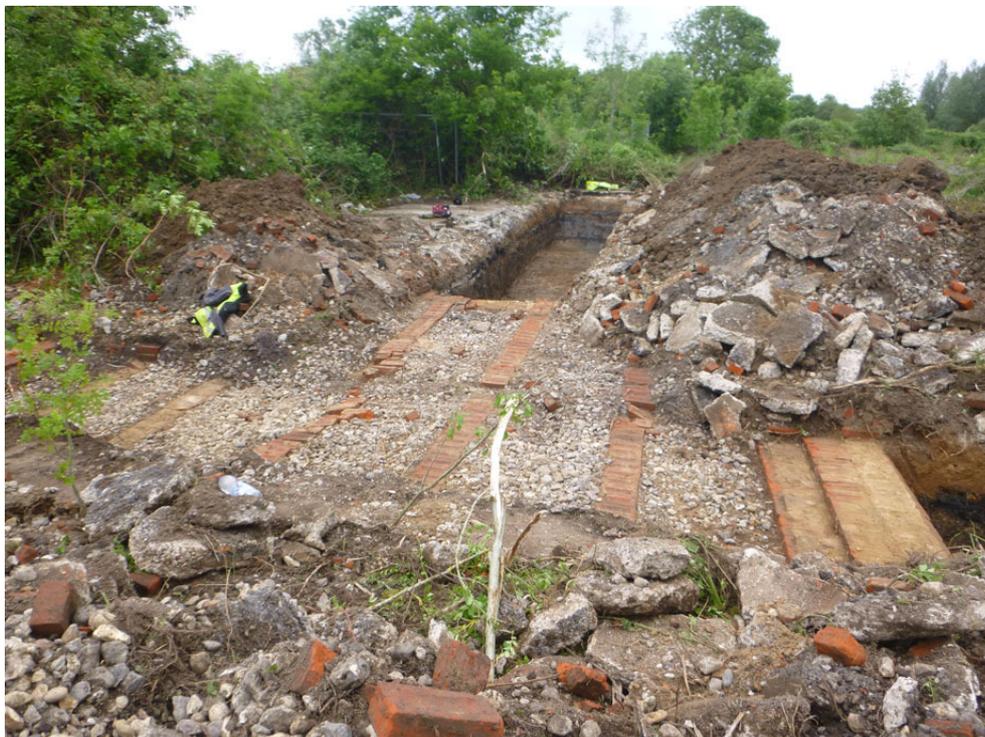
Photograph 5 T2-T3, looking SE

Photograph 7 (and 5): To the north-east of this external wall were five lines of internal brickwork spaced 6-8.5mm apart with rounded river cobbles laid between them. The lines were 230mm wide, and were made of a single row of bricks laid side-by-side. Representing the remains of raised plinths, this brickwork would have probably supported the ground floor (machinery/spout floor) of the mill. Raising the floor this way would have increased ventilation and prevented the timbers from rotting on what would have been very damp ground.

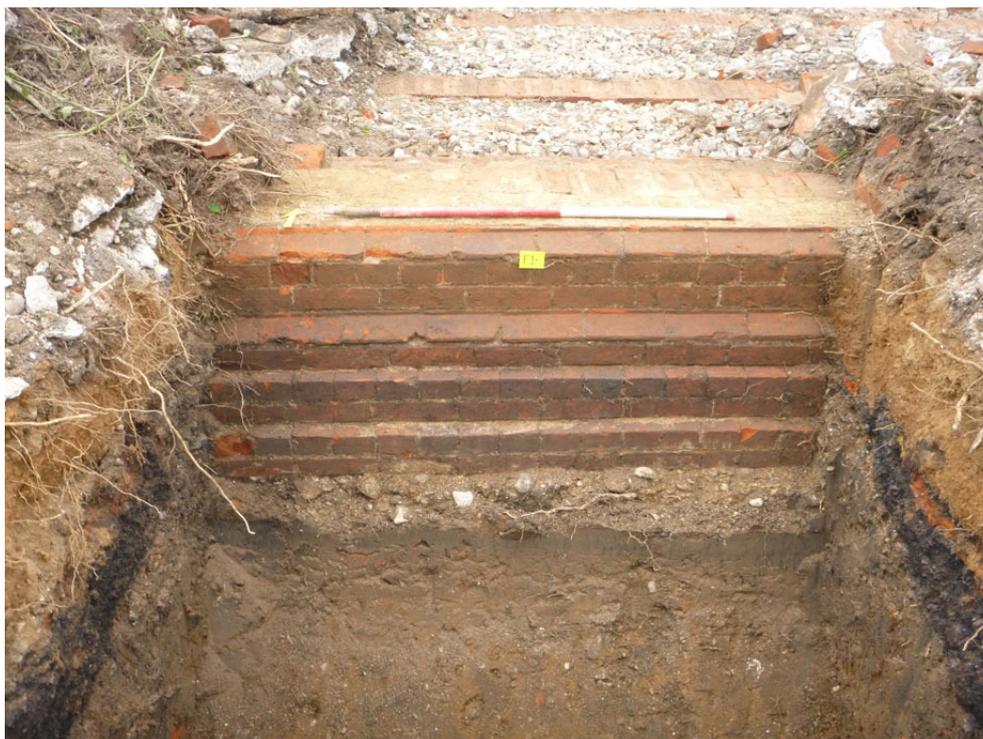
Photograph 6 South-west facing external wall of mill showing low plinth wall with two moulded chamfered brick courses, looking NE

Photograph 6: The south-west facing external wall of the building is represented by the remains of a low plinth wall with two moulded chamfered brick courses. This decorative moulding would originally have stood above ground, indicating that L5 represents ground-level at the time the mill was demolished and all subsequent layers post-date demolition (c 2000). The wall measured approximately 0.8m wide.

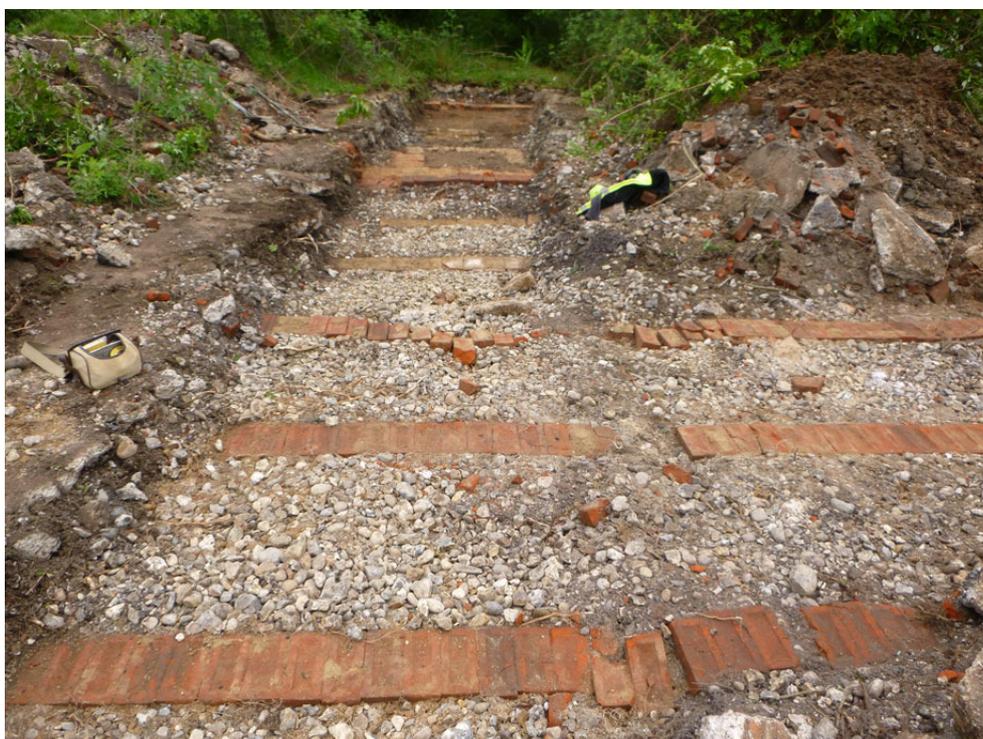
Photograph 7 Lines of frogged brickwork representing the remains of plinths used to support a raised floor, looking NE

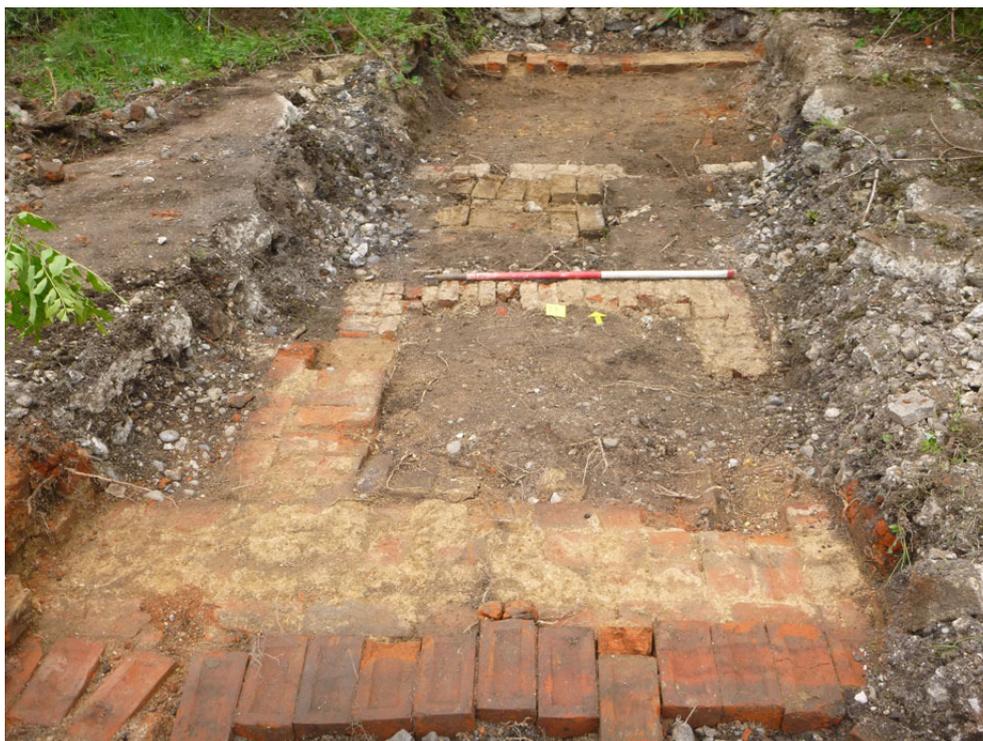
Photograph 8 Square brick-built foundation, possibly an inspection pit, looking NE

Photograph 8-9: Beyond the lines of brickwork is a square brick-built foundation measuring 1.5m by 1.5m. This is possibly an inspection pit or shaft for some of the machinery that would have been in operation on the ground floor.

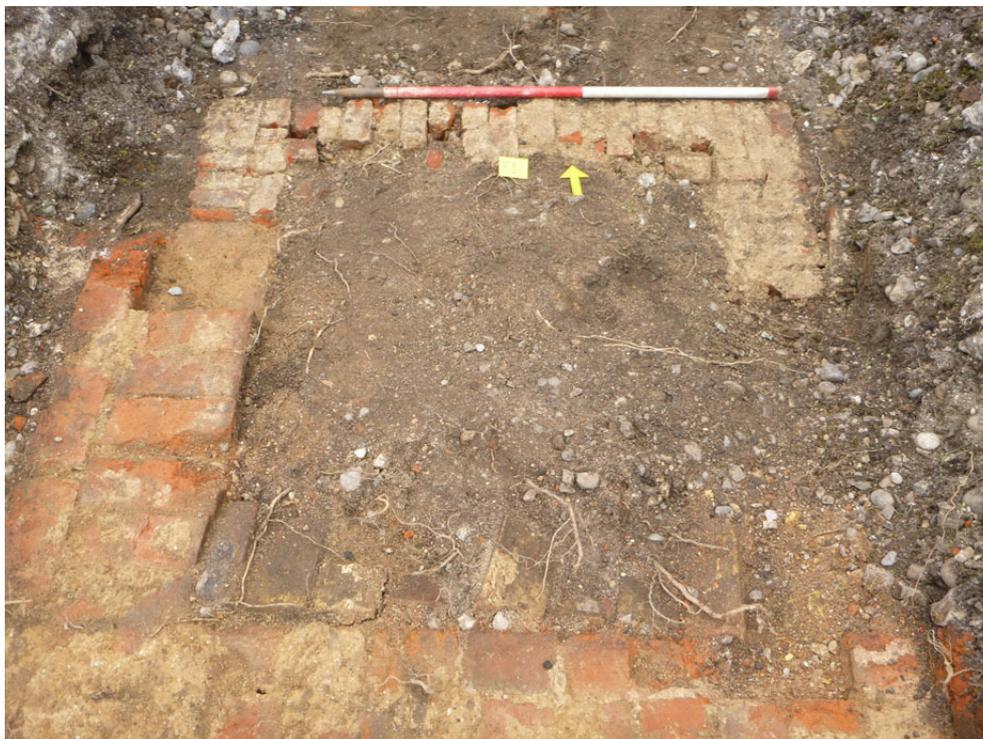
Photograph 9 Square brick-built foundation, possibly an inspection pit, looking NE

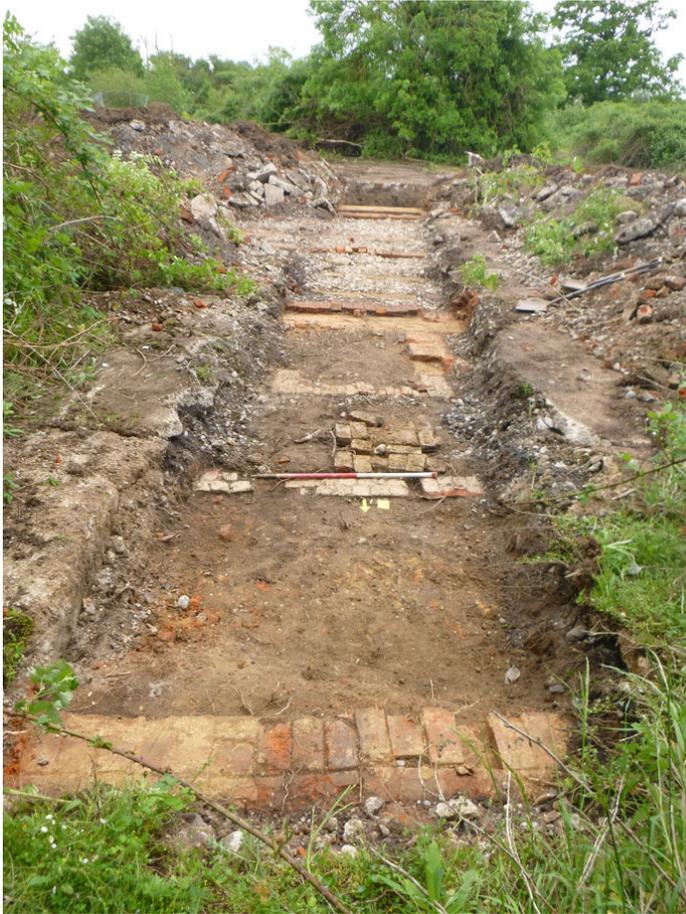
Photograph 10 Wall foundations and brick pavior at the far NE end of the trench, possibly including the pit for the pit-wheel in the foreground, looking SW

Photograph 10: Beyond the square foundation are two the remains of two further brick wall foundations and a small section of what appears to be a brick pavior (floor). The brick pavior probably also functioned as part of an inspection pit. It is possible that the area between the last two brick walls was the pit for the pit-wheel. If so, this would mean that the north-eastern most brick foundation is the north-east facing external wall, but this can not be confirmed.

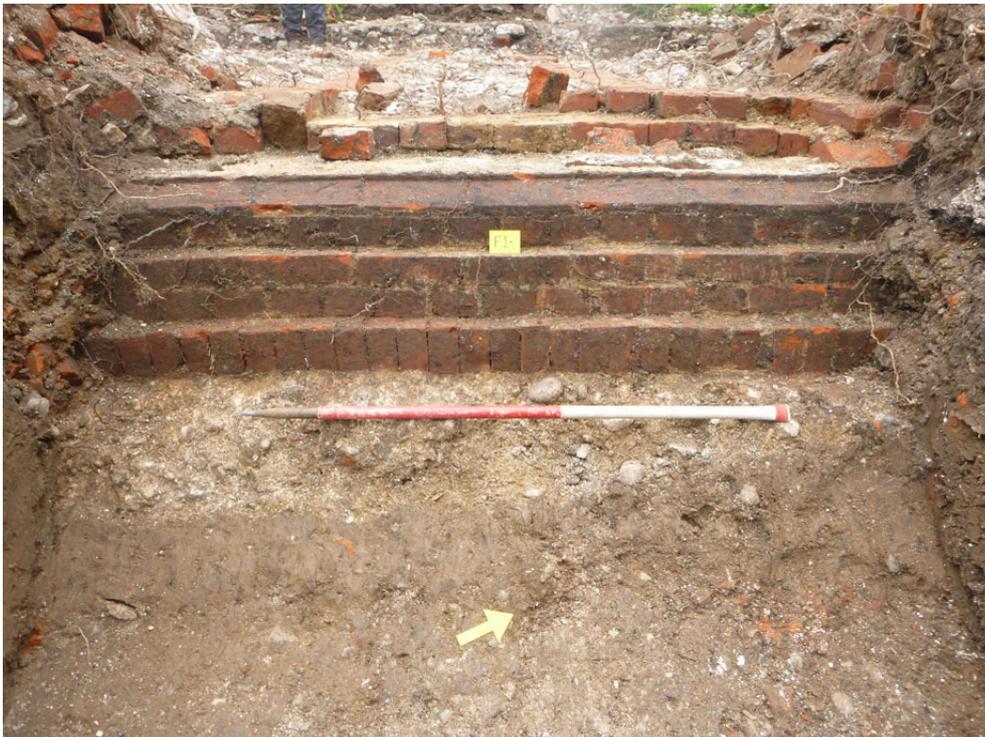
Photograph 11 South-east facing external wall of mill showing low plinth wall with lower moulded chamfered brick course, looking NW

Photograph 11-12: Also identified in T3 was part of the south-east facing external wall of the mill. The remains of the lower moulded chamfered brick course have survived in this section, but the upper course has been damaged.

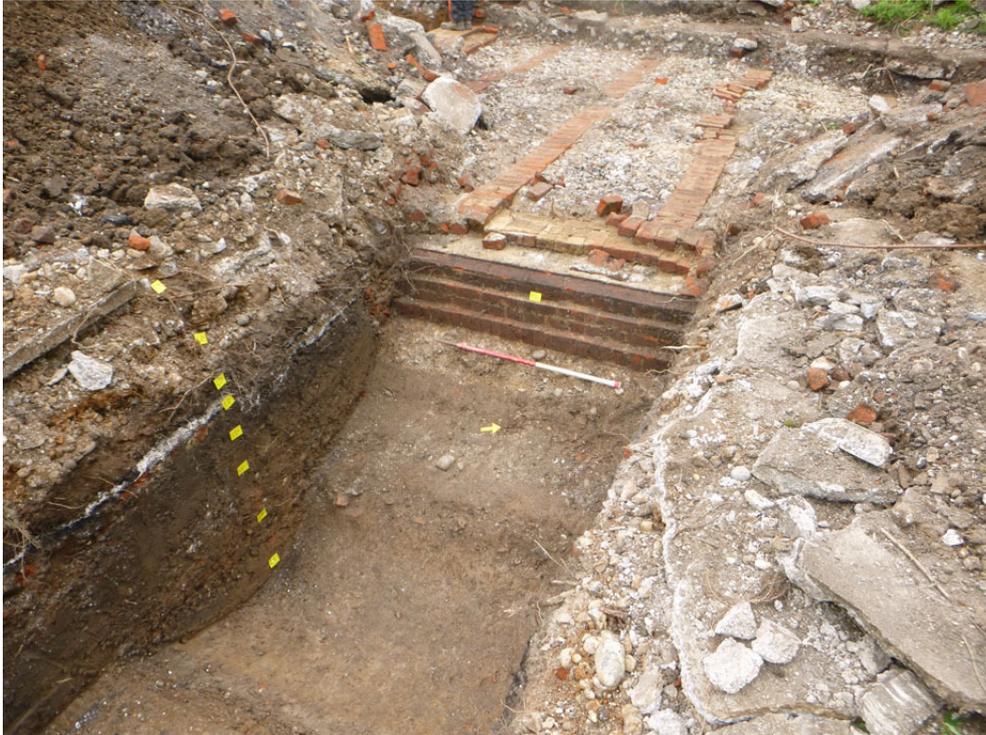
Photograph 12 South-east facing external wall of mill with brick plinths beyond and representative section from ground level to natural, looking W

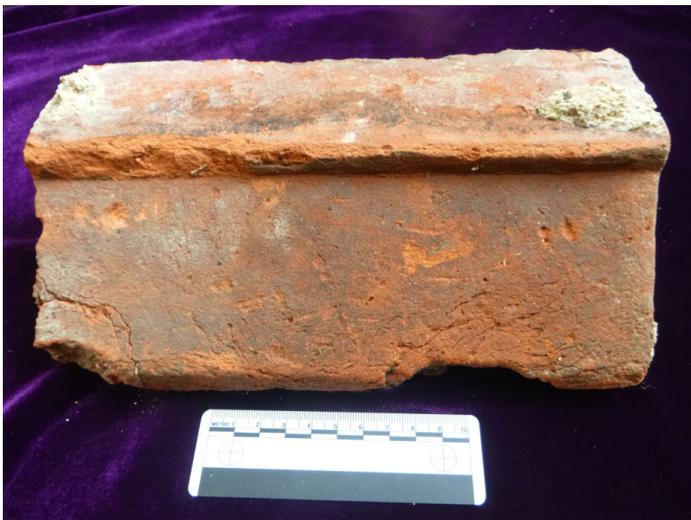
Photograph 13 Chamfered brick

A single brick from the foundation wall of the mill was retained for identification (finds number 2). It was a frogged 'soft red' brick measuring 230mm by 112mm by 68mm (19th century). A single chamfered brick was also retained (finds number 2). It was also a 'soft-red' measuring 230mm by 112mm by 68mm, but with a 45° angle on one face.

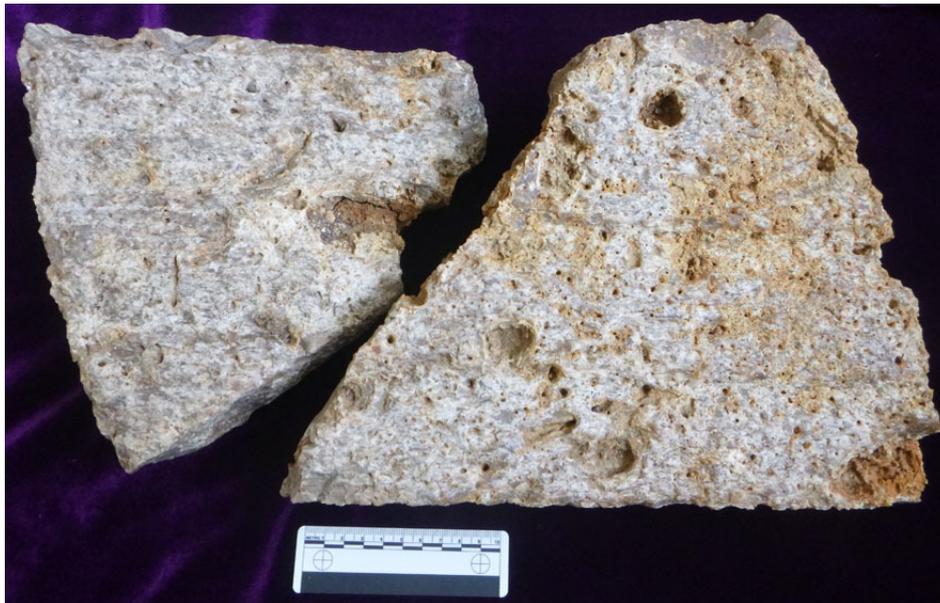
Photograph 14 Millstone fragments

Two fragments of millstone were recovered from modern demolition layer L2 (finds number 3). The fragments measured 300mm by 240mm by 100mm and 250mm by 240mm by 70mm. Both are dressed with three furrows evident on the larger piece and two on the smaller. The stone appears to be French burrstone (identified by Stephen Benfield), used for finer grinding. This stone is not cut from one piece but built up from sections of quartz cemented together with plaster and bound with iron bands. French burr comes from the Marne Valley in northern France.

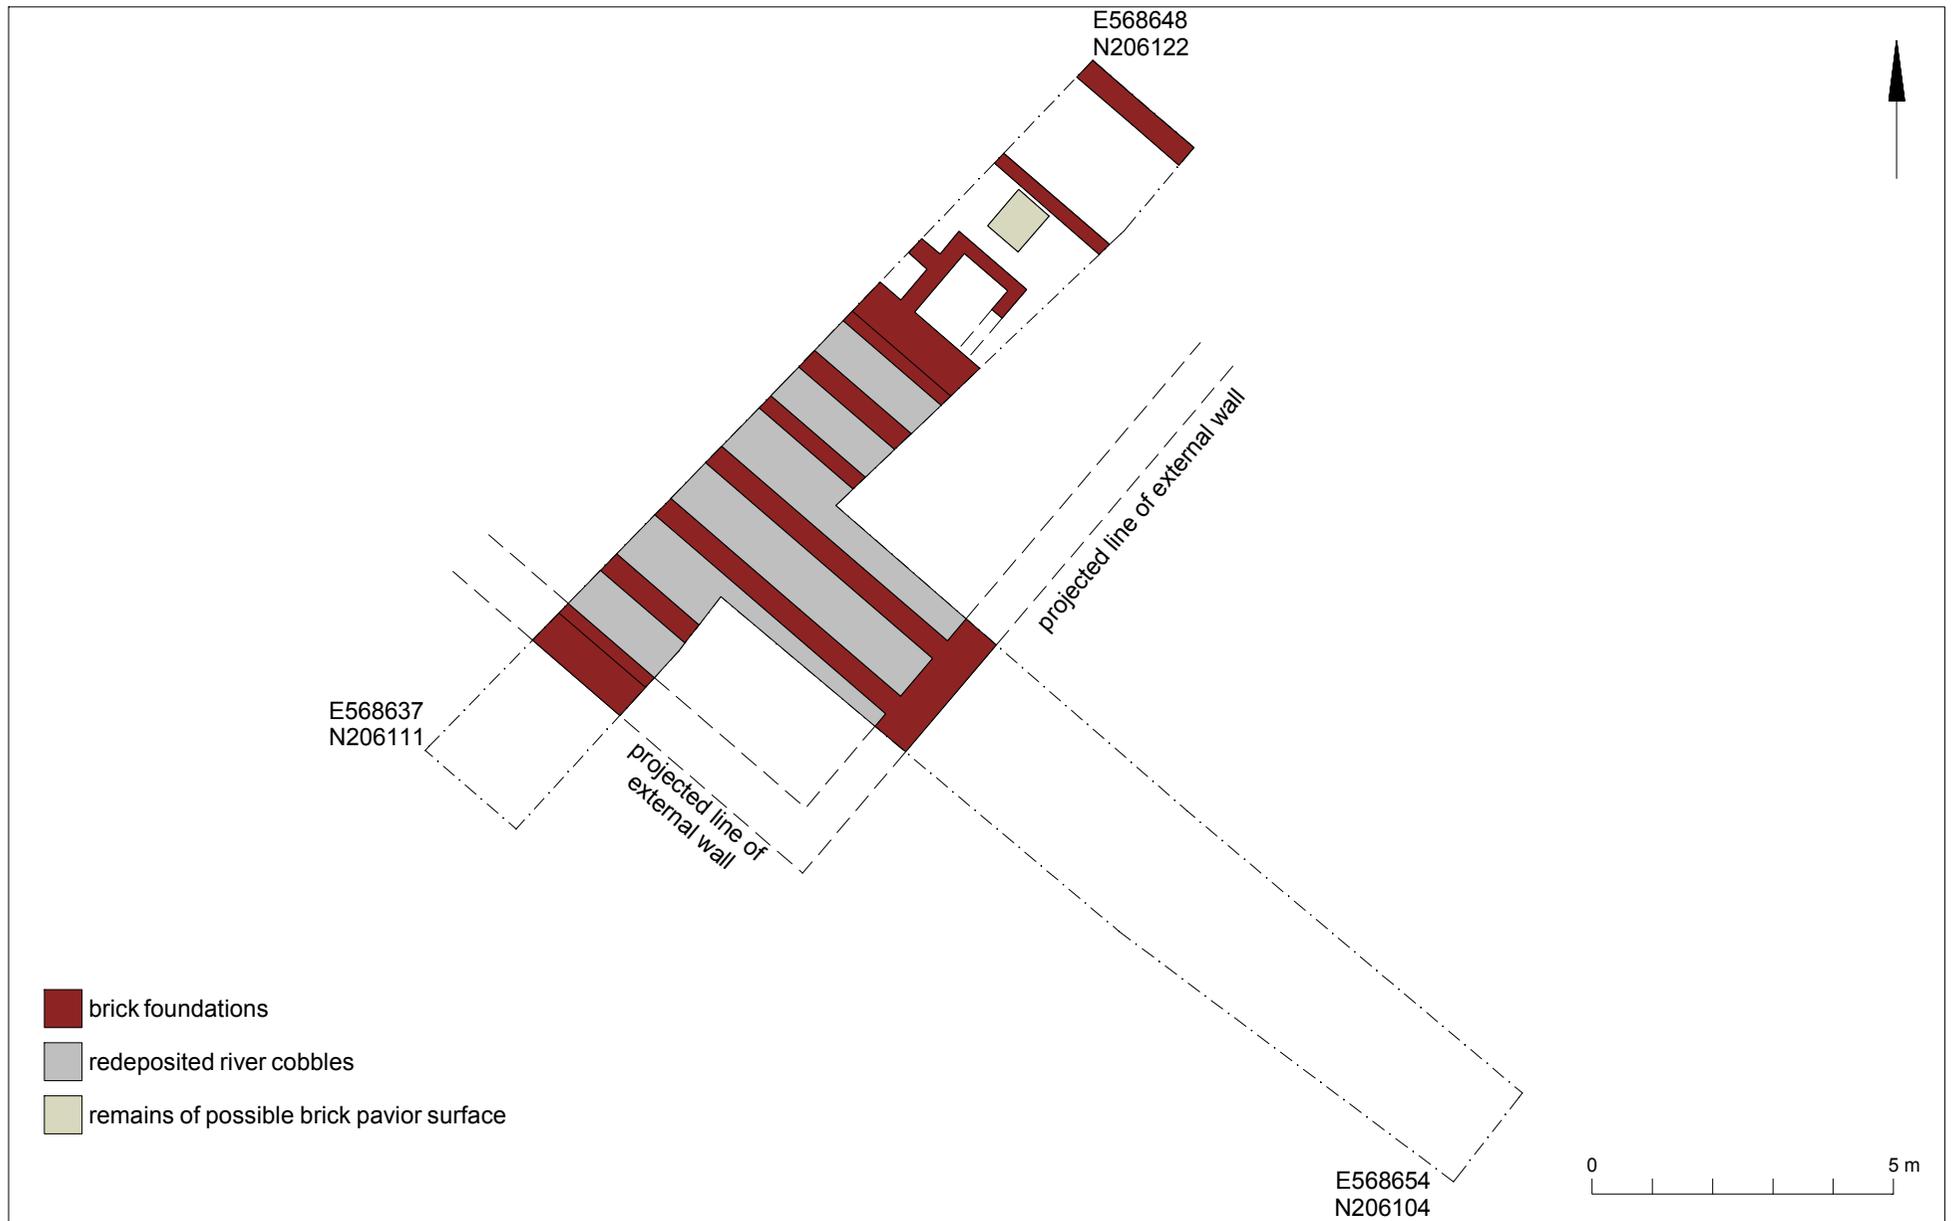
Fig 2 Results.

4 Results (Figs 2-3)

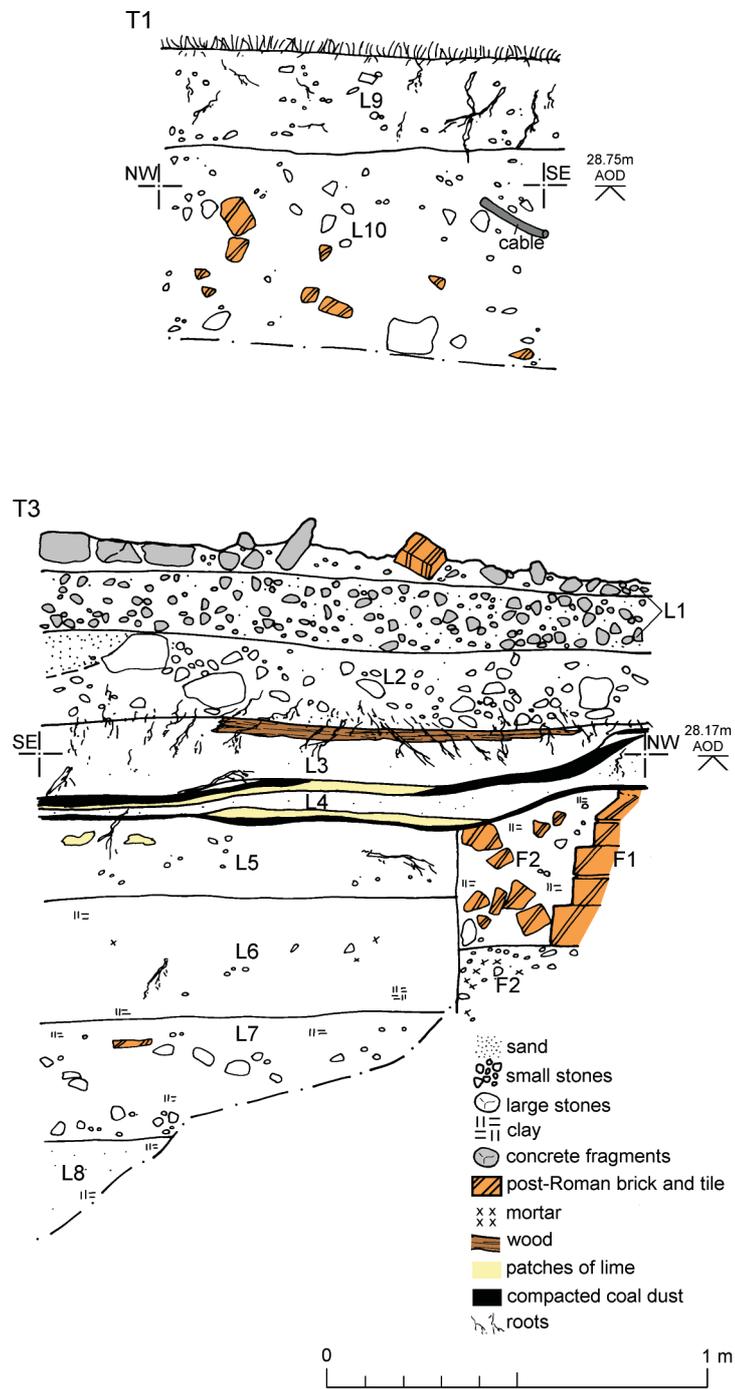
Fig 3 T1 and T3: Representative trench sections.
