**CAT Report 2010  
issued January 2024**

**Historic building recording at Spital Farm,  
Station Road, Tolleshunt D'arcy, Essex, CM9 8HR**

**Historic building recording at Spital Farm,  
Station Road, Tolleshunt D'Arcy, Essex,  
CM9 8HR**

**Planning ref.: MAL/23/00010**

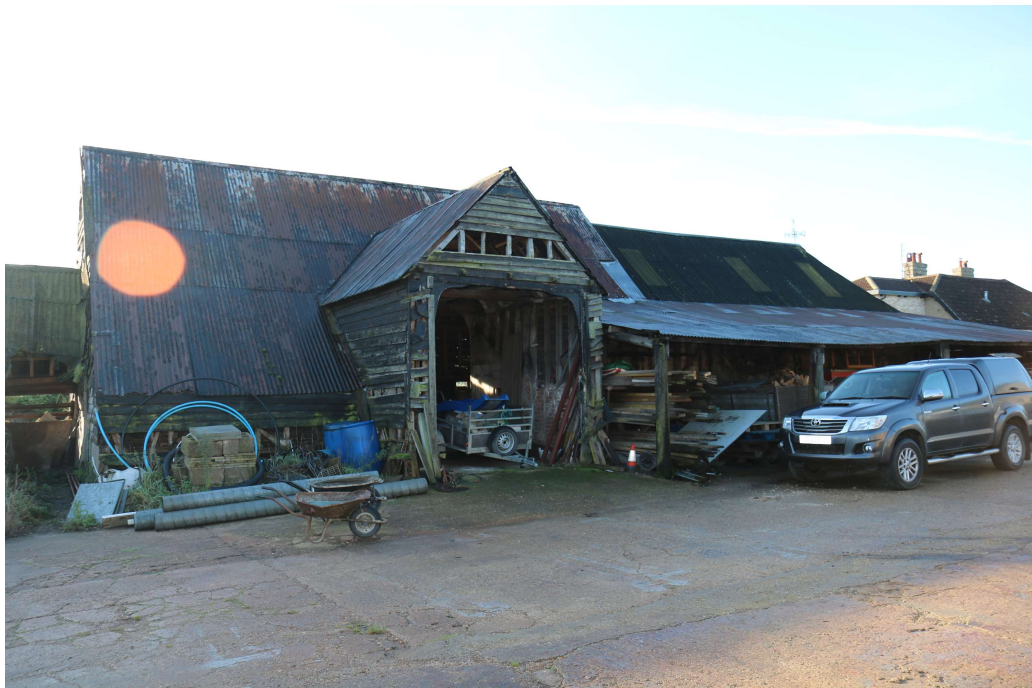
**Photograph 1** Northern elevation. Photograph taken facing south south-west.

The midstrey projects from the northern elevation of the threshing barn, between lean-to 1 and 2. The northern elevation of the midstrey is dominated by a large opening which would have originally housed a set of double barn doors, the upper eastern strap hinge of which is still present. In both top corners of the opening is a timber-knee brace. To the west of the midstrey, lean-to 1 is open fronted and supported on five posts which comprise reused telegraph poles. To the east, lean-to 2 is plain weatherboarding. The northern elevation of four-bay building B consists of a low red brick wall (brick dimensions: 215 x 105 x 60mm) laid in Flemish bond. At the western end of the wall is an opening.

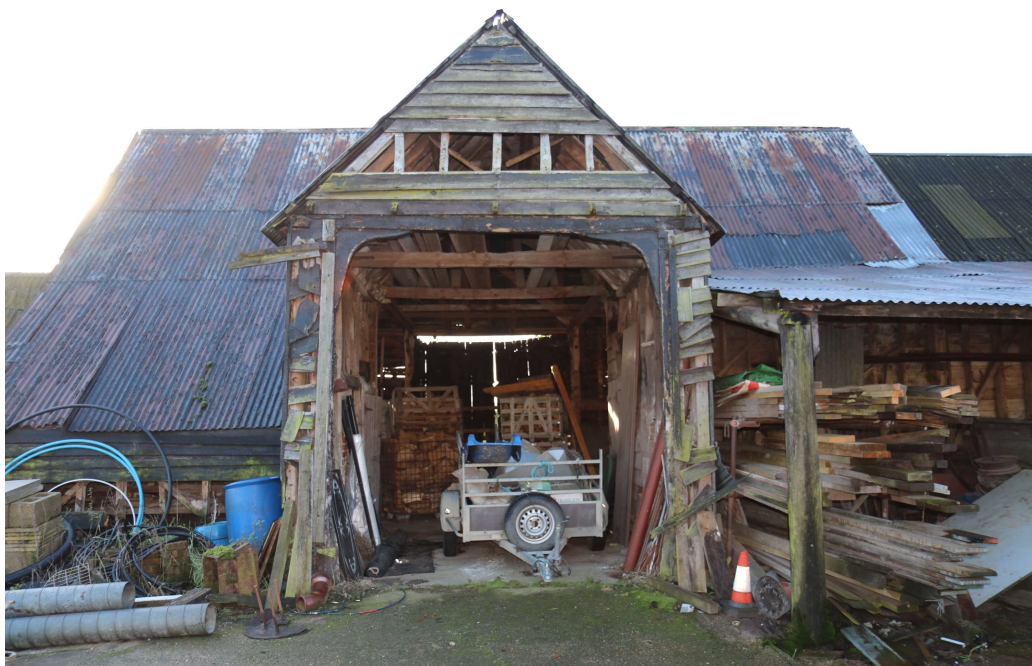
**Photograph 2** Northern elevation. Photograph taken facing south south-east.

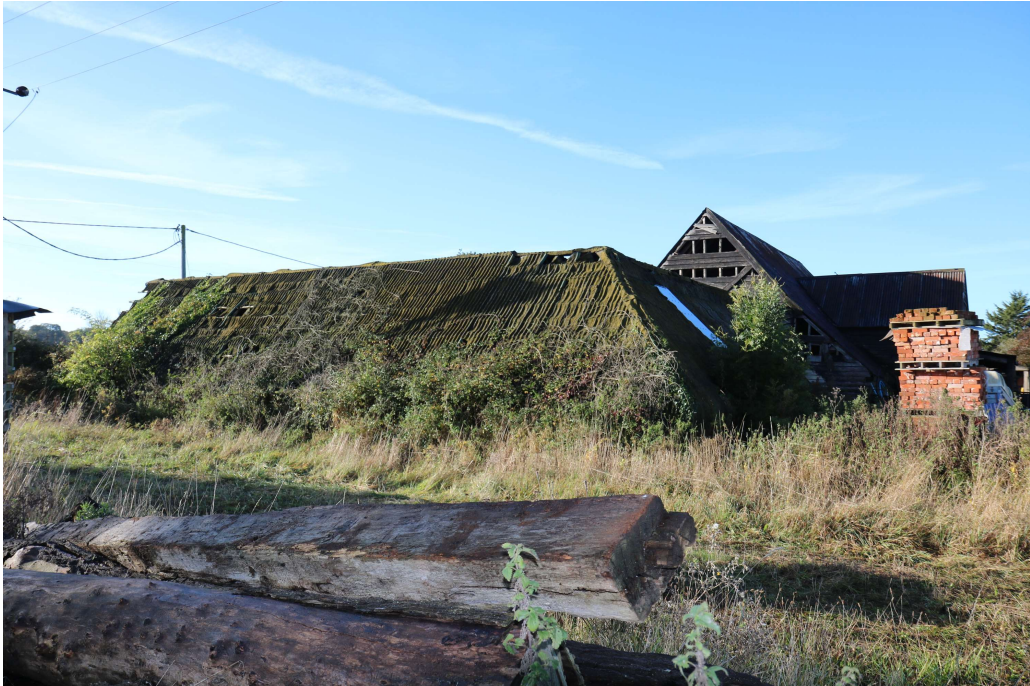
**Photograph 3** Eastern elevation. Photograph taken facing south-west.

a rough English Garden Wall bond. Presumably, this is the same for the rest of the elevation. The eastern elevation of the threshing barn is plain weatherboarding.

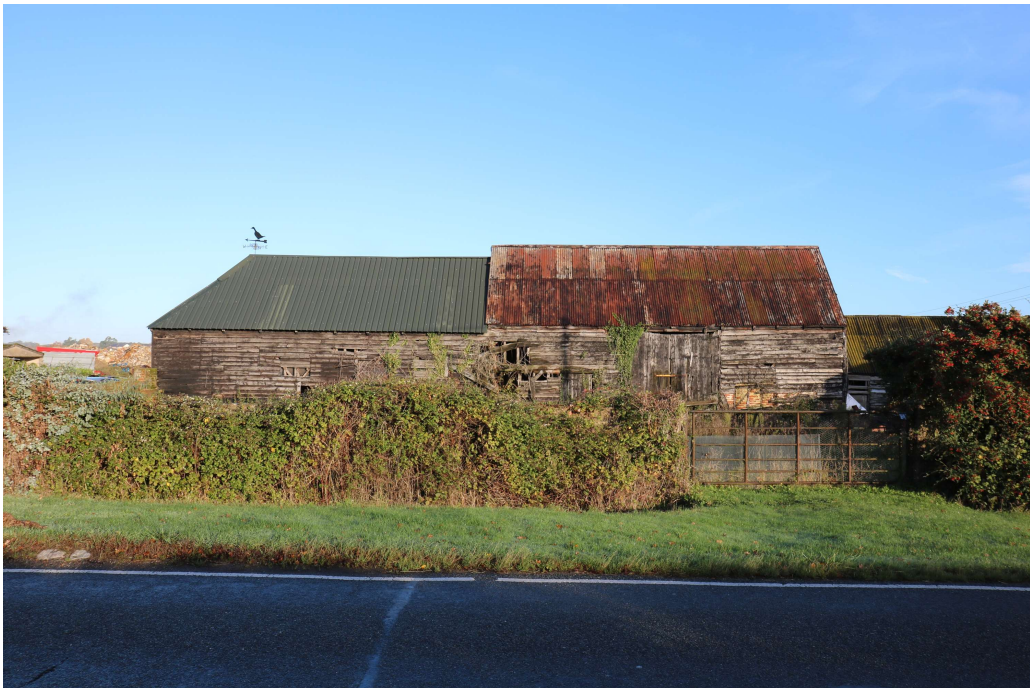
**Photograph 4** Southern elevation. Photograph taken facing west north-west.

In the centre of its southern elevation, the threshing barn has a set of full-height double doors. They are secured with iron strap hinges and likely had a threshold leap at their base but, due to their dilapidated state, it's difficult to be certain. To the west of the double doors is a smaller single door and to the east missing weatherboarding has revealed red brick nogging beneath. The southern elevation of four-bay building A has a blocked door way adjacent to a small inserted poultry opening.

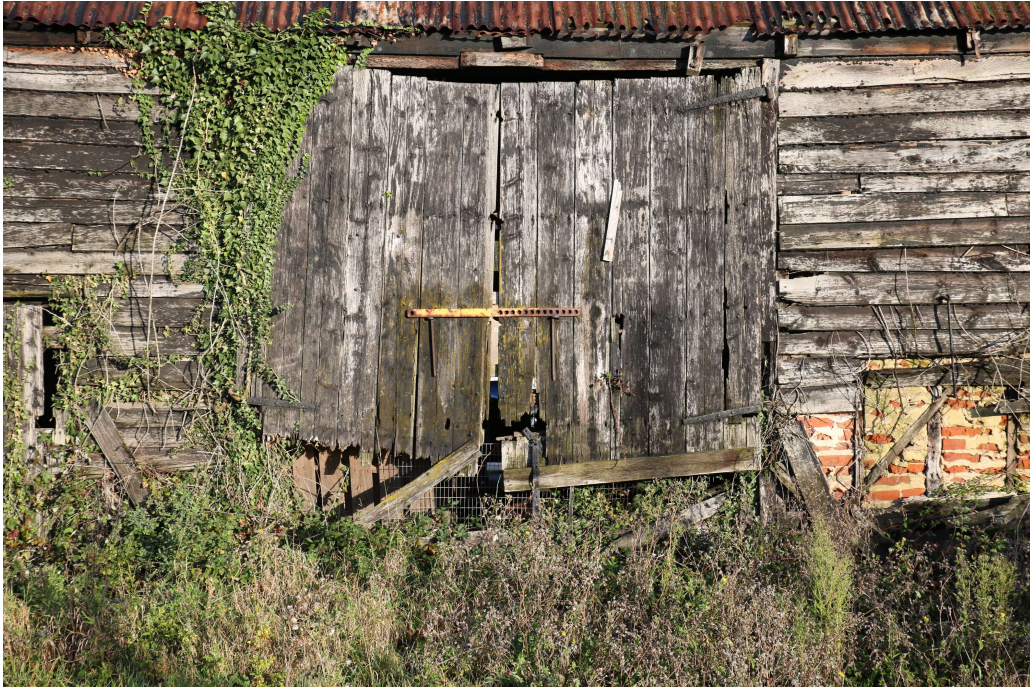
**Photograph 5** Detail of double barn doors in southern elevation. Photograph taken facing west north-west.

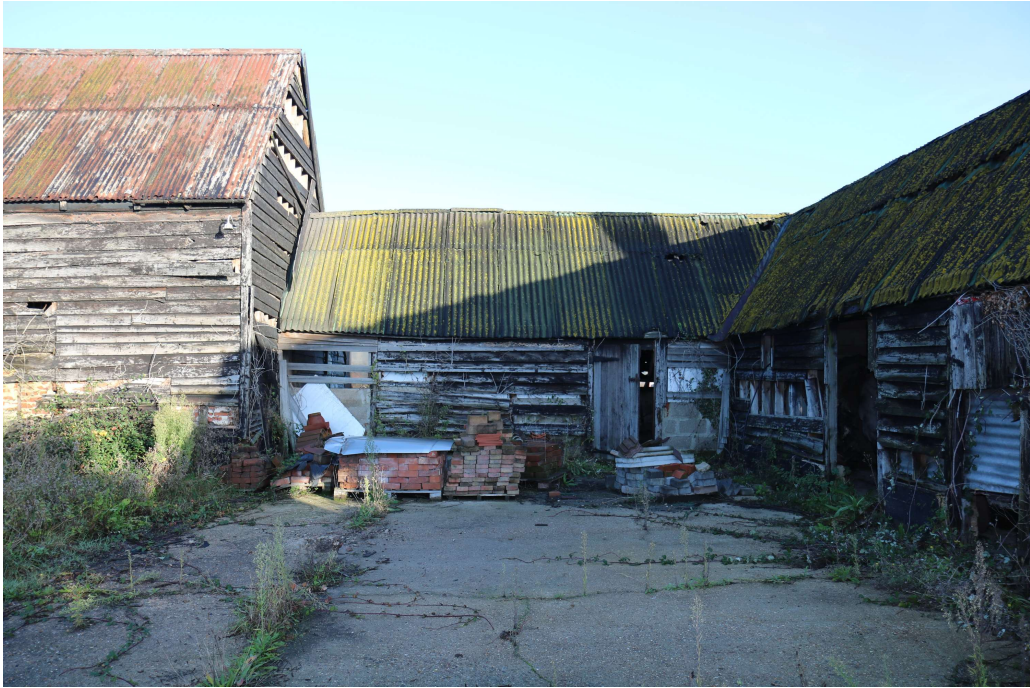
**Photograph 6** Southern elevation of four-bay building B. Photograph taken facing west north-west.

On the southern elevation, four-bay building B has an opening blocked with breeze-blocks to the west and a door to the east. Adjacent to the door, a breeze-block plinth has been added. At the time of recording, the six-bay building was largely obscured by vegetation, but is presumably plain weatherboarding. The cladding of the gable-end has come away, leaving a large opening.

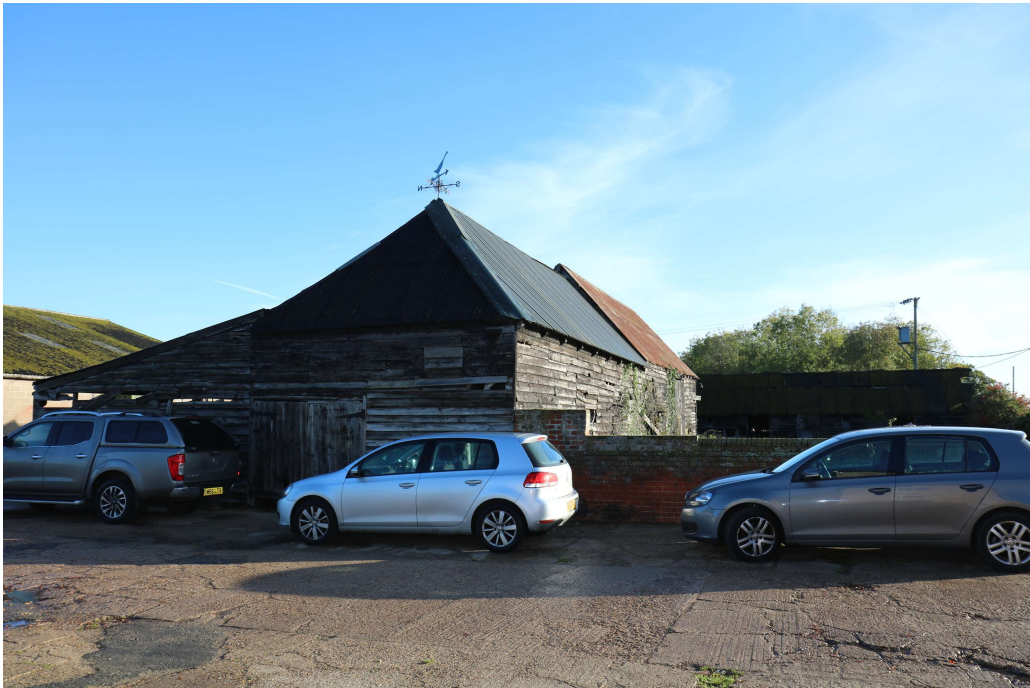
**Photograph 7** Western elevation. Photograph taken facing east north-east.

On the western elevation, four-bay building A has a set of double doors, secured with iron strap hinges. A small concrete plinth is present at the base of the elevation. The six-bay building has three door openings and two smaller openings on this elevation. The northern-most doorway no longer has a door present, while the remains two have dilapidated stable doors, with the central one blocked from the inside. A concrete plinth has been added between the doors. Lean-to 1 is plain weatherboard with a small concrete plinth.

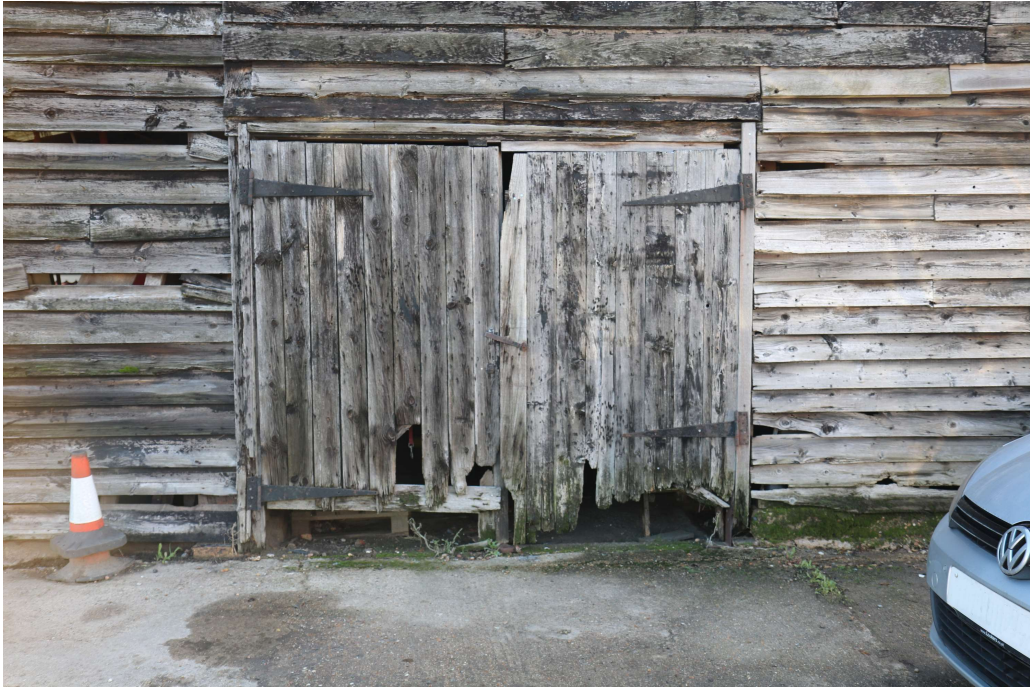
**Photograph 8** Detail of double doors on western elevation. Photograph taken facing east north-east.

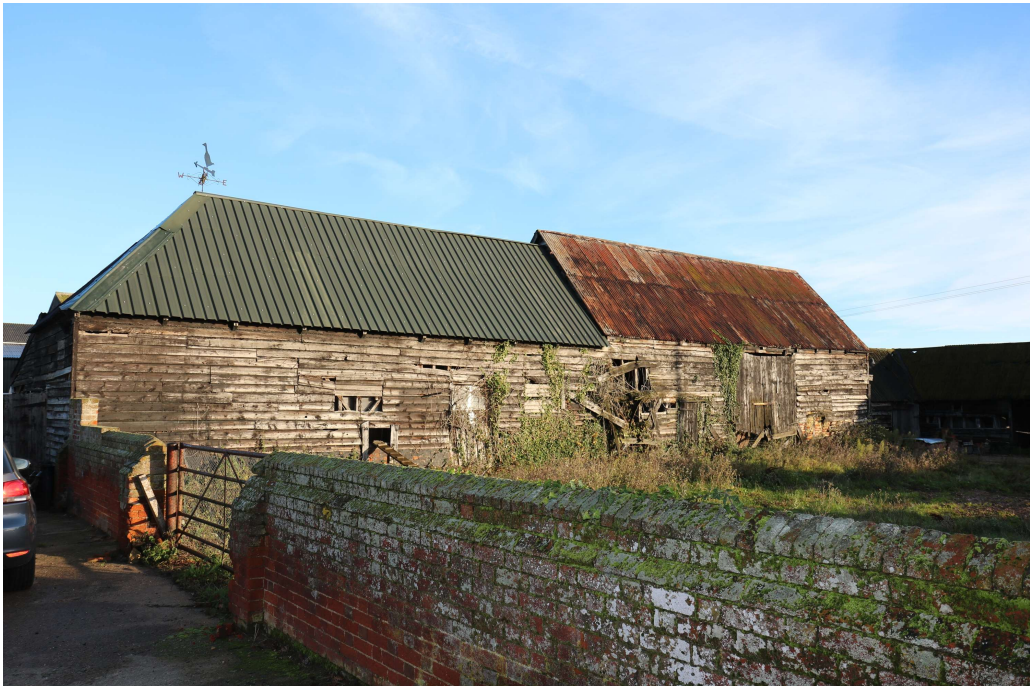
**Photograph 9** Southern elevation, boundary wall visible in the foreground. Photograph taken facing north-east.

The courtyard of the complex is defined by the buildings to the north and east, a modern boundary to the south and a historic brick wall to the west. The wall is red brick (brick dimensions: 220 x 110 x 60mm), laid principally in Flemish bond. Towards the top of the wall is a single course of chamfered bricks, topped with a course of alternating headers and stretchers which in turn are capped with triangular copping bricks. Three small buttresses project from the wall, one where the wall meets four-bay building A and two flanking the gateway. There is an area of modern repair at the northern end.

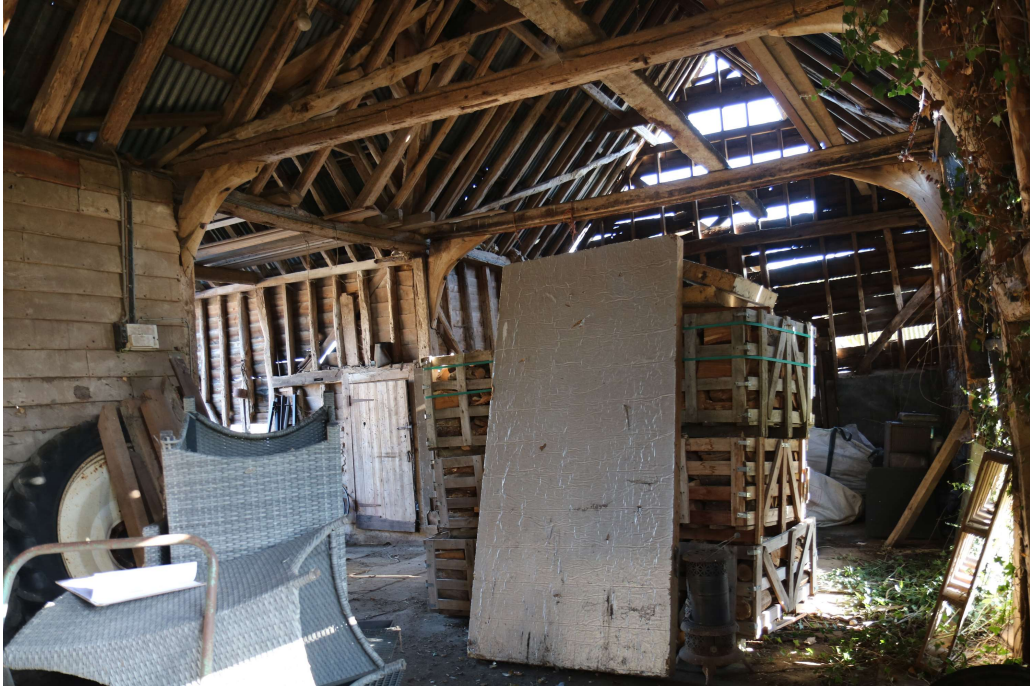
**Photograph 10** Interior of threshing barn. Photograph taken facing north-east.

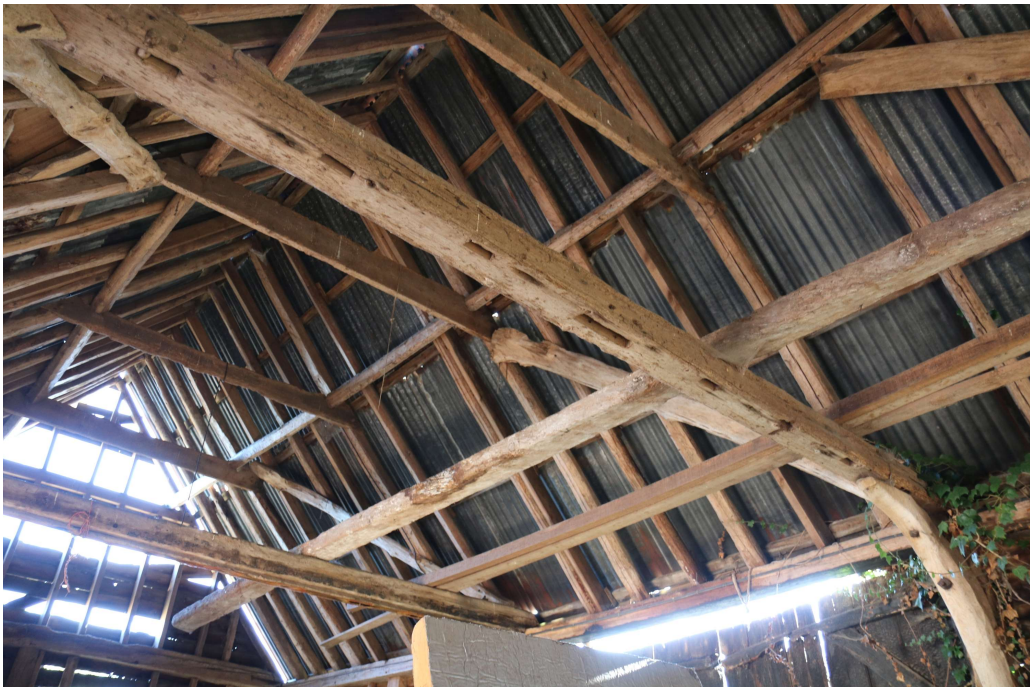
**Photograph 11** Detail of reused tie-beam between bays 1 and 2 of threshing barn. Photograph taken facing south-east.

bracing is fixed to the rafters, beneath the purlins, on both pitches of the roof. Each bay of the barn is separated by a tie-beam, which are supported at both ends at by a knee-brace. Both tie-beams show signs of reuse in the form of empty mortices on their underside. The frame of the barn comprises a combination of hand-sawn and machine-cut timbers.

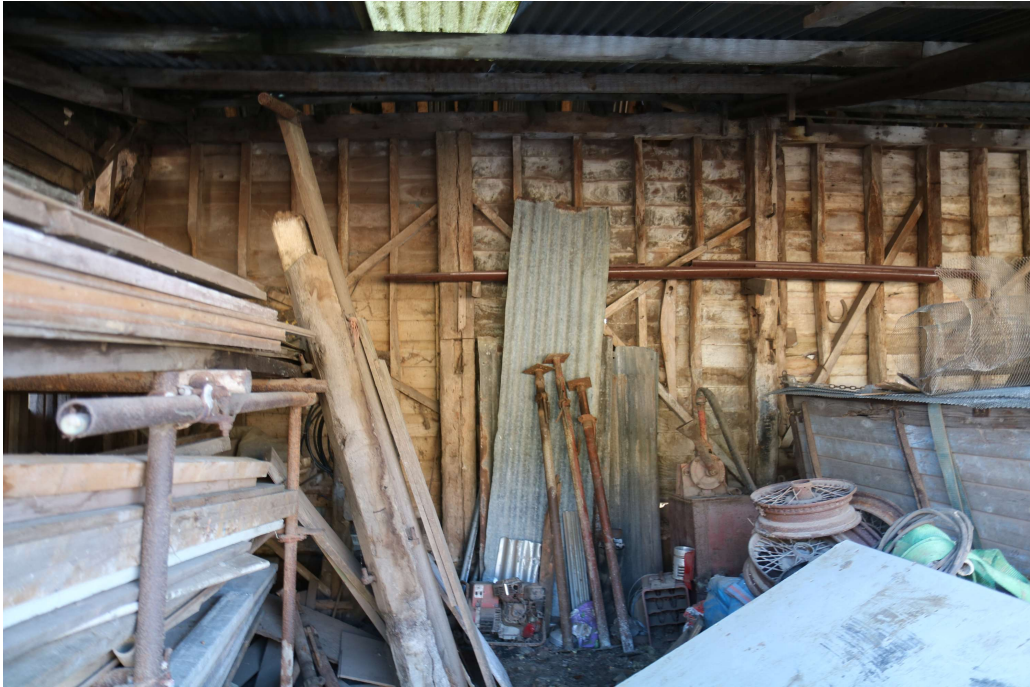
**Photograph 12** Detail of exposed timber-frame of threshing barn in lean-to 1. Photograph taken facing south.

The northern wall of bay 1 is clad in weatherboard, concealing the wall-framing beneath, but from the interior of lean-to 1 it can be seen that the frame comprises diagonal through-bracing with a secondary perpendicular brace (henceforth referred to as Y-bracing). The frame appears to comprise a combination of machine-cut and hand-sawn timbers and has likely been, at least partially, rebuilt. Both the wall-plate and sill-beam have signs of reuse.

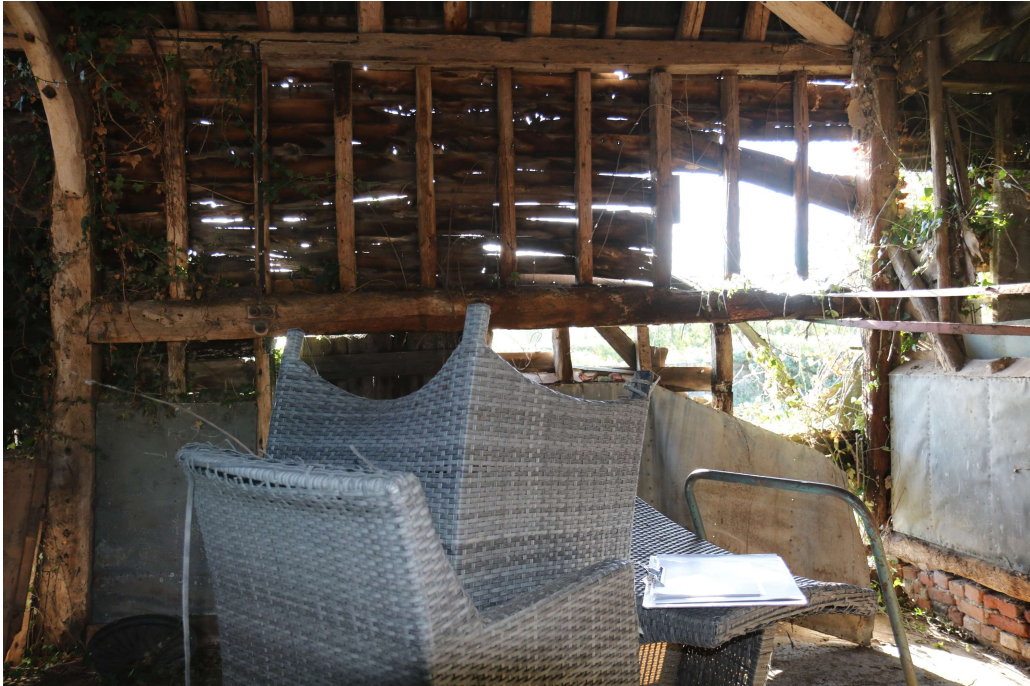
**Photograph 13** Southern wall of bay 1 of threshing barn. Photograph taken facing south south-east.

The southern wall of the bay is different. It comprises a series of timber studs, interrupted by a sizeable girding-beam, with no bracing. There is an inserted door in the lower half of the wall. A face-halved and bladed scarf-joint is present in the southern wall-plate.

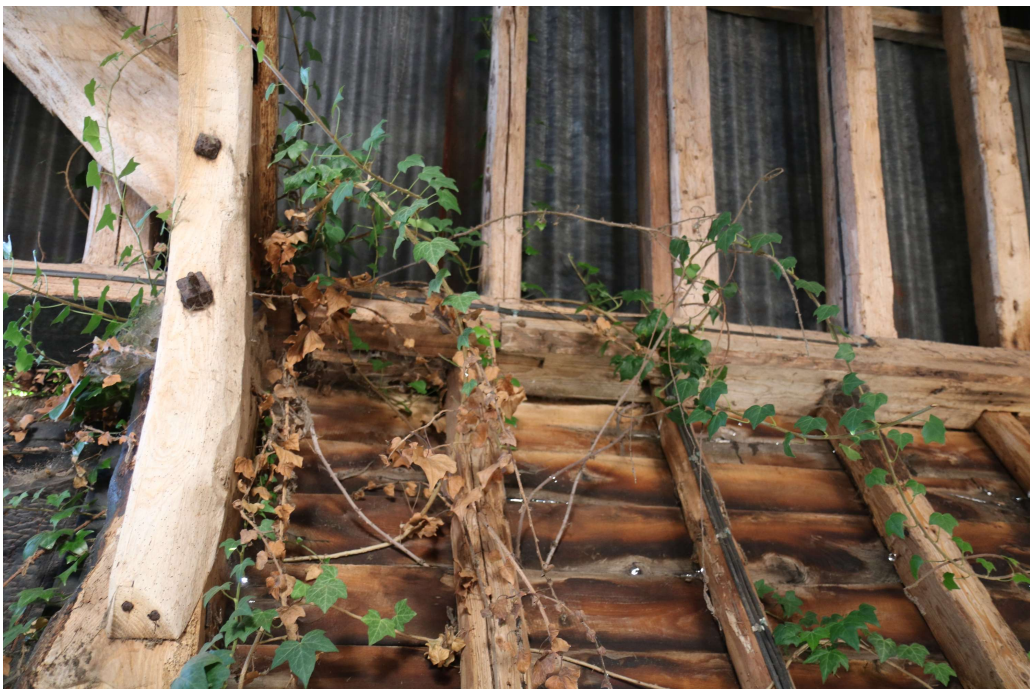
**Photograph 14** Detail of wall-plate scarf joint in southern wall of bay 1 of threshing barn. Photograph taken facing south.

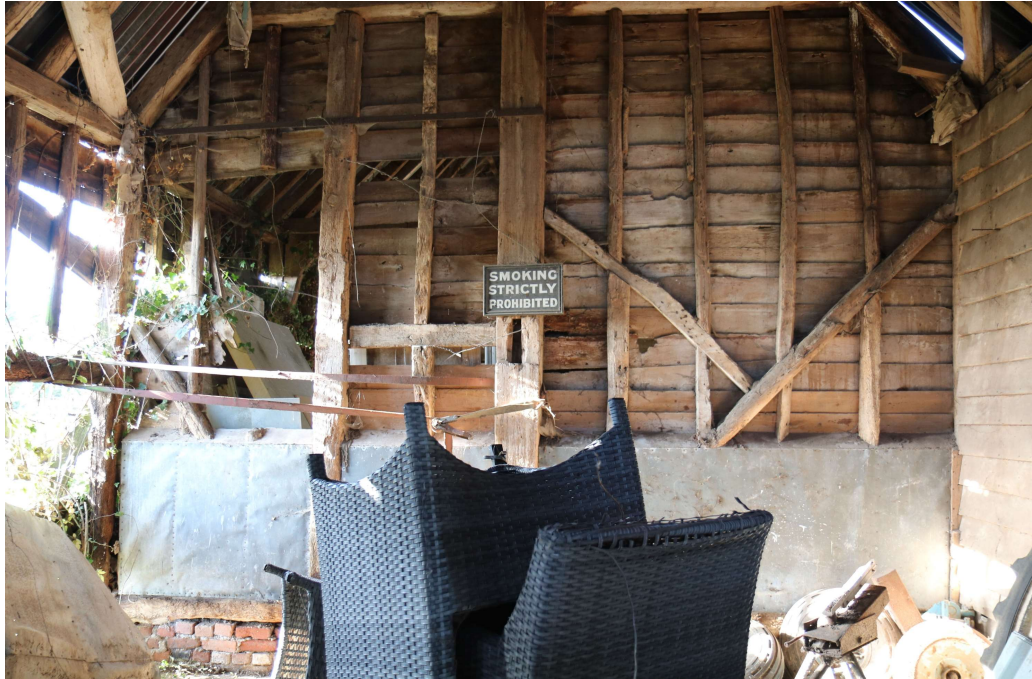
**Photograph 15** Western wall of bay 1 of threshing barn. Photograph taken facing west south-west.

The southern half of the western wall has diagonal through-bracing and thin studs which appear to be blocking an opening. Adjacent to the opening is a single stud interrupted by a short beam. The northern half of this wall has Y-bracing. The wall-plate does not continue through the gable-end, instead the frame has a higher horizontal timber. The central post on this wall has a large empty mortice on its face, evidence it has been reused. The lower portion of the frame has been encase in concrete, which in turn is sheathed in metal sheets.

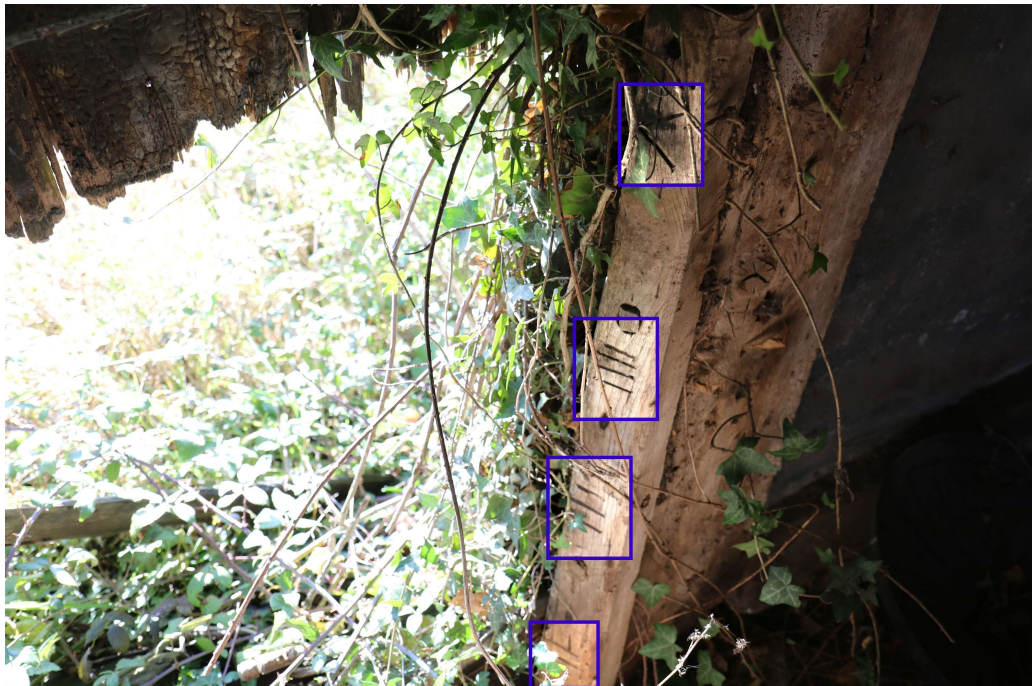
**Photograph 16** Detail of carpenter's marks on timber adjacent to door in bay 2 of threshing barn. Photograph taken facing south south-west.

Bay 2 is the central bay of the threshing barn and is the narrowest of the three bays. The southern wall of the bay is dominated by a set of large barn doors while the northern wall is open for access to the midstrey. The southern wall-plate is a continuation of that seen in bay 1 and therefore has a series of empty mortices on its underside. In the door frame on the northern wall is a timber with a series of carpenter's marks (I, II, III, IIII and V) carved into it. The function of the timber is unclear but is possibly related to the threshold leap. As the carpenter's marks do not have corresponding marks on the adjacent frame, the timber is likely reused.

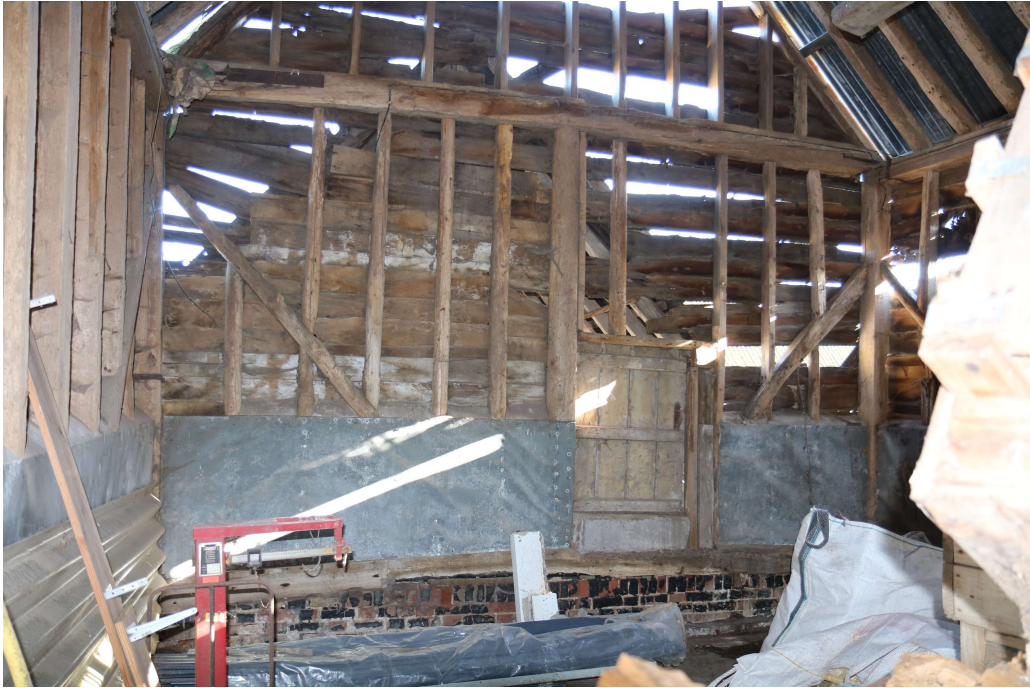
**Photograph 17** Eastern wall of bay 3 of threshing barn. Photograph taken facing east.

The northern wall of bay 3 of the threshing barn has diagonal through-bracing, as does the eastern wall. The southern wall, however, has diagonal through-bracing on its eastern side and Y-bracing on the western side. A face-halved and bladed scarf-joint is present in the northern wall-plate and iron straps are present on the eastern wall-plate. An inserted door is located in the eastern wall. The lower portion of all three walls has been encased in concrete and sheathed with metal sheets. The studs in the gable-end have been largely replaced with modern timber.

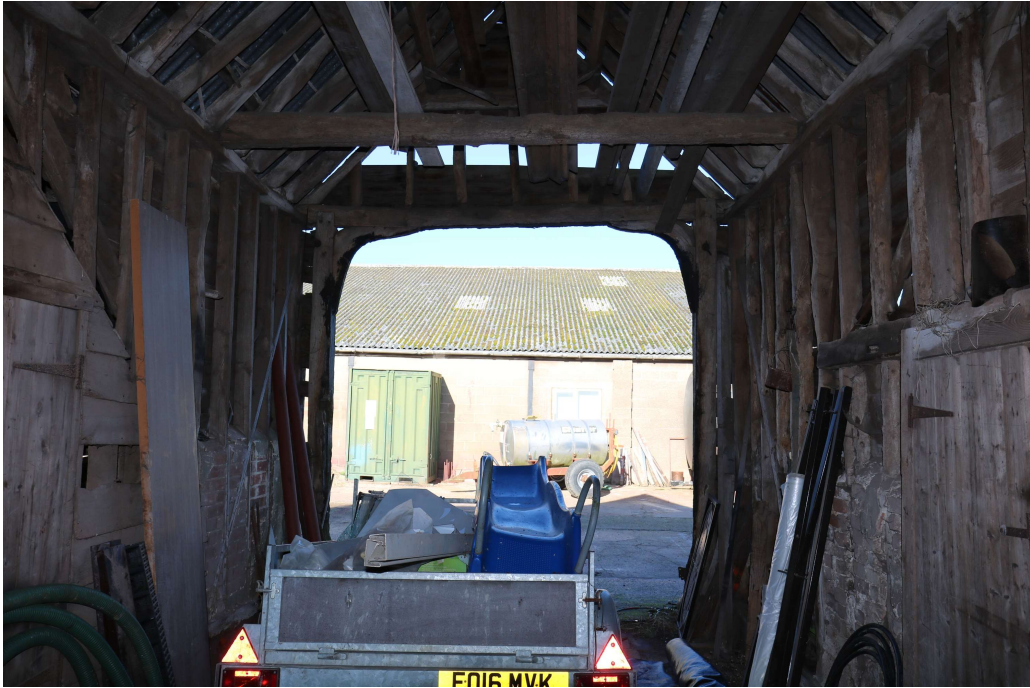
**Photograph 18** Northern wall of midstrey of threshing barn. Photograph taken facing north north-west.

The midstrey projects from the northern wall of bay 2, and appears to be a later addition to the barn. This is evidenced by weatherboard, from the northern elevation of the barn, being present beneath the frame of the midstrey and the lack of knee-braces supporting the tie-beam. The eastern wall comprises diagonal through-bracing in its northern half and studs with a girding-beam (which has been reused) in the southern half. The western wall comprises diagonal through-bracing, though the southern brace is obscured by weatherboard. A door is present in both walls. Brick nogging has been added between many of the studs on the lower half of both walls. The northern wall of the midstrey is dominated by a large opening, which would have originally housed a set of double barn doors. In both top corners of the opening is a knee-brace, the addition of which is further evidence for the midstrey being a later addition as this differs from the doors in the southern elevation.

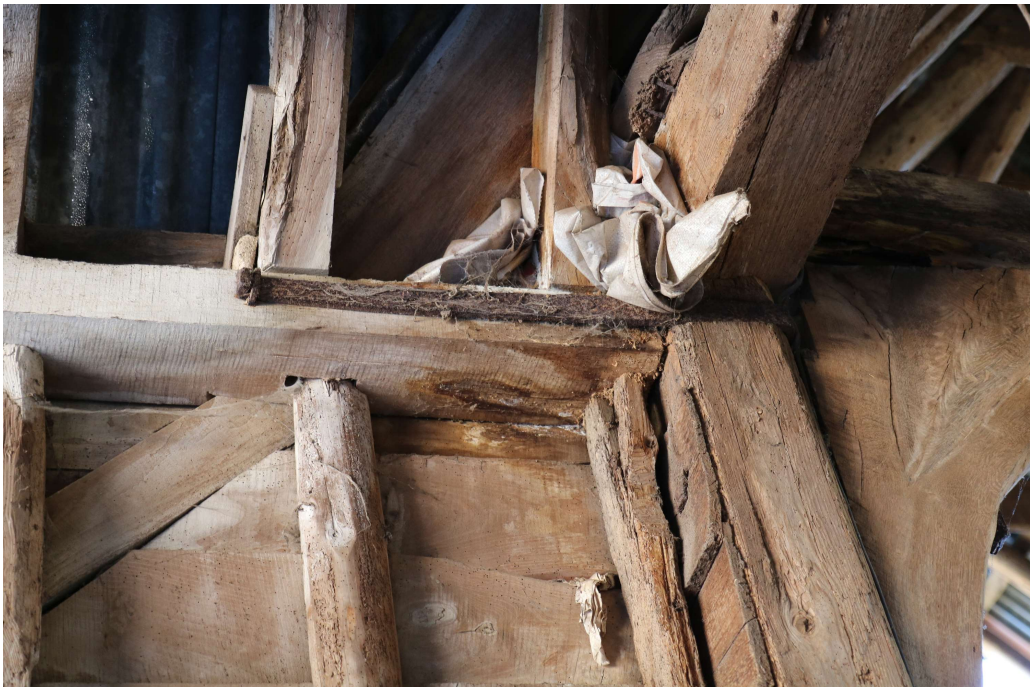
**Photograph 19** Detail of iron strap in eastern wall-plate of midstrey of threshing barn. External weatherboarding visible adjacent to the right-most stud. Photograph taken facing east.

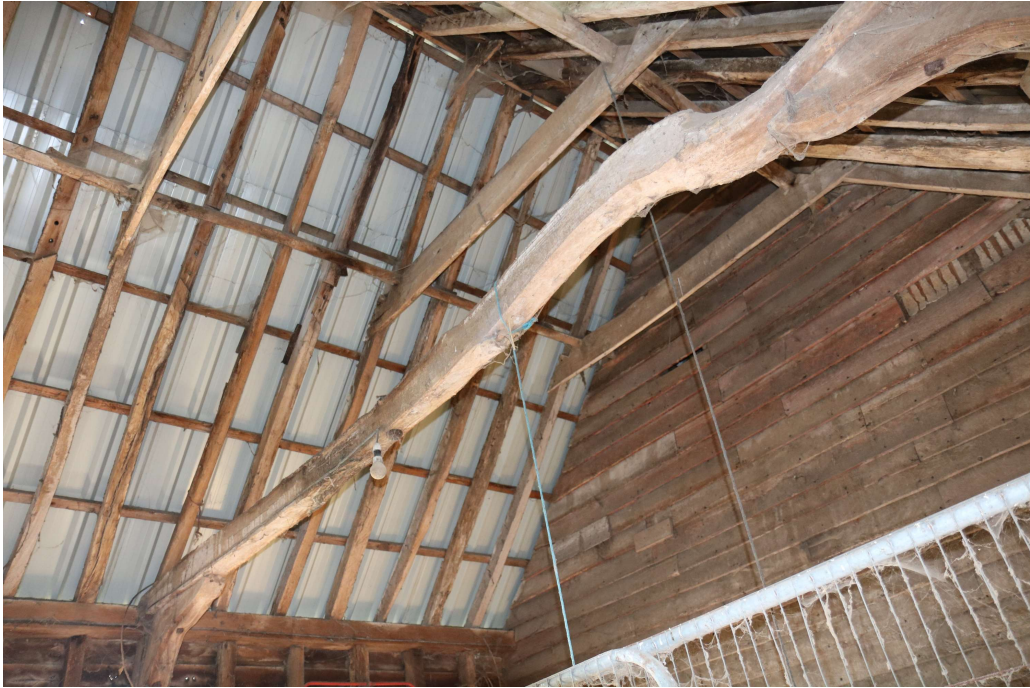
**Photograph 20** Detail of roof construction of four-bay building A. Photograph taken facing south-west.

The roof of four-bay building A is constructed from pairs of rafters that meet at a ridge-board at the roof's apex. Each roof pitch has a single clasped purlin, which are clasped by two collars per bay (except in bay 1, due to the presence of the loft). The tie-beams between bays 2 and 3 and bays 3 and 4 are very sinuous in nature and are both supported at each end with a timber knee-brace. The wall-framing comprises diagonal through-bracing with studs and intermediate posts. The timbers used are primarily hand-sawn, a number of which have signs of reuse, although areas of repair are machine-cut.

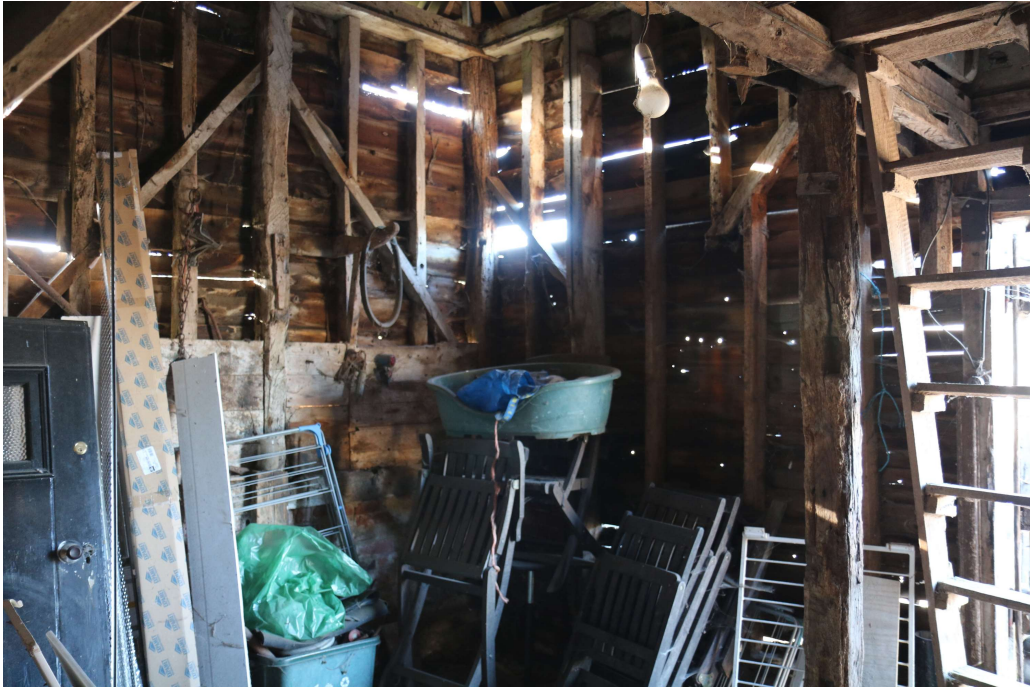
**Photograph 22** Interior of four-bay building A (bay 1). Photograph taken facing south-west.

Bay 1 of four-bay building A is the largest of the four bays and has been divided from the rest of the building by a timber wall. The wall is supported on a red brick plinth laid in Flemish bond. The frame of the western wall is somewhat irregular, likely as it has been partially rebuilt after the removal of the window and door seen in the photograph from the 1920 sales catalogue (Plate 2). Adjacent to this is a set of small double doors.

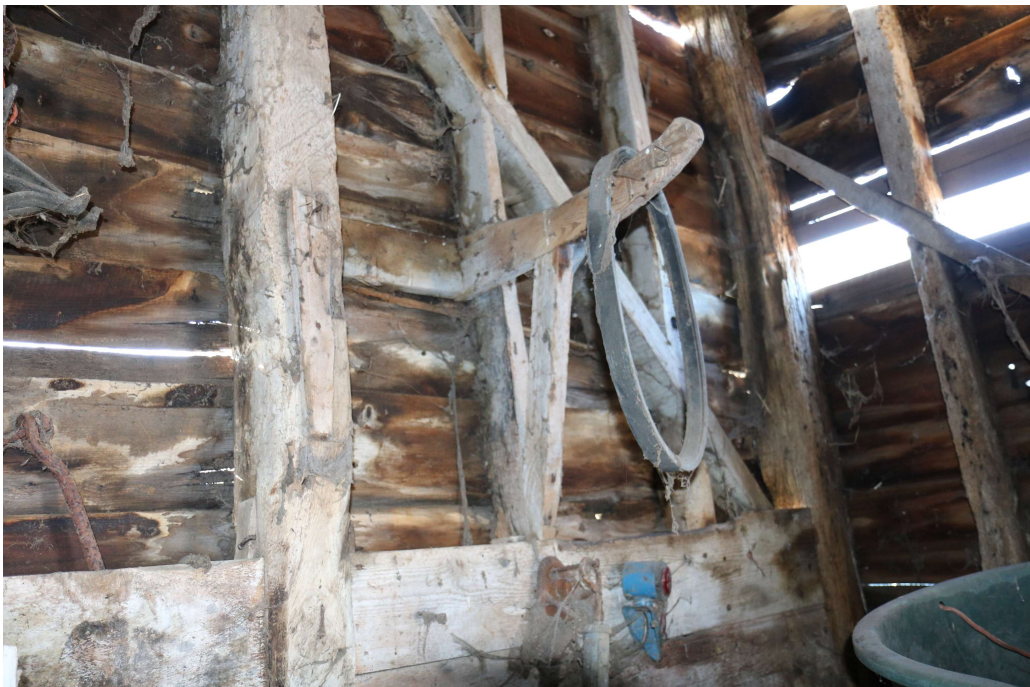
**Photograph 23** Detail of saddle hook in four-bay building A (bay 1). Photograph taken facing south-east.

sill-beam of the eastern wall both have iron straps. Two timber saddle hooks are located on the southern wall.

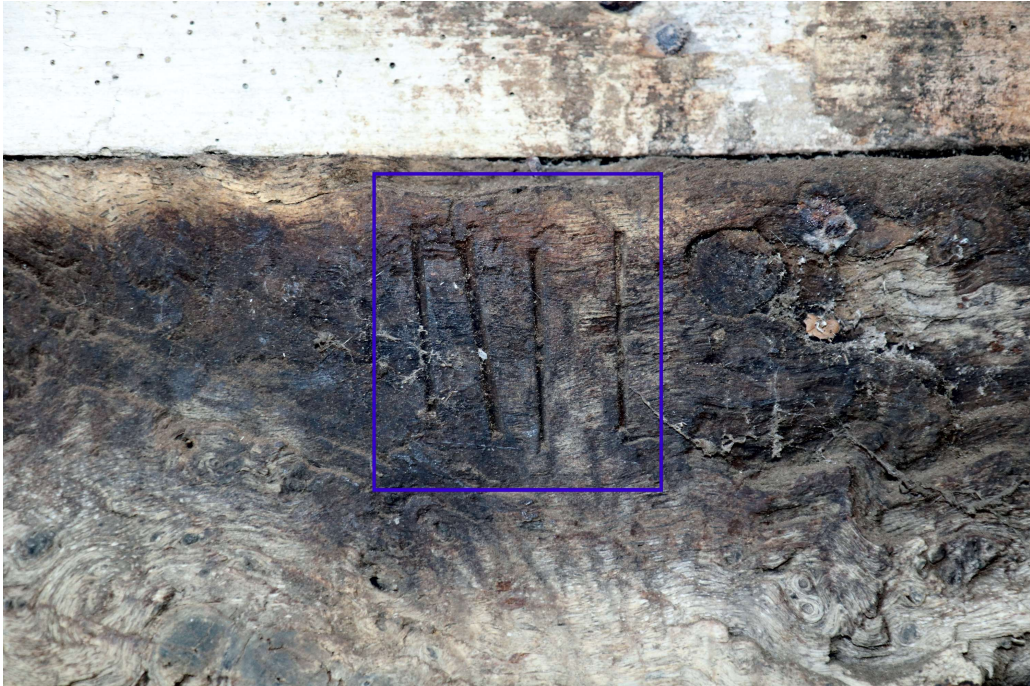
**Photograph 24** Detail of carpenter's mark in northern sill-beam of bay 1 of four-bay building A. Photograph taken facing north north-west.

The northern wall is clad in weatherboard and a carpenter's mark (IIII) is present on the northern sill-beam, its location suggestive that the timber is reused. A side-halved scarf-joint is present in the northern sill-beam (seen from lean-to 1). The tie-beam and

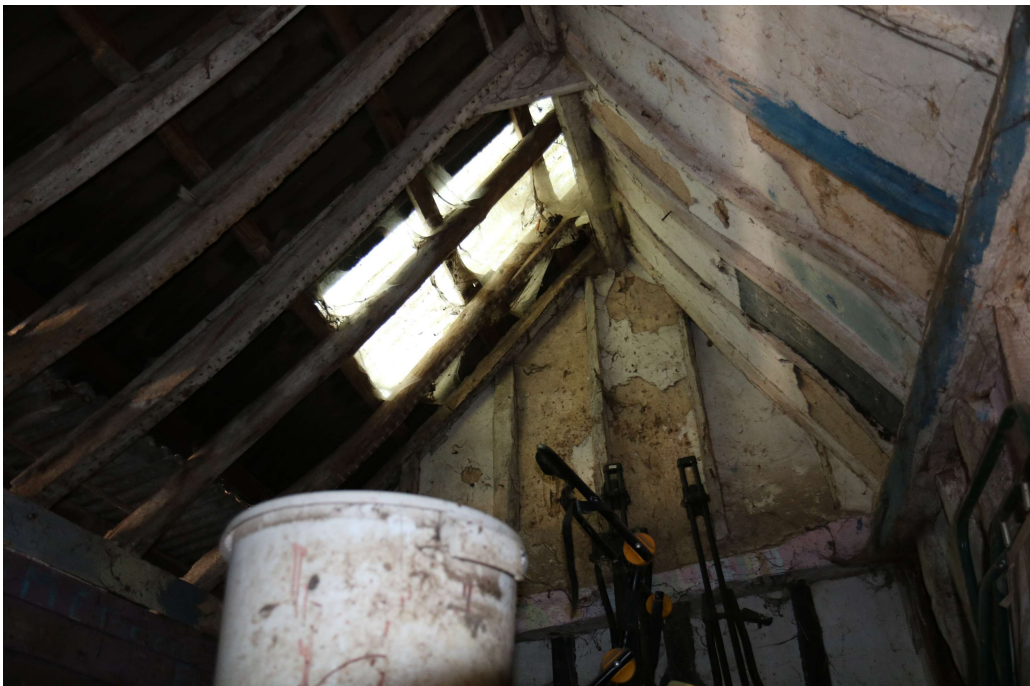
**Photograph 25** Interior of loft in bay 1 of four-bay building A. Photograph taken facing north-east.

A loft has been inserted into the northern half of bay 1. It is constructed from hand-sawn timbers and supported on a single post and straight brace. It is enclosed and clad in weatherboard on its exterior.

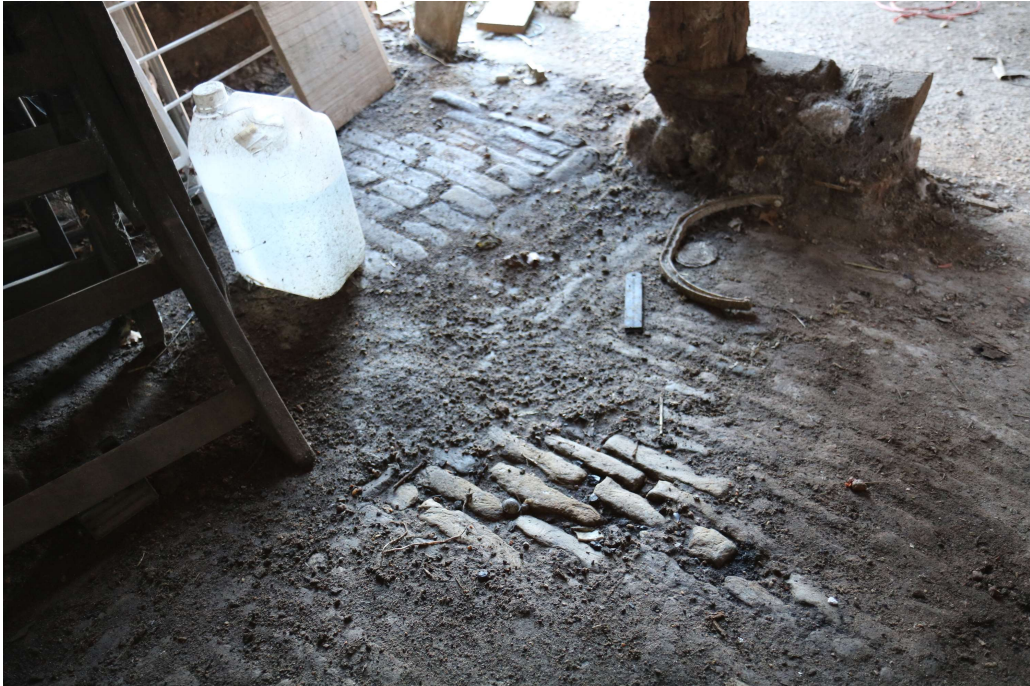
**Photograph 26** Detail of brick floor in bay 1 of four-bay building A. Photograph taken facing north-west.

The southern half of the floor in bay 1 is laid with floor bricks (brick dimensions: 210 x 105 50mm).

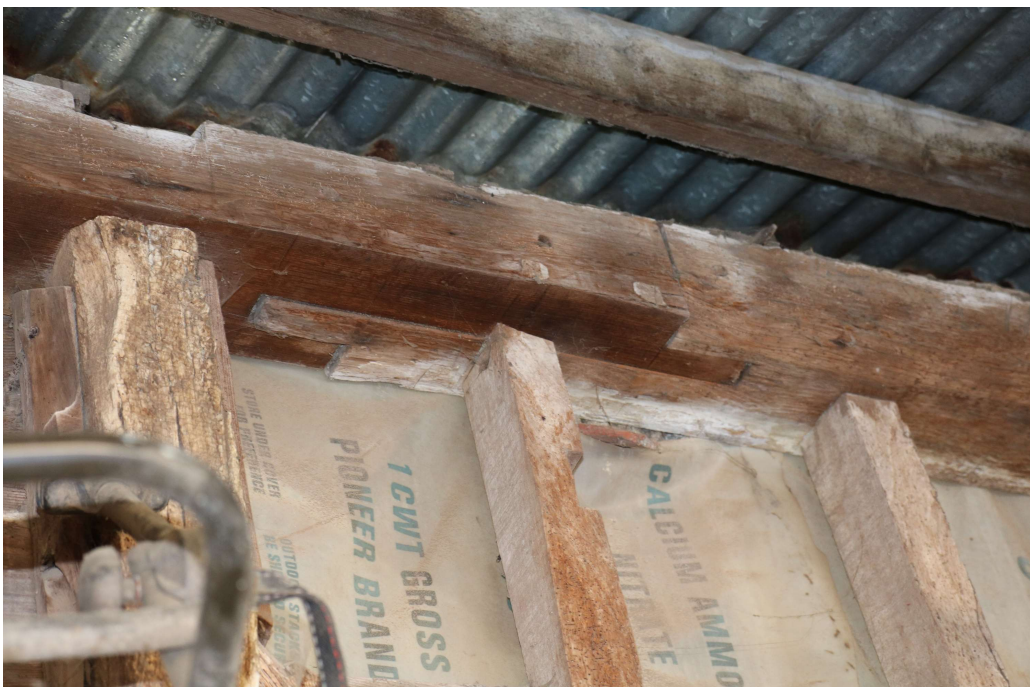
**Photograph 27** Detail of scarf joint in northern wall-plate in four-bay building A. Photograph taken facing south-east.

The western wall of bay 2 is covered with weatherboard while the northern wall is covered with modern plastic. A side-halved scarf-joint is present in the southern sill-beam while the northern wall-plate contains a face-halved and bladed scarf-joint. A 'VIII' carpenter's mark has been carved into the sill-beam of the western wall, its solitary nature an indication the timber is reused. Bay 2 is currently segregated by Heras panels and is being used to house chickens.

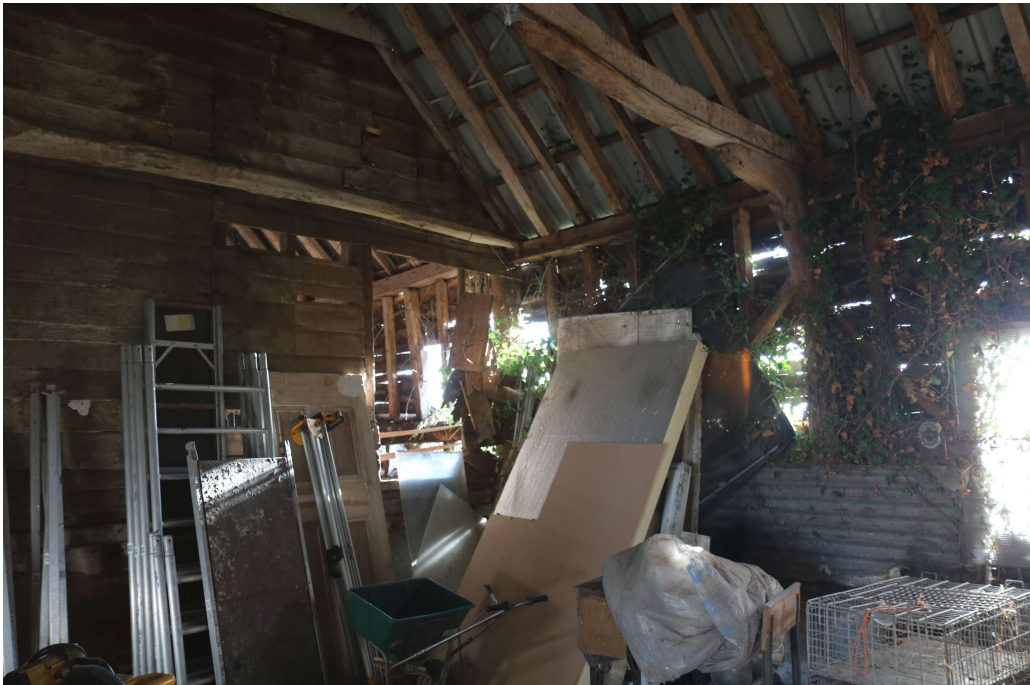
**Photograph 29** Interior of four-bay building A (bays 2-4). Photograph taken facing east south-east.

Bay 3 has a door in the northern and southern walls, although the southern door has been blocked. Both door openings appear to be original to the building. Bay 4 is smallest of the four bays. The northern wall of both bays is clad in weatherboard, as is the eastern wall of bay 4 (the original external wall of the threshing barn). In bays 2-4, much of the brick plinth has been skimmed in concrete.
