**CAT Report 2010  
issued January 2024**

**Historic building recording at Spital Farm,  
Station Road, Tolleshunt D'arcy, Essex, CM9 8HR**

**Historic building recording at Spital Farm,  
Station Road, Tolleshunt D'Arcy, Essex,  
CM9 8HR**

**Planning ref.: MAL/23/00010**

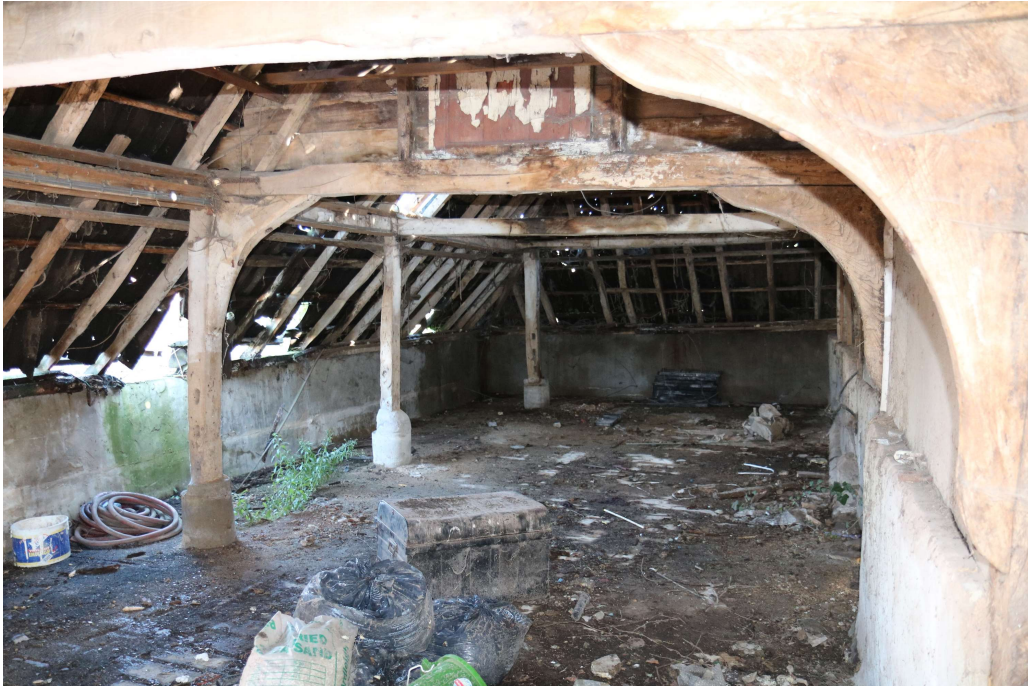
**Photograph 30** Interior of four-bay building B. Photograph taken facing north-east.

Four-bay building B projects from the eastern elevation of threshing barn. It has a semi-aisled construction, with an aisle on the northern and eastern sides of the

building. It has four bays, labelled from west to east, divided by a series of tie-beams. The western two tie-beams are supported at each end by a knee-brace.

The roof of the building comprises pairs of rafters which rise, from the wall-plate on the southern wall and the arcade-plate on the northern wall, to meet at ridge-board at the apex of the roof. Smaller rafters rise from the northern wall-plate to meet the base of the main rafters on the arcade plate. Equally spaced high collars clasp a purlin on each roof pitch. Each high collar has a corresponding lower collar which is much slimmer. A lower purlin has been added to the rafters below the arcade-plate. The frame comprises mainly hand-sawn timbers, with additional machine-cut timbers where the frame has been repaired.

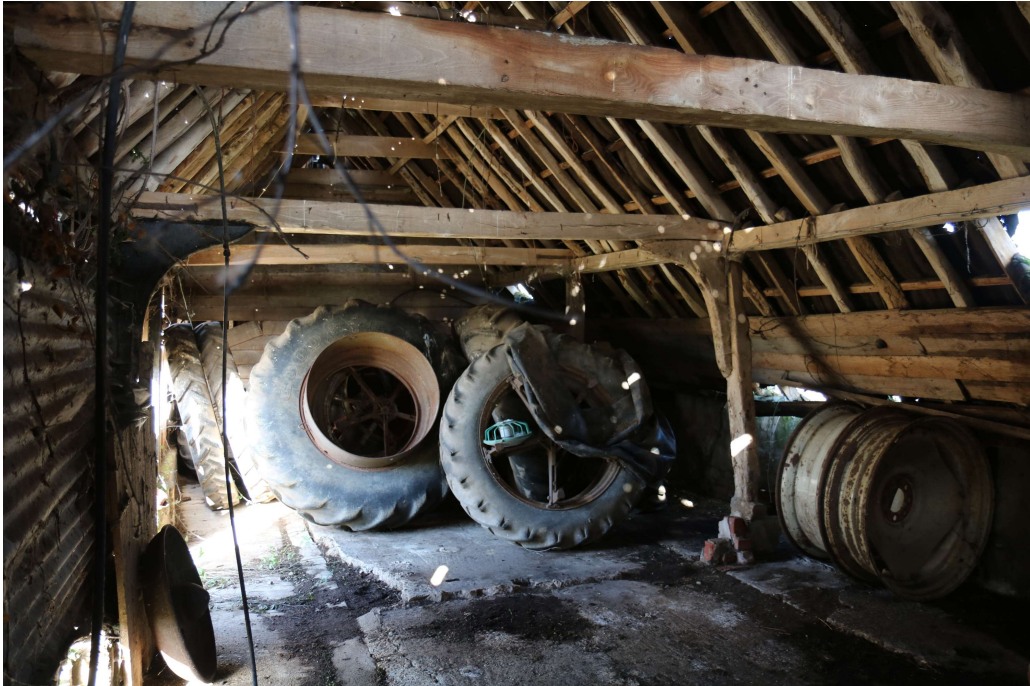
**Photograph 31** Interior of six-bay building (bays 1-4). Photograph taken facing north-east.

The bays of the building are defined by tie-beams, two of which have knee-bracing at both ends. Each bay has two collars, which clasp a purlin on both roof pitches. The purlins support the rafters, which, in pairs, rise from the wall-plate and the arcade-plate

to meet at a ridge-board. The timber-frame of the six-bay building comprises a combination of hand-sawn and machine-cut timbers.

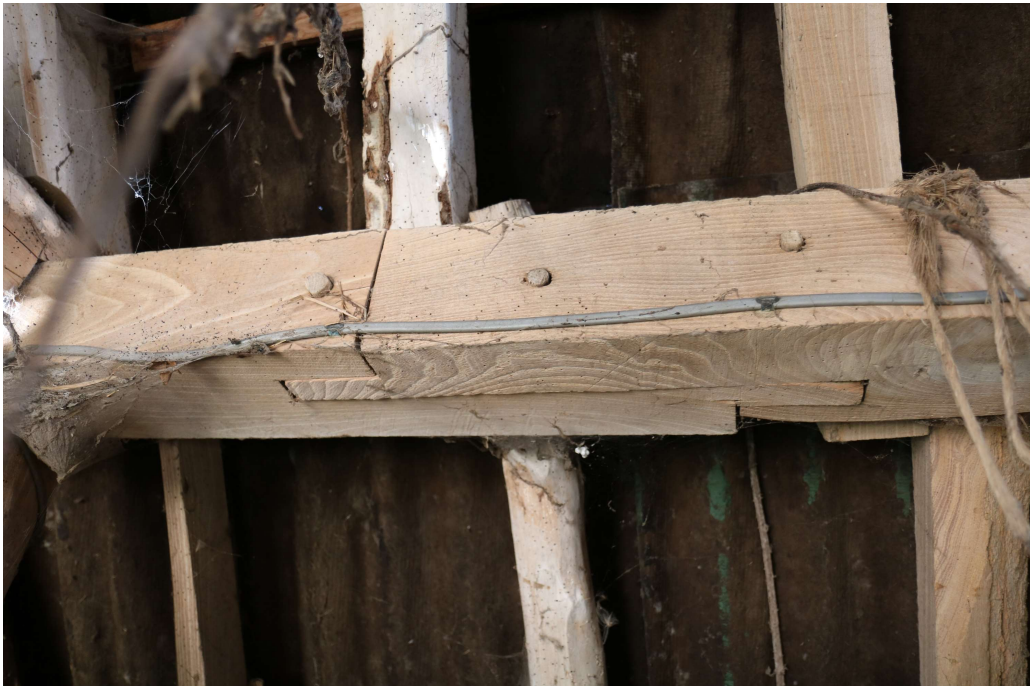
**Photograph 32** Detail of scarf-joint in eastern arcade-plate of six-bay building (bay 3). Photograph taken facing east north-east.

A number of scarf-joints are present in the six-bay building. The western wall-plate has two, between bays 3 and 4 and bays 5 and 6, both face-halved and bladed. Three more face-halved and bladed joints are present in the arcade-plate, in bays 1, 3 and 5. Finally, each purlin has a single splayed scarf-joint in bay 4.

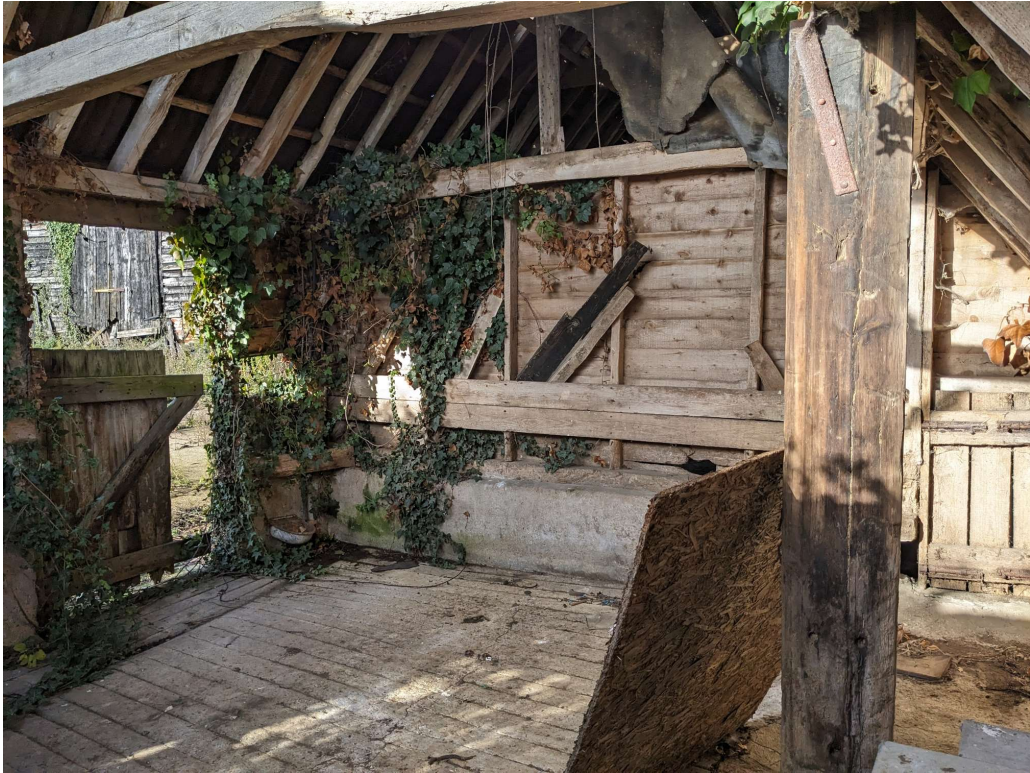
**Photograph 33** Interior of six-bay building (bays 5-6). Photograph taken facing north-west.

A dividing wall has been inserted between bays 4 and 5, incorporating the tie-beam and posts into its structure. A timber king-post has been added to the tie-beam. It is

supported on a plinth sheathed in concrete and is clad in weatherboard on the northern side. A small livestock door is present in the wall.

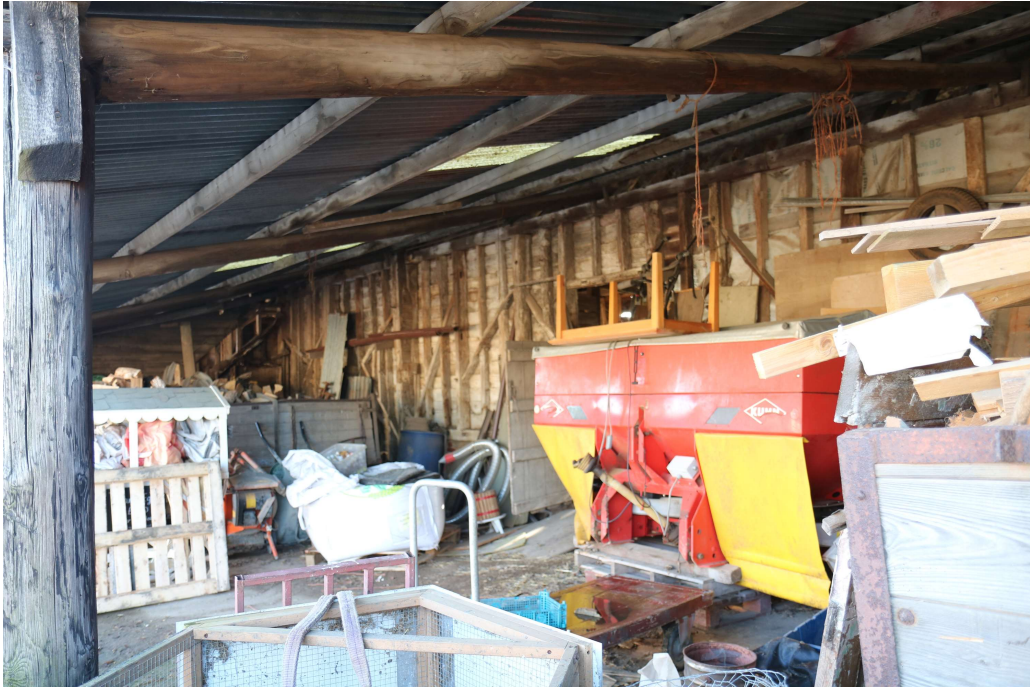
**Photograph 34** Interior of lean-to 1. Photograph taken facing south-east.

Lean-to 1 is rectangular in shape and open-fronted. It is built on to the northern elevations of the threshing barn and four-bay building A.

Lean-to 1 is modern in construction. The roof comprises single rafters, which rise from the posts in the northern wall to meet the wall-plate of the buildings. The posts in the northern wall and the rafters are reused telegraph poles. The southern wall of lean-to 1 has the exposed timber-framing of the threshing barn and four-bay building A.

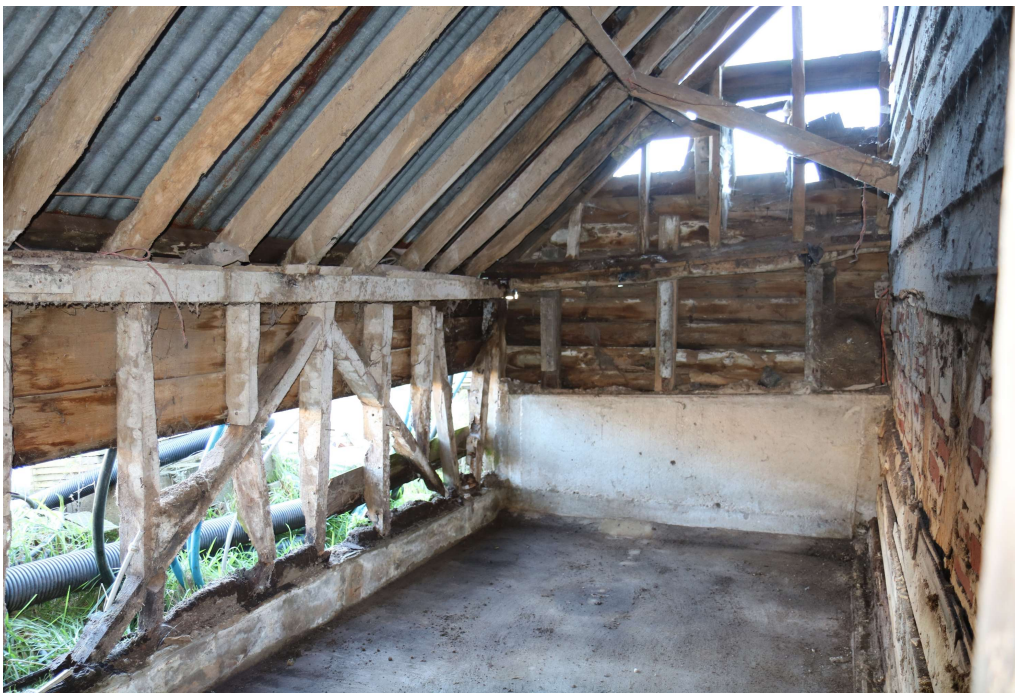
**Photograph 35** Interior of lean-to 2. Photograph taken facing north-east.

The roof of lean-to 2 comprises single rafters rising from the wall-plate to meet the northern elevation of the barn. A single purlin supports the rafters, which is in turn supported by two inclined struts projecting from the southern wall. The timber-frame of lean-to 2 consists of hand-sawn timbers.

The northern wall of the lean-to is constructed using evenly spaced studs with through-bracing while the eastern wall is only constructed from studs, the lower half of which have been encased in concrete. Iron straps are present on the wall-plate in the eastern wall.

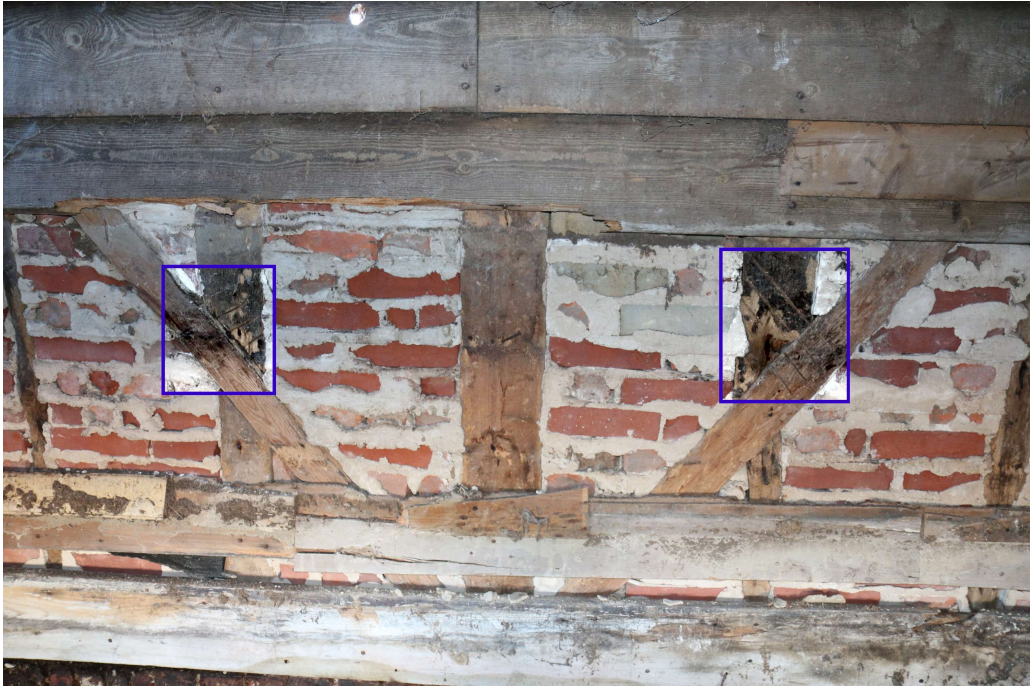
**Photograph 36** Detail of 'III' and 'IIII' carpenter's marks in northern wall of bay 3 of threshing barn (seen in lean-to 2). Photograph taken facing south south-east.

The southern and western walls of lean-to 2 are external walls of the threshing barn, so consequently are clad in weatherboard. Some of the weatherboard of the southern wall has come away revealing the barn's timber-frame beneath, along with red brick nogging. On the timber-frame are two carpenter's marks, 'III' and 'IIII', incised through each diagonal brace its adjacent stud.
