# Gryme's Dyke, Stanway Green

A short assessment of the archaeological impact of contractor's groundworks at the southern end of the Gryme's Dyke Middle earthwork

# February 2000

# **Archive report**

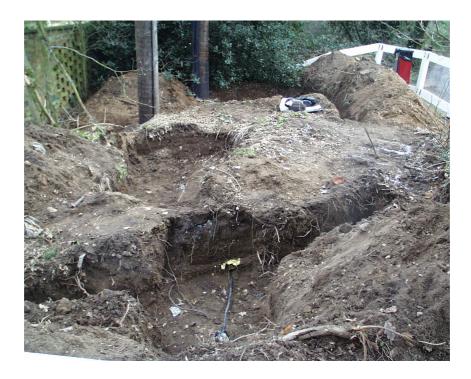
Pl. 2 Site area looking south, Trench 1 in foreground.

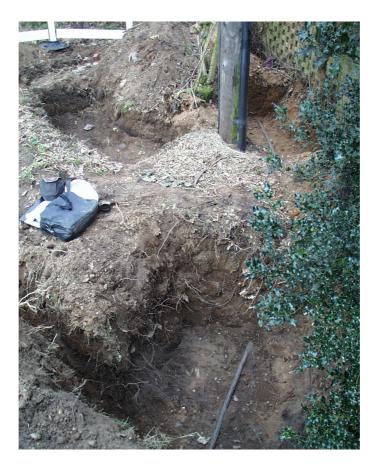
Pl. 3 Site area looking north, Trench 4 in foreground.

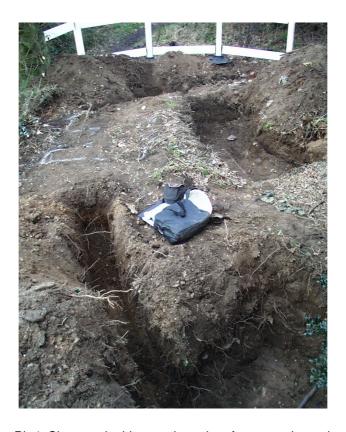
Pl. 4 Site area looking north to site of proposed trench (middle left of picture), Trench 4 in foreground.

- the southern telegraph pole (one of the pair supporting the transformer) to be removed
- the transformer to be relocated on a concrete base close to the road which will require the excavation of a further trench approximately 1.0 x 1.0 m in area and 1.0 m deep (area outlined and hatched on Fig. 2)
- the relocated transformer to be connected by cables, probably through the area of Trenches 1, 2 and 3 to the remaining telegraph pole. This will involve digging out the baulks between these trenches.
