Watching Brief: 4A East Hill, Colchester

Reason for Watching Brief: Test pits (prior to construction of two houses)

Date: 9th June 2000

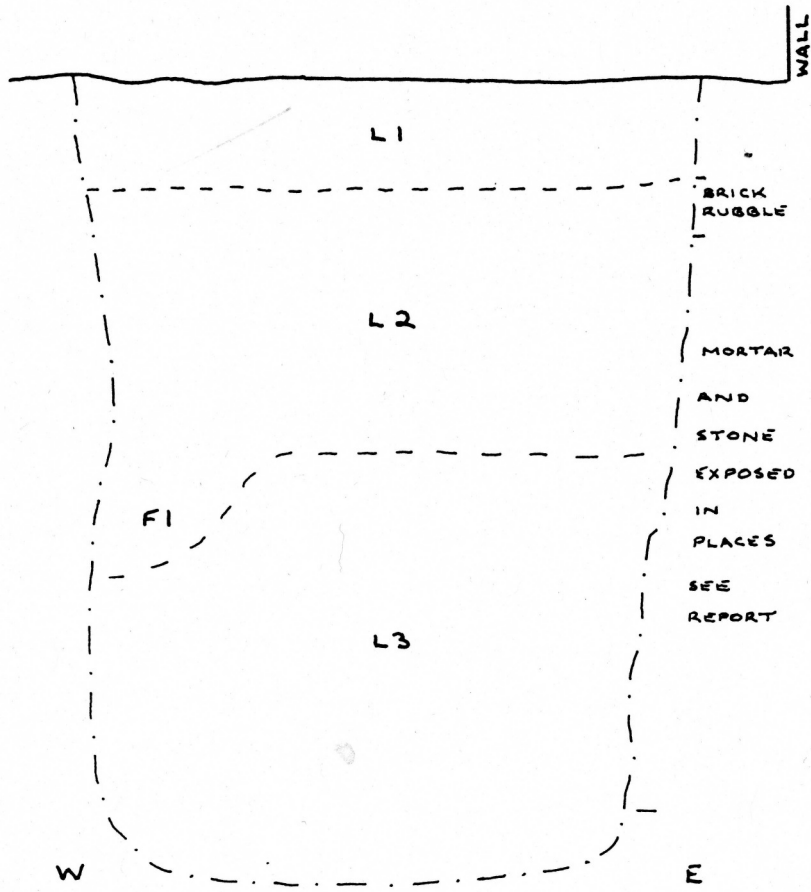
TRENCH 4 SECTION

The eastern end was roughly dug against the boundary wall with The Ship. Here, L1 sealed a 20cm thick layer of red brick rubble. The section beneath this was heavily obscured by sand, but in spots revealed part of the boundary wall in the form of small projections of mortar and stone continuing as far as the bottom of the trench. In the western part of the trench a possible pit (F1) extended to an overall depth of 1.6m. Its fill was identical to L2 but the section was too smeared to display a clear outline of the feature.

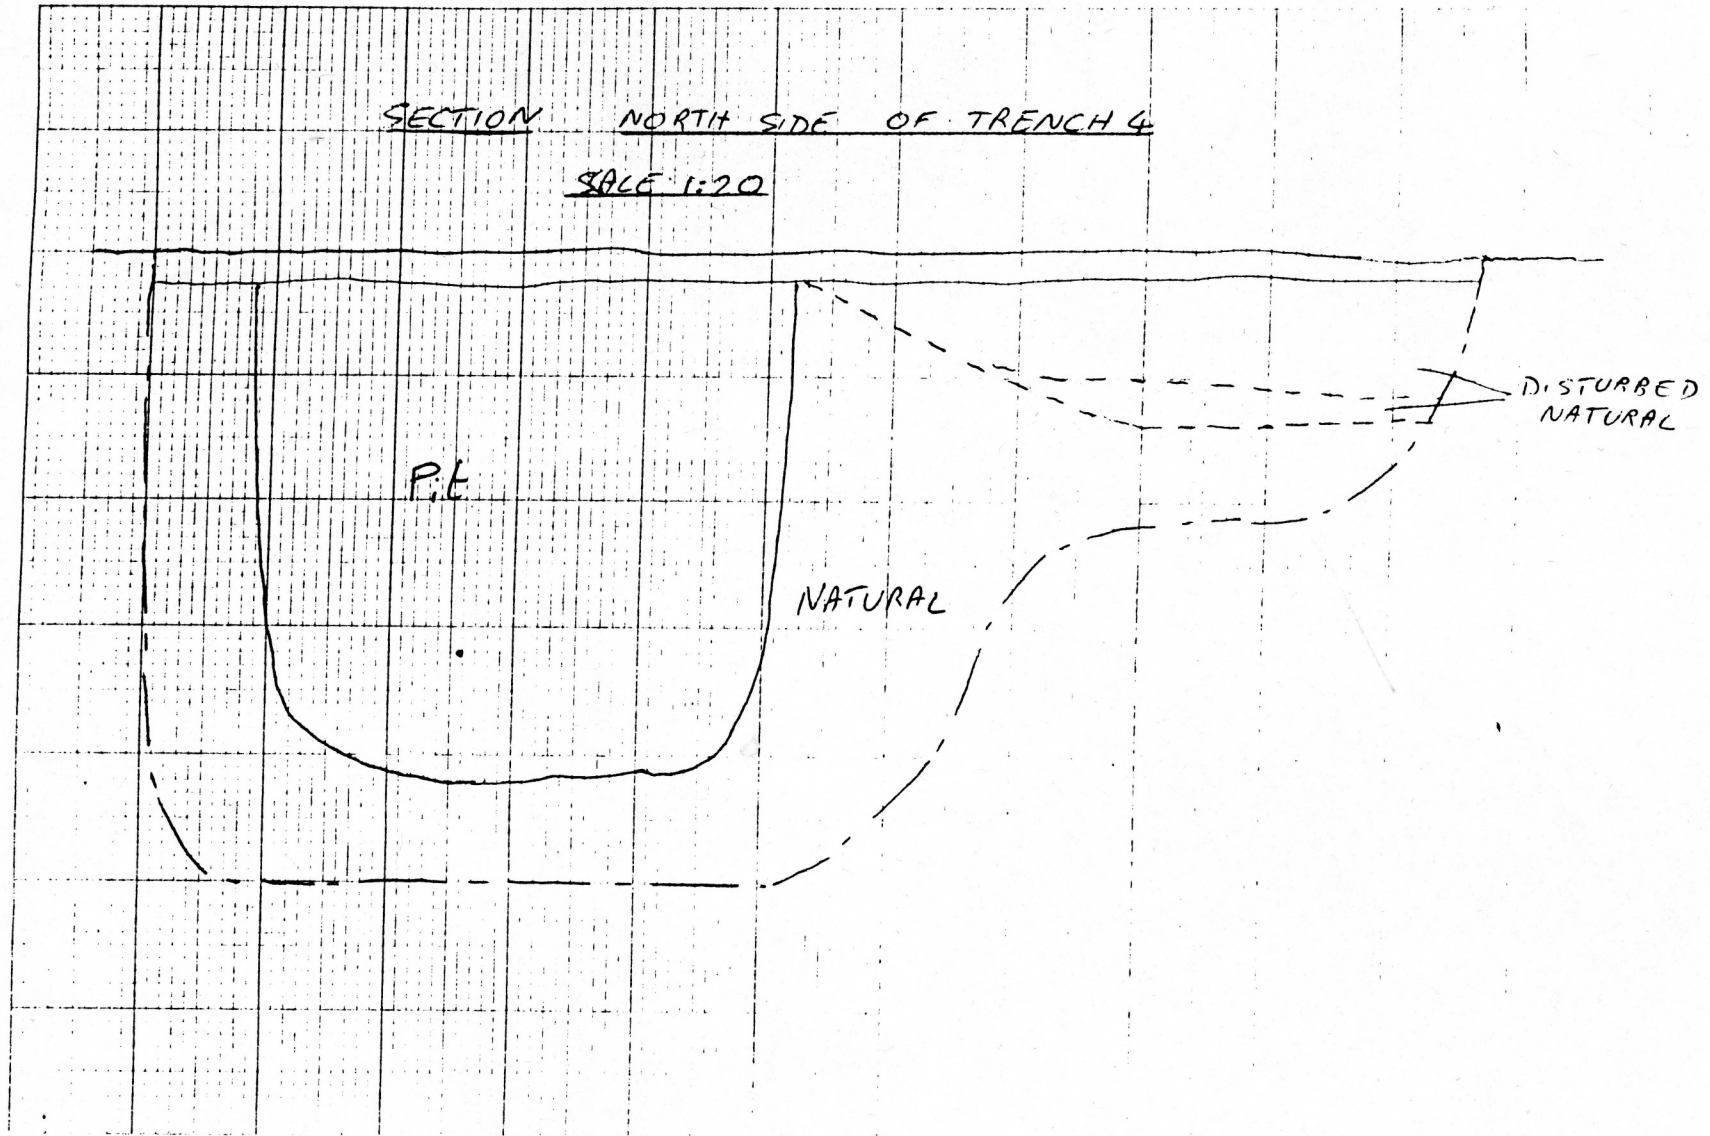
SECTION NORTH SIDE OF TRENCH 4

The fourth trench was dug at the north end of the site. This part of the site (approx. 6m from pavement) was approx. 1.5m lower than the southern part. The sections of trench 4 revealed natural sand only a few centimeters below ground level cut by a trench or pit (see sketch-section). Both sections were very similar. Matching on southern

edge of this trench confirmed that it was a pit. No pottery could be found in this pit. There were a few tile fragment including peg-tile. The peg-tile was however high in the fill.
