**An archaeological
watching brief at
10 East Hill (rear of),
Colchester, Essex**

November 2001

CAT Report 168
January 2002

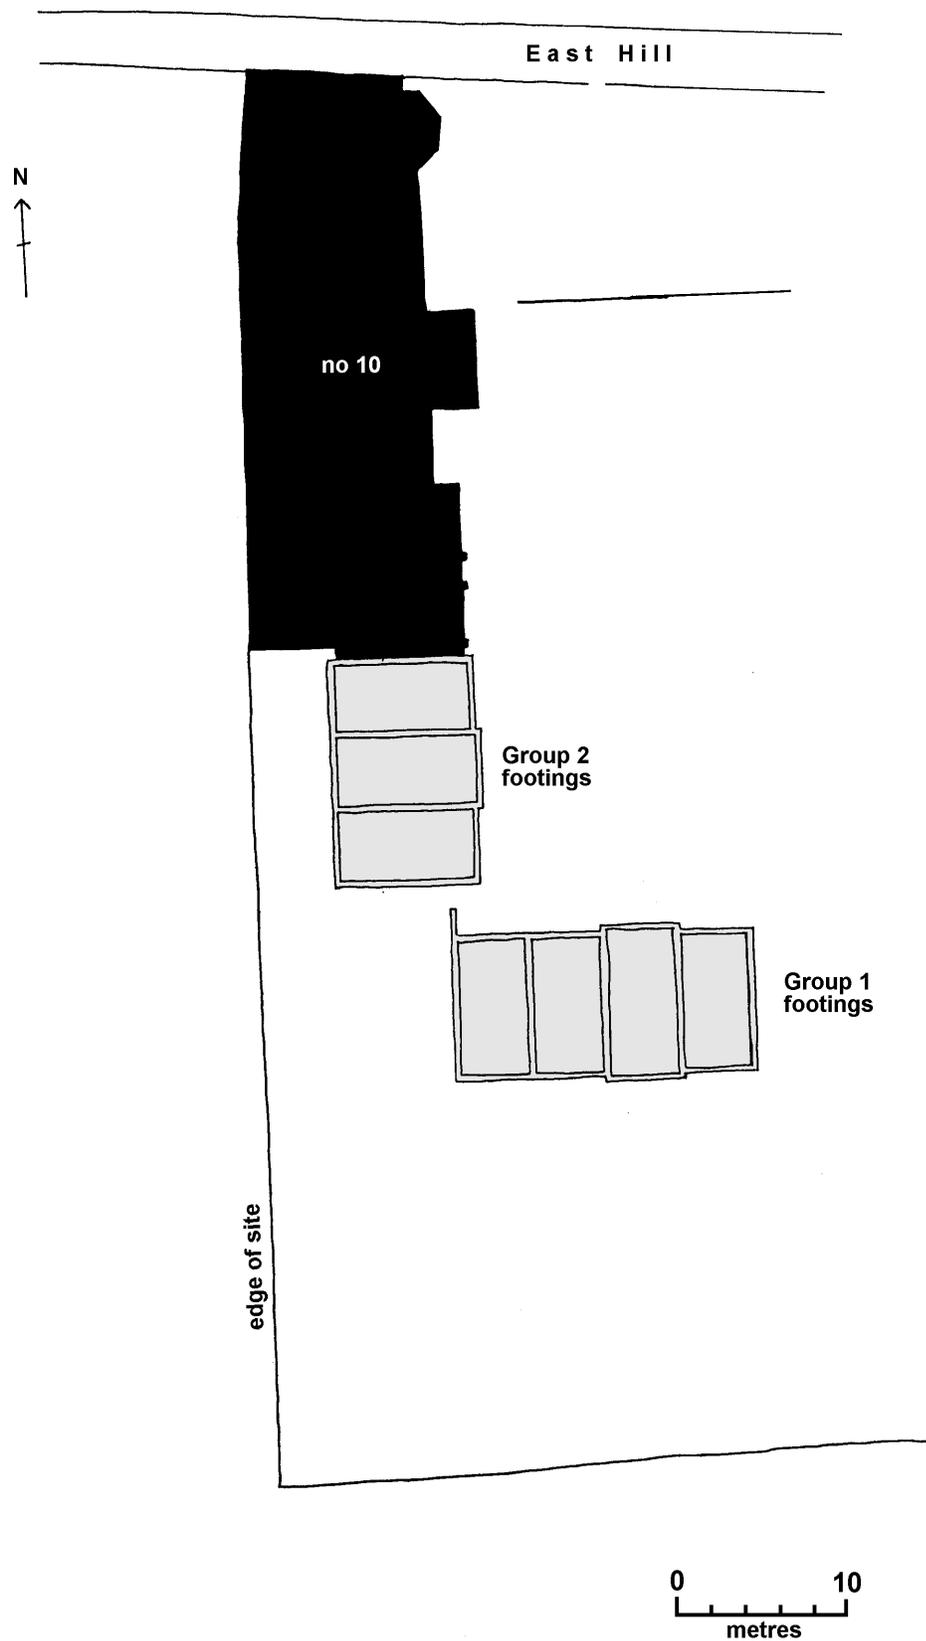
Fig 2 Trench plan.

The site was inspected on four occasions for the purpose of recording any archaeological information that became apparent as groups of building foundation trenches were dug. The trench locations are shown in Figure 2.

Footing trenches 1500mm wide and 2000mm deep were cut into natural yellow/orange sand. The top 200mm contained a disturbed dark brown layer where modern building debris had been compacted into the ground, and further disturbance had been caused by constant movement of plant across the site.

Footing trenches 1500mm wide and 2000mm deep were cut into the same yellow/orange natural sand. There was the same dark brown layer of disturbance, 200mm thick, containing modern brick and concrete and sitting on the natural sand.

Footing trenches were cut in natural yellow/orange sand. The sand contained a natural coarse gravel deposit and some root action. There was also what appeared to be the remains of a tree stump with adhering dark brown soil containing bottle glass and post-medieval red earthenware of 17th- to 19th-century date. The compacted layer was also present, although among the modern building debris there were again post-medieval pottery fragments, clay-pipe stems and some animal bone. There was, however, no visible feature to which they appeared to belong.
