**An archaeological evaluation
at 14 Vineyard Street,
Colchester, Essex
March 2006**

**report prepared by
Ben Holloway**

CAT Report 363
April 2006

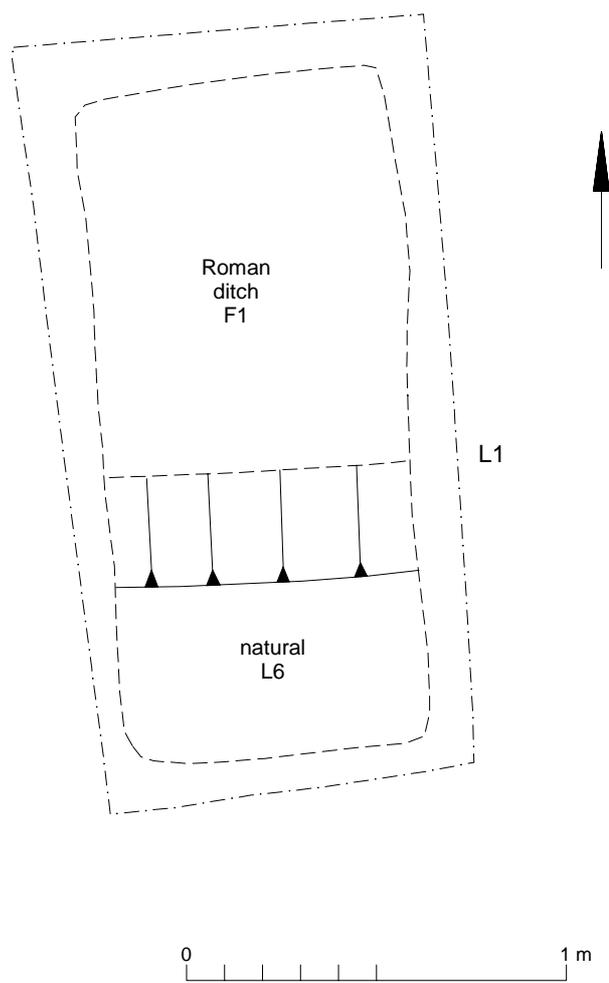
Fig 2 Trench 1: plan.

The uppermost 350mm consisted of modern concrete floors (L1, L2) and hardcore (L3). Beneath this material was a layer of dark earth (L4) which extended to an overall depth of 700mm. Finds from the dark earth indicate a post-medieval to early modern date for this soil. Below the dark earth was a 400m- to 500mm-thick deposit of dark brown silt loam (L5) which contained Roman pottery, *tegulae* (roof tile) and box-flue tile fragments, together with a dumped deposit of oyster shell at the northern end of the trench. L5 continued down to the top of natural sand and gravel (L6), which was exposed at an overall depth of 1.1m in the southern end of the trench. In the central and northern part of the trench, the natural (L6) had been cut by an east-west linear feature (F1). The fill of F1 was removed to an overall depth of 1.3m, at which point excavation ceased for safety reasons. A 700mm-deep auger probe into the F1 fill at the northern end of the trench showed no soil change, which suggests that the feature extends to an overall depth of at least 2m from the surface. Datable finds from the fill of F1 were exclusively Roman.

Trench 1 (plan, Fig 2; section, Fig 3)

The major feature identified in this trench was F1 which is almost certainly the southern (outer) side of the defensive ditch which lay beyond the Roman and medieval town wall. The datable finds from limited excavation of the fill indicate that the ditch cutting located here is Roman (rather than a later medieval recut). Although the ditch appeared to be sealed by L5, the soil definition at that level was poor and it is possible that L5 actually forms the uppermost level of ditch fill.
