Colchester Archaeological Trust
CAT Report 469

Summary sheet

Site address: 9 East Hill, Colchester, Essex	
Parish: Colchester	District: Colchester Borough
NGR: TM 0025 2522 (centre)	Site codes: CAT project code: 08/3g COLEM accession code 2008.57
Type of work: Watching brief	Site director/group: Colchester Archaeological Trust
Date of work: 13th March-14th April 2008	Size of area investigated: footings and a service trench in a 530m ² site
Location of finds/curating museum: Colchester and Ipswich Museums	Funding source: Developer (Rose Builders)
Further seasons anticipated? No	Related UAD nos:
Final report: CAT Report 469 (summary sheet)	
Periods represented: late medieval, post-medieval, modern	
<p>Summary of fieldwork results:</p> <p><i>Footings were excavated for a new development on the site of a car-park on Priory Street between properties 52 and 54 and in front of 52a (Fig 1). These footings were dug to a depth of between 600mm and 700mm below the modern ground-level which included a 250mm-thick layer of concrete and hogging. The footprint of the new building overlay that of a building which once fronted onto Priory Street, the remains of which were observable as numerous l

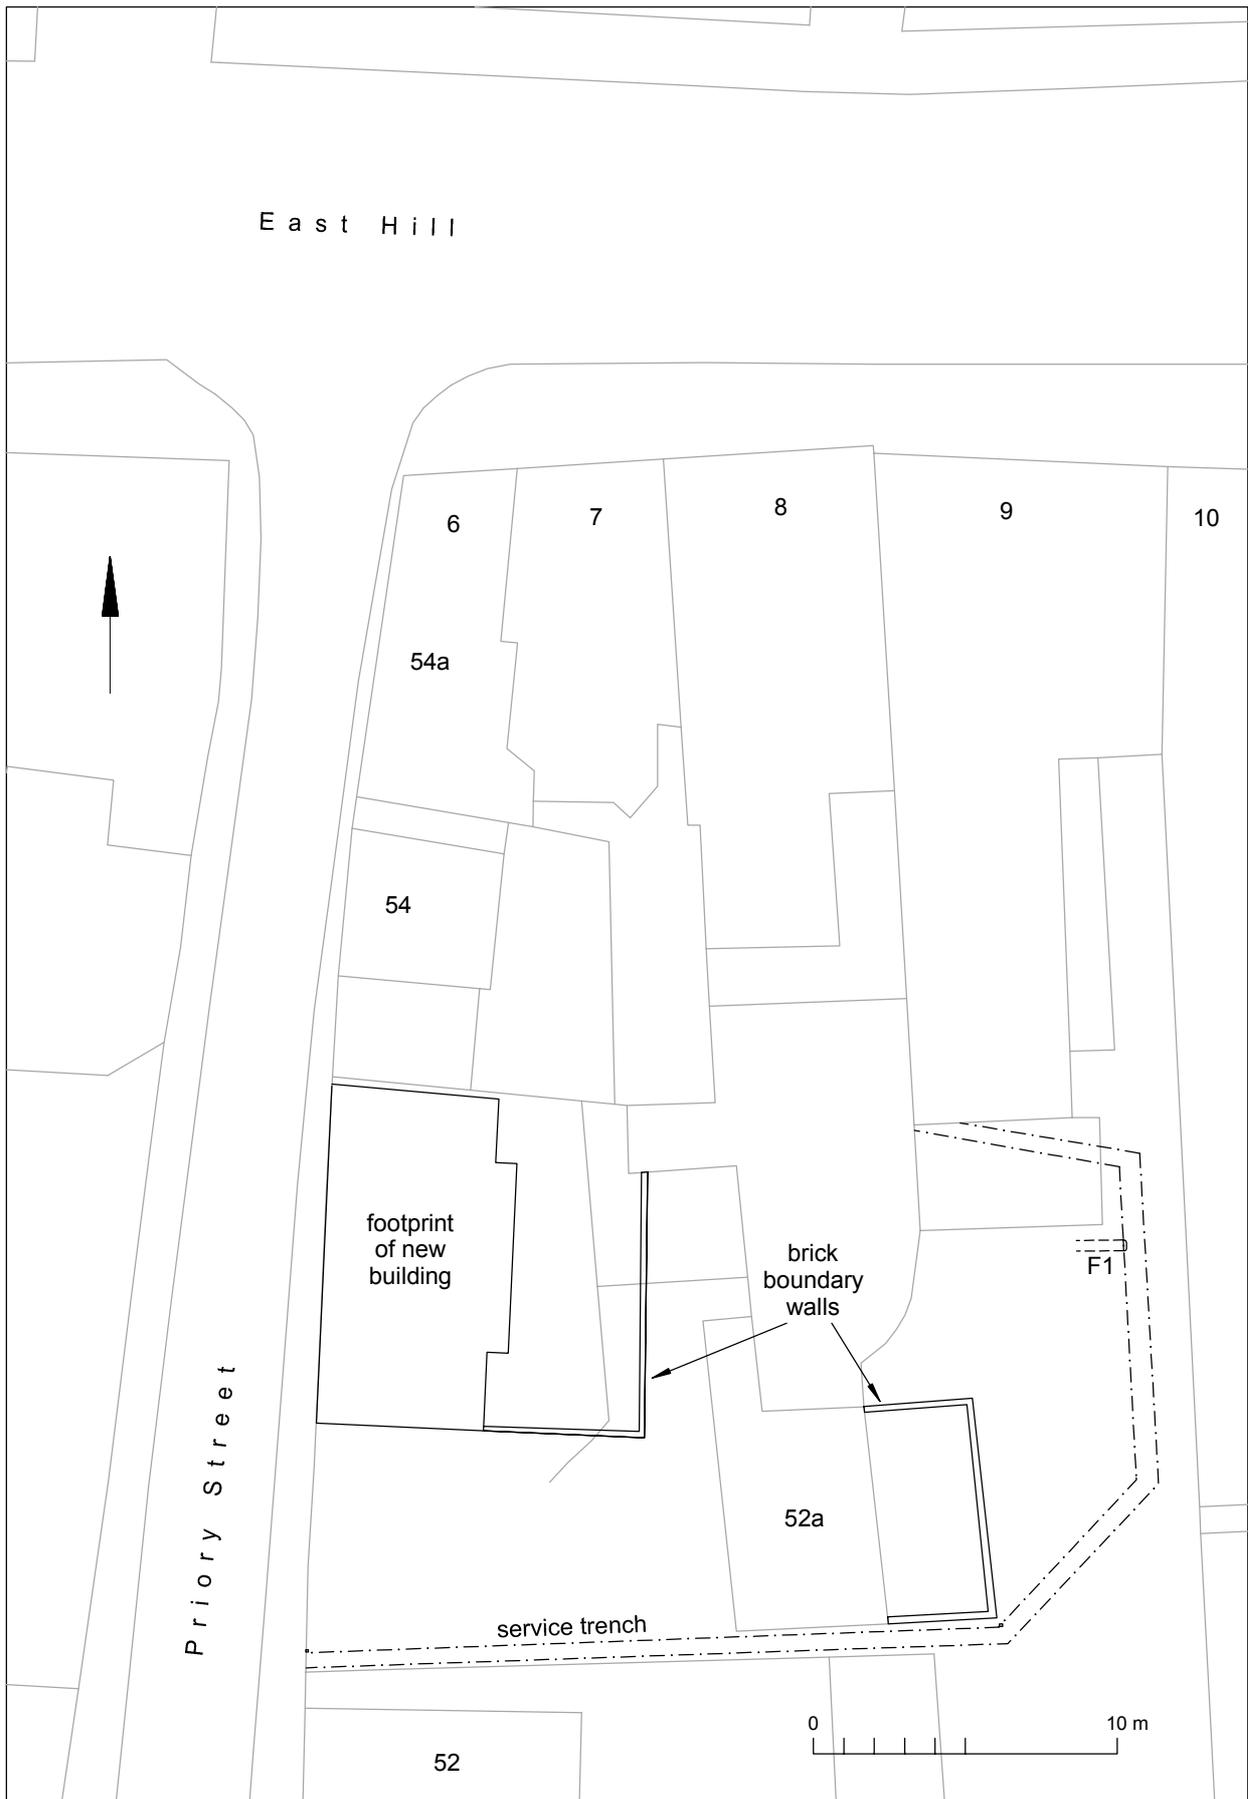
Fig 1 Plan showing the location of the new development and the brick boundary walls for which the footings were excavated, and the service trench with the late medieval/post-medieval wall foundation (F1).
