Archaeological evaluation on land south of 70 Victoria Road, Laindon, Basildon, Essex, SS15 6AR

July 2016

CAT Report 984
August 2016

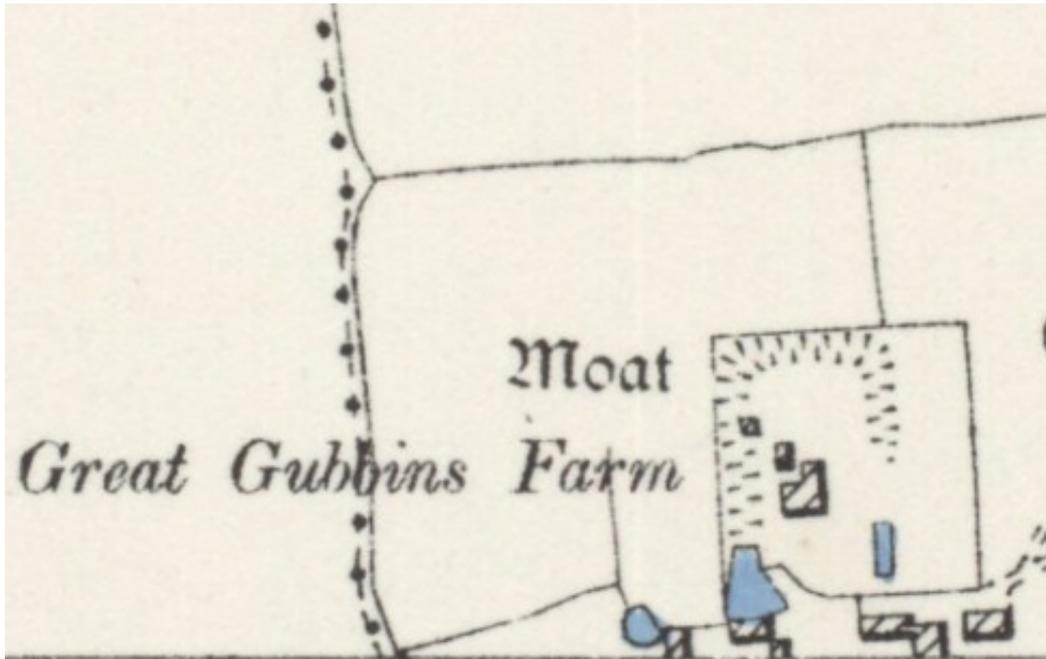
Map 1 Six-inch OS map (Essex LXVIII.SW), revised 1895, published 1898, showing the moat partially filled with water and remaining earthwork.

The proposed development lies on land that historically lay partially upon a moated enclosure at Great Gubbins Farm (HER 5134). The site may have a long history of settlement and possibly be associated with the family of John Gubiun (1258), it is also mentioned in documents dating from 1457. Moated enclosures are typically medieval in date and were often high status settlement sites. The moat is clearly depicted from the 1st to the 4th edition OS maps, although the 1st edition OS shows that only a small part of it still contained water, so the earthwork for the moat must have remained visible until c 1940. The modern garage block has been erected upon the northern arm of the moat.

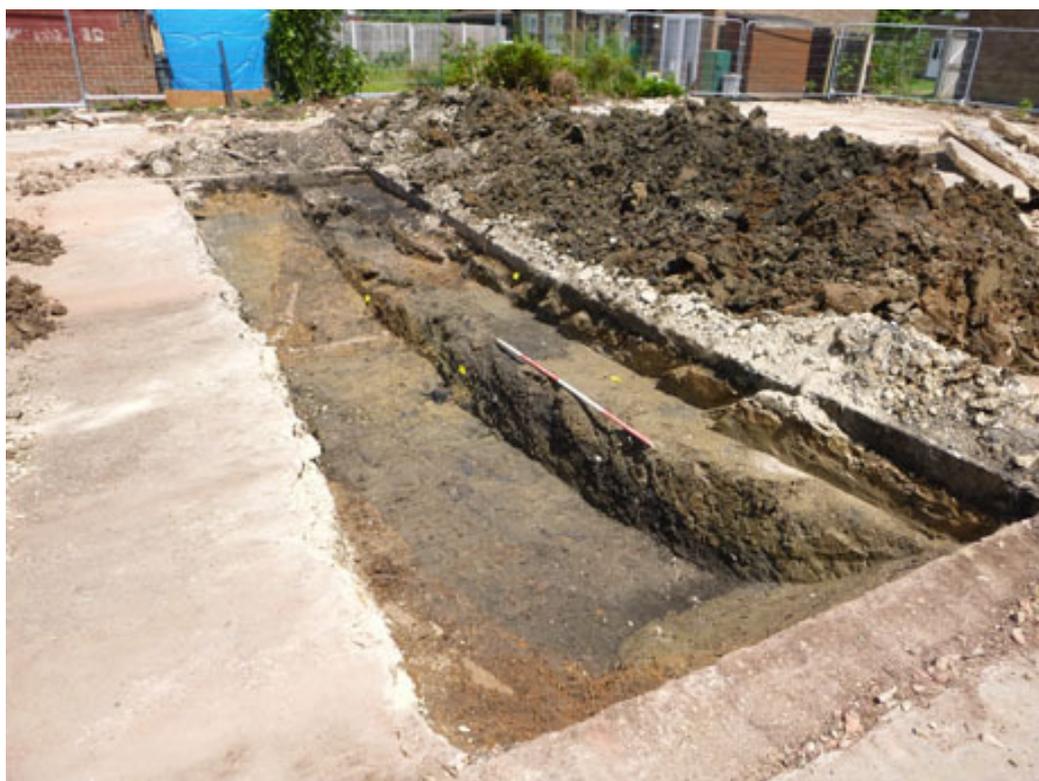
Photograph 1 Trench shot showing the fill of moat F1, looking NE

The entire trench had been disturbed by a number of modern services. At the north and south ends, two layers were identified. Modern hard-standing (L1, c 240-400mm thick) sealed natural clay (L2, identified at a depth of 400mm below current ground level). However, although both edges had been truncated by modern services, the moat (F1) was identified in the centre of the trench. It was excavated to a safe-working depth of 1.10m bcgl and was augured for a further 700mm (making it at least 1.6m deep). The backfill was a firm, moist, dark grey clay containing early 20th-century finds with residual post-medieval pottery.

Despite significant modern disturbance, the Great Gubbins Farm moat was still visible within the evaluation trench. It was identified approximately 200mm below current ground level and excavated to a depth of 800mm, although auguring showed that it survived for a depth of at least 1.6m. The excavated fill of the moat contained early 20th-century pottery with residual late 17th/18th- to 19th-century pottery. OS mapping shows that the moat was only partially filled with water from the late 19th century and the remaining earthwork was visible until c 1940. With the finds evidence, this suggests that the earthwork was being gradually filled during these decades with most of the backfilling occurring in the early 20th century, presumably in advance of the building of the housing estate. Unfortunately the bottom of the moat could not be excavated within the safe-working depth of the trench so we do not know if finds or waterlogged deposits from the medieval period had survived.

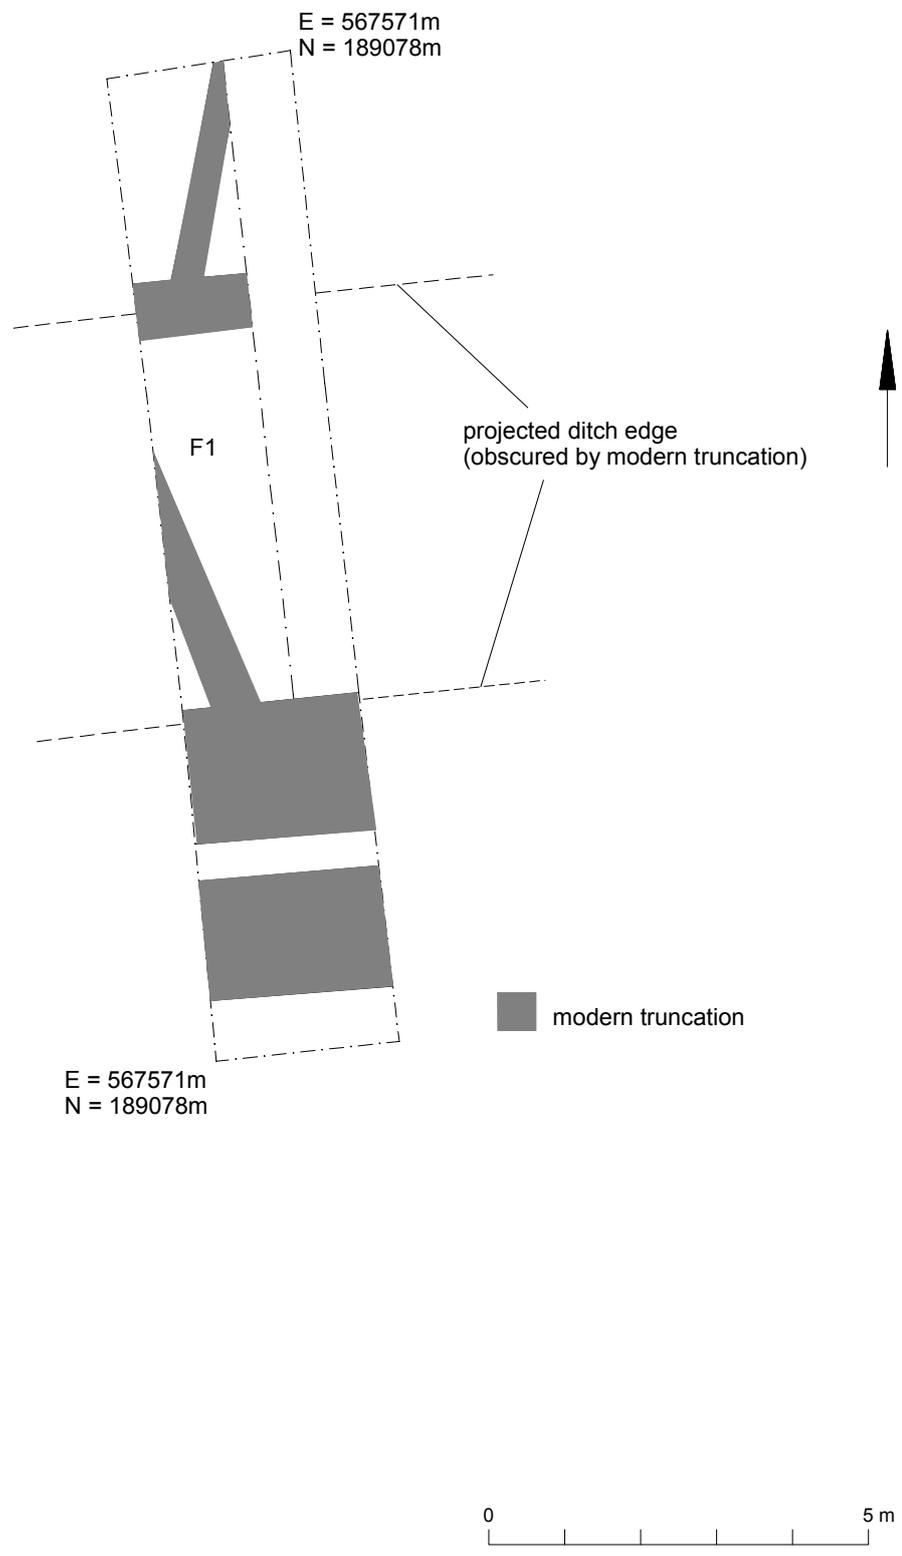
Fig 2 Trench Detail.

A single trial-trench was dug by mechanical excavator under archaeological supervision, measuring 13m long by 2.4m wide. It was located within the footprint of the eastern housing block directly over the projected northern side of the Great Gubbins Farm moat.
