CAT Report 1777

Archaeological monitoring at 3 Hurnard Drive, Colchester, Essex, CO3 3SH: April 2019

Nature of the work: Observation of groundworks for single-storey rear extension. The proposed front extension did not happen.

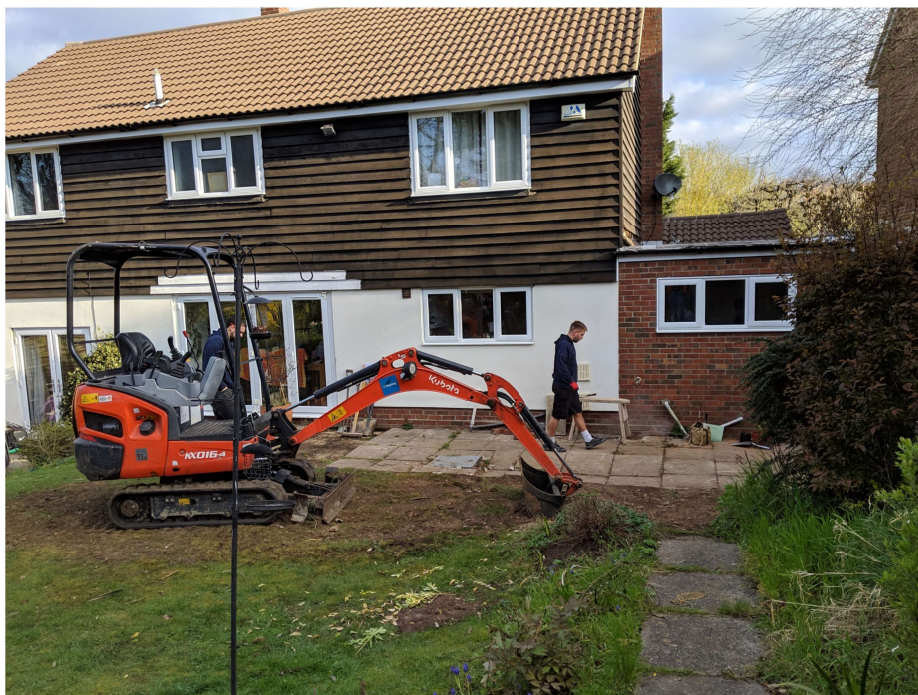
Photograph 1 Site shot - view north

An area of 12 square metres was mechanically-stripped down roughly 0.70m. This area was excavated into two layers: topsoil (L1, c 0.25-0.29m thick, soft, dry, medium grey/brown sandy silt) and into the subsoil (L2, c 0.40-0.44m thick, firm, medium brown sandy silt).

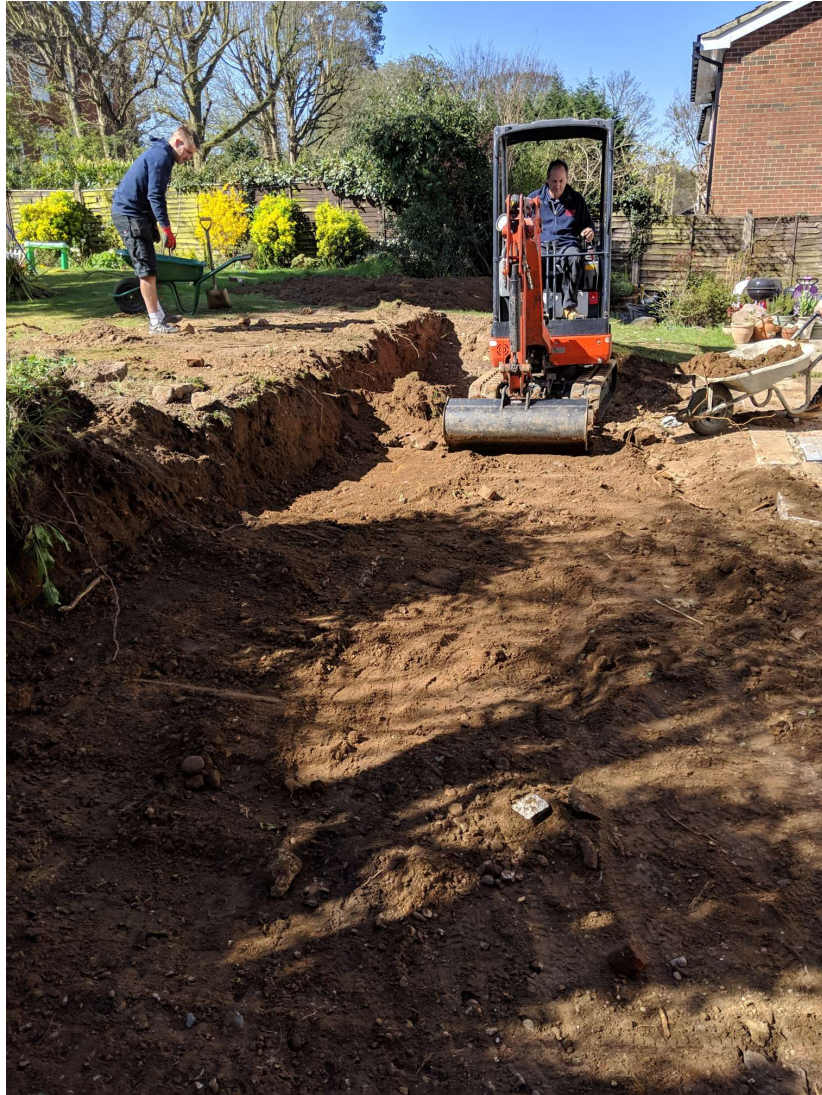
Photograph 2 Working shot - view west

Approximately 15m of foundation trenching was then excavated. The trench was cut through a modern patio and sand sub-base layer (L3, c 0.14m thick), a make-up layer (L4, c 0.35-0.42m thick, hard, dry, medium grey sandy silt) and into the natural sands and gravels (L5, c 0.49-0.56m below current ground level, soft, moist, medium yellow/orange/brown sand with gravel). The trench was 0.65m wide and 1.25m deep.

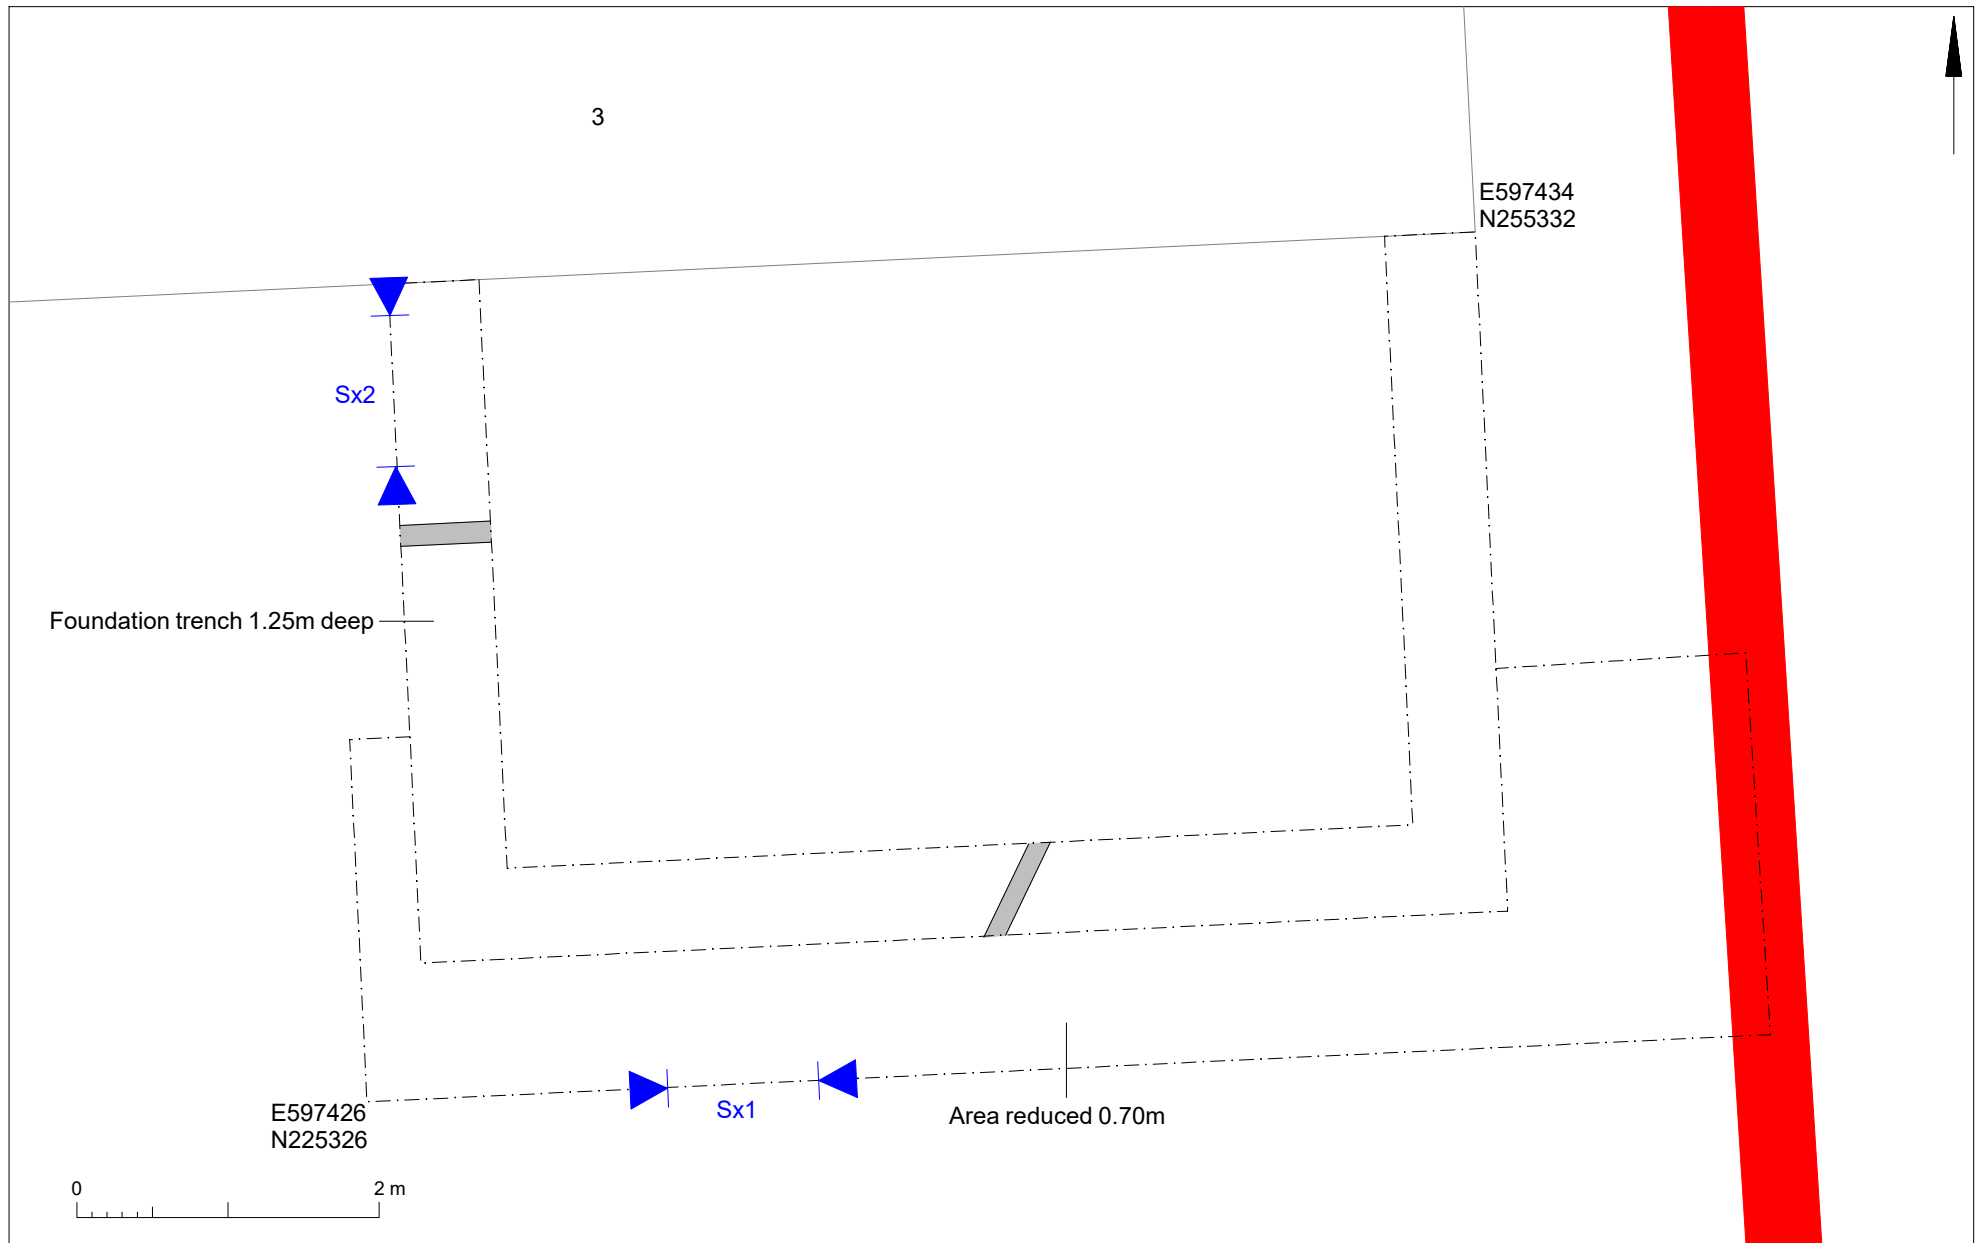
Fig 2 Results. Modern services in grey.

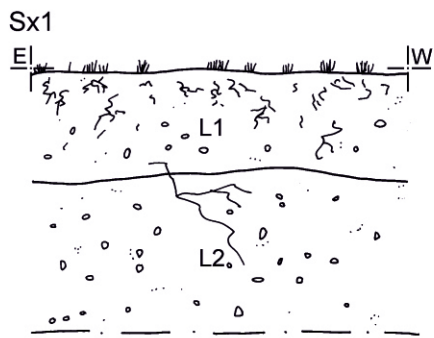
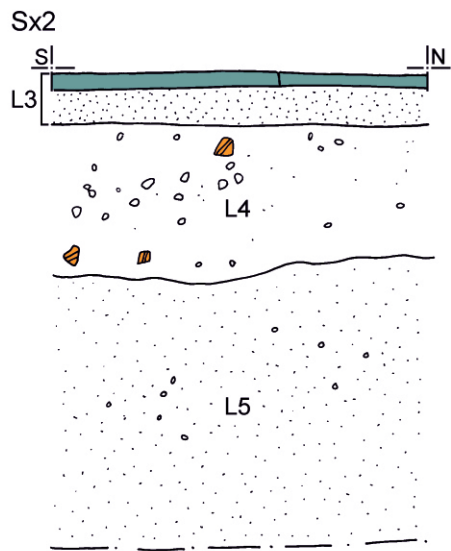
-   stones
-   sand
-   post-Roman CBM
-   roots
-   paving slab

Fig 3 Representative sections.
